Lord Howe Island
Aerodrome Technical
Inspection 2017

AERODROME TECHNICAL INSPECTION

23rd – 26th July 2017

Airport Operation Support Pty Ltd

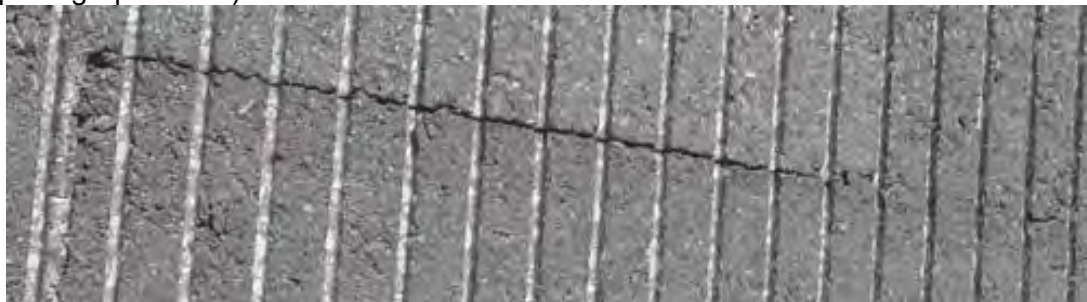
- Cracking: One isolated longitudinal crack was observed to the runway (see photograph below).

- This crack along with any type of surface rupture must be maintained sealed to prevent the ingress of water into the pavement subgrade.
- ➔ **Recommendation 1: To monitor and seal any surface ruptures to the sealed manoeuvring areas (RWY, TWY and apron).**

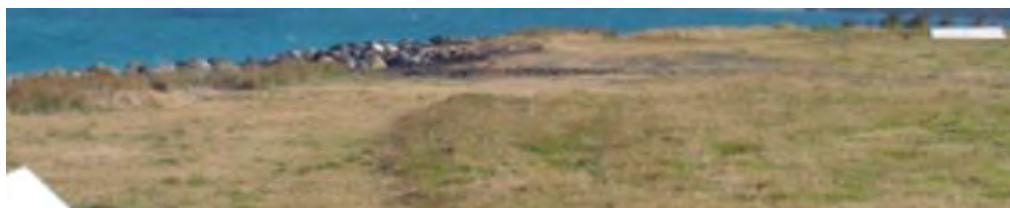
- Dimensions: The overall strip dimensions are 1008m long by 90m wide.
 - The 90m wide RWS width is mildly truncated at both ends (right hand side of approach) and details of this non-compliance against the requirements of CASR 139, Section 139.015 have been included in the Aerodrome Manual under the "Aerodrome Information" chapter (paragraph 4.0 Aerodrome Exemptions) as an explanation.
- Surface: The surface is generally well graded with evenly mown dense grass that is evenly maintained at about 200mm in height.
- Slopes: For most of the RWS, the transverse and long section slopes appeared minimal but met the specifications MOS 139.
 - At the southern side of THR 10 (RHS of APCH), the transverse slopes appeared to be too steep (refer to photograph to determine approximate location).

- ▲ When crudely assessed based on 6 ground level survey points, the results revealed that the transverse slope was not compliant for a Code 2 runway.
- ▲ For a Code 2 runway, the maximum permitted slope on the graded portion of the runway strip must not be more than 3.0% (refer MOS 139 Section 6.2.22.1(a) excerpt).
- ▲ It is important for the Board to maintain the RWS compliant especially because the full required RWS is not provided (truncated at two corners).

→ **Recommendation 2:** To backfill and re-grade the runway strip to achieve compliant transverse slopes to the southern side of THR 10 (refer to MOS 139, Section 6.2.22).

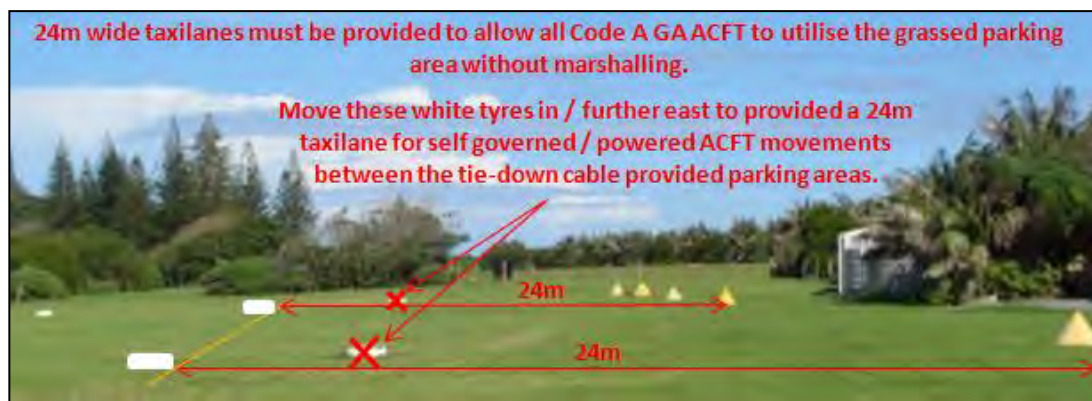
EXAMPLE FROM 2013 ATI REPORT.

In the 2013 ATI, it was brought to the Board's attention that the painted white tyres (that reveal the tie-down cable locations and therefore parking extents) locate too close the boundary and the RPT apron. It was recommended that the tyres be moved further east to provide a clear 24m wide taxilane along the boundary and clear of the RPT apron.

- The LHIB has acknowledged this and has stated that they intend to improve this in the future.
- It is noted that in all past ATI inspection, no ACFT has ever been observed parking in this area.

- Considering Section 8.5.1.2 of the MOS 139 and the LHIB intentions to re-configure the grass apron and general non-use of the area, any recommendation and / or advice will be reserved for when necessary.

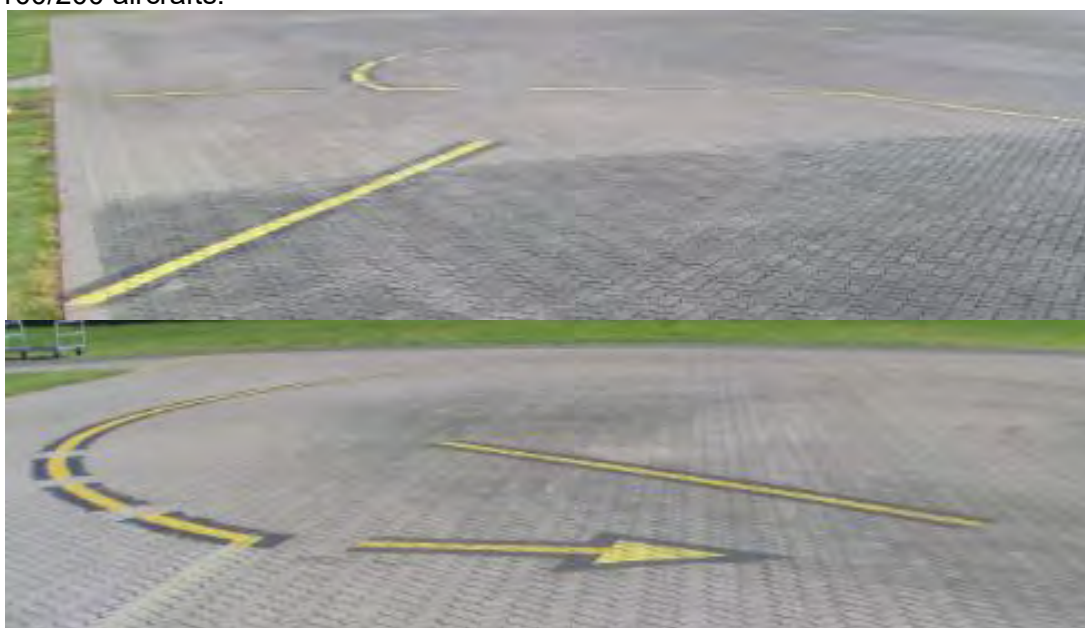
- The western parking position or bay 1 has been marked in accord with an older plan design (2002). Whilst sighted in past inspections, this plan was no longer available for perusal.

- ▲ In this older 2002 design, it was observed that parking bay 1 located further to the east than the parking bay 1 design revised in the latter design (discussed below). Hence, in theory, wing tip clearances must be greater.
