# Lord Howe Island Coastline Hazard Definition and Coastal Management Study

Prepared for the Lord Howe Island Board by Haskoning Australia Pty Ltd

9 September 2014

Issue 5 (Final)

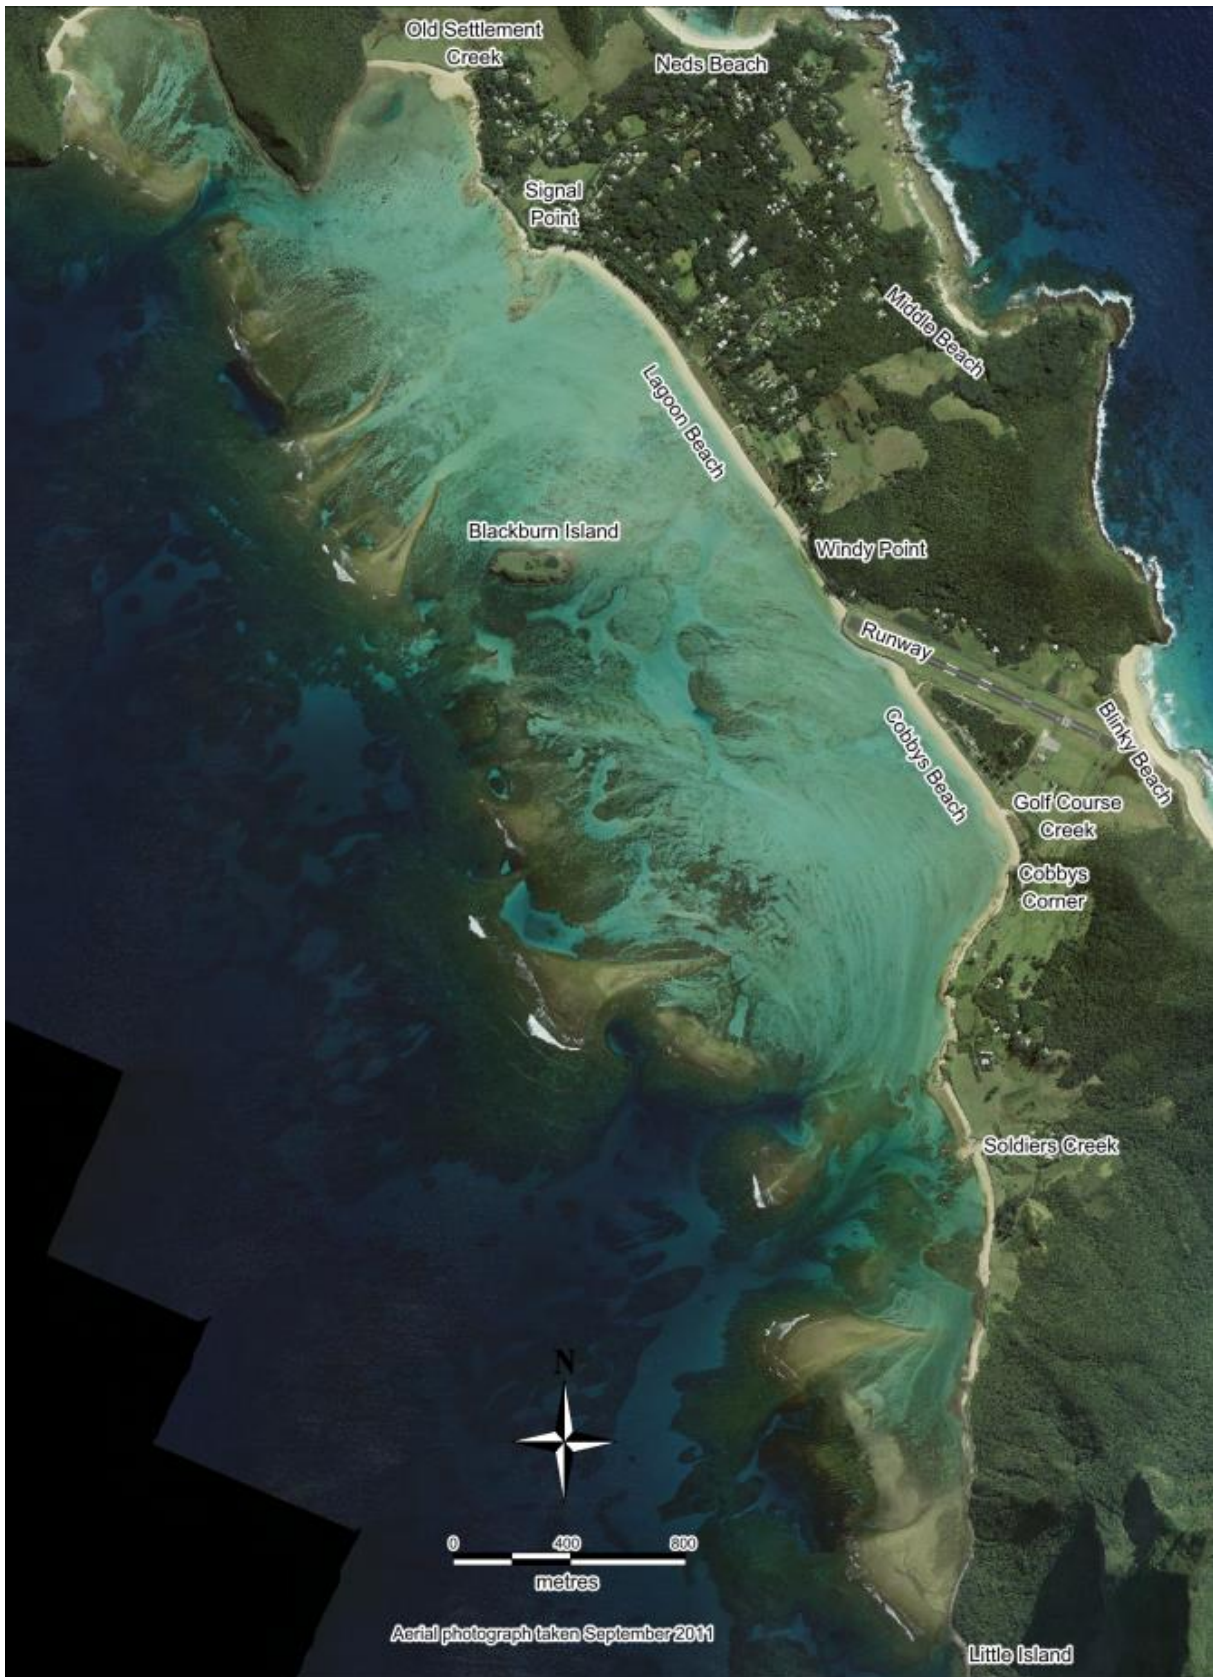
**Figure 3: Aerial photograph of Lagoon area at Lord Howe Island**

An aerial photograph of the entire Lagoon area is provided in Figure 3. Lagoon Beach has been defined herein to extend from Signal Point in the north to the runway (where it juts out into the Lagoon) in the south, over a length of about 1.7km. Cobbys Beach has been defined to extend from the runway in the north to Cobbys Corner in the south<sup>2</sup>, over a length of about 0.8km.

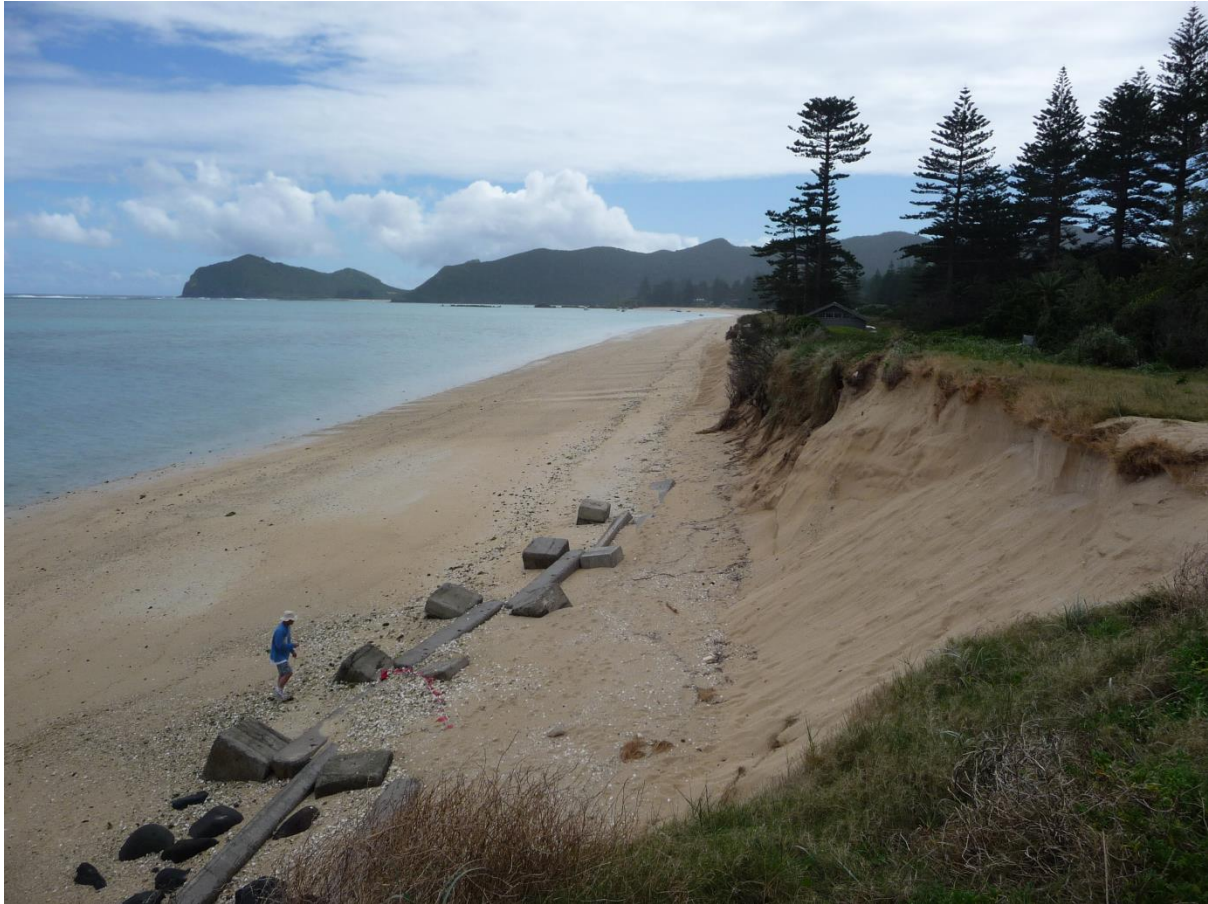
**Figure 5: Concrete north of sand-filled geotextile container wall, 28 August 2012**

After completion of the bag wall in May 2011, the concrete blocks originally placed in 2004 were placed immediately north of the bags at the toe of the dune. The concrete moved under wave action and was put back into position in October 2011, and then again in May 2012. A view of this area in August 2012, indicating that the concrete had again moved (or that dune erosion had extended further landward), is given in Figure 5.

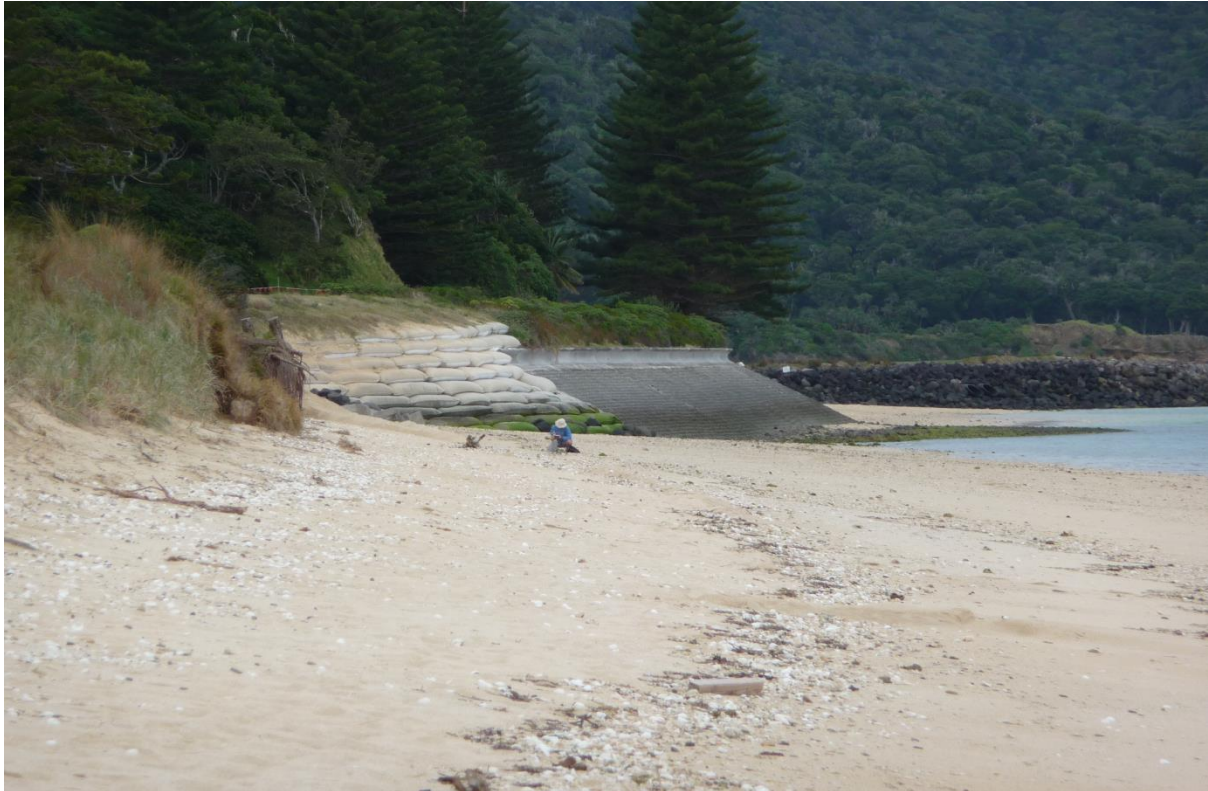
**Figure 6: View of sand-filled geotextile container wall, Seabee revetment and runway revetment from the southern end of Lagoon Beach, 28 August 2012**

A view of the geotextile bag wall, Seabee revetment and runway revetment from the southern end of Lagoon Beach is provided in Figure 6. A view of the bag wall and Seabee revetment from offshore is given in Figure 7. An aerial view of the location of all of these works is depicted in Figure 8.

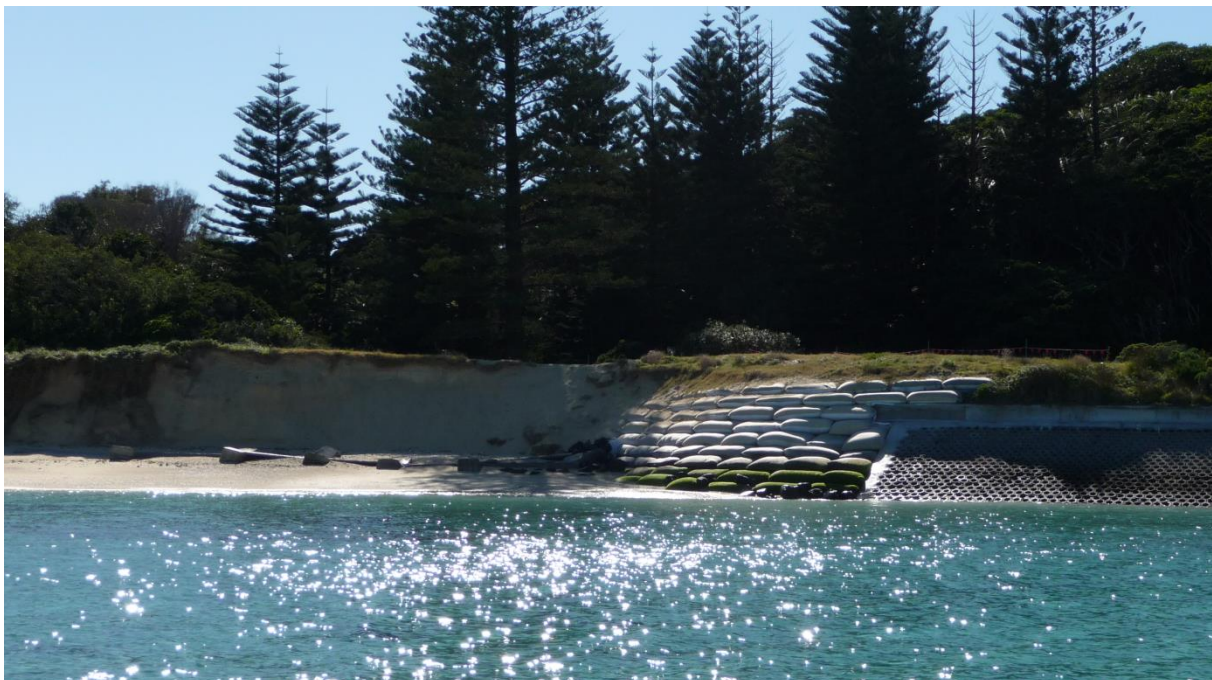
**Figure 7: View (left to right) of eroding dune with concrete and rock on beach, sand-filled geotextile container wall and Seabee revetment (29 August 2012)**

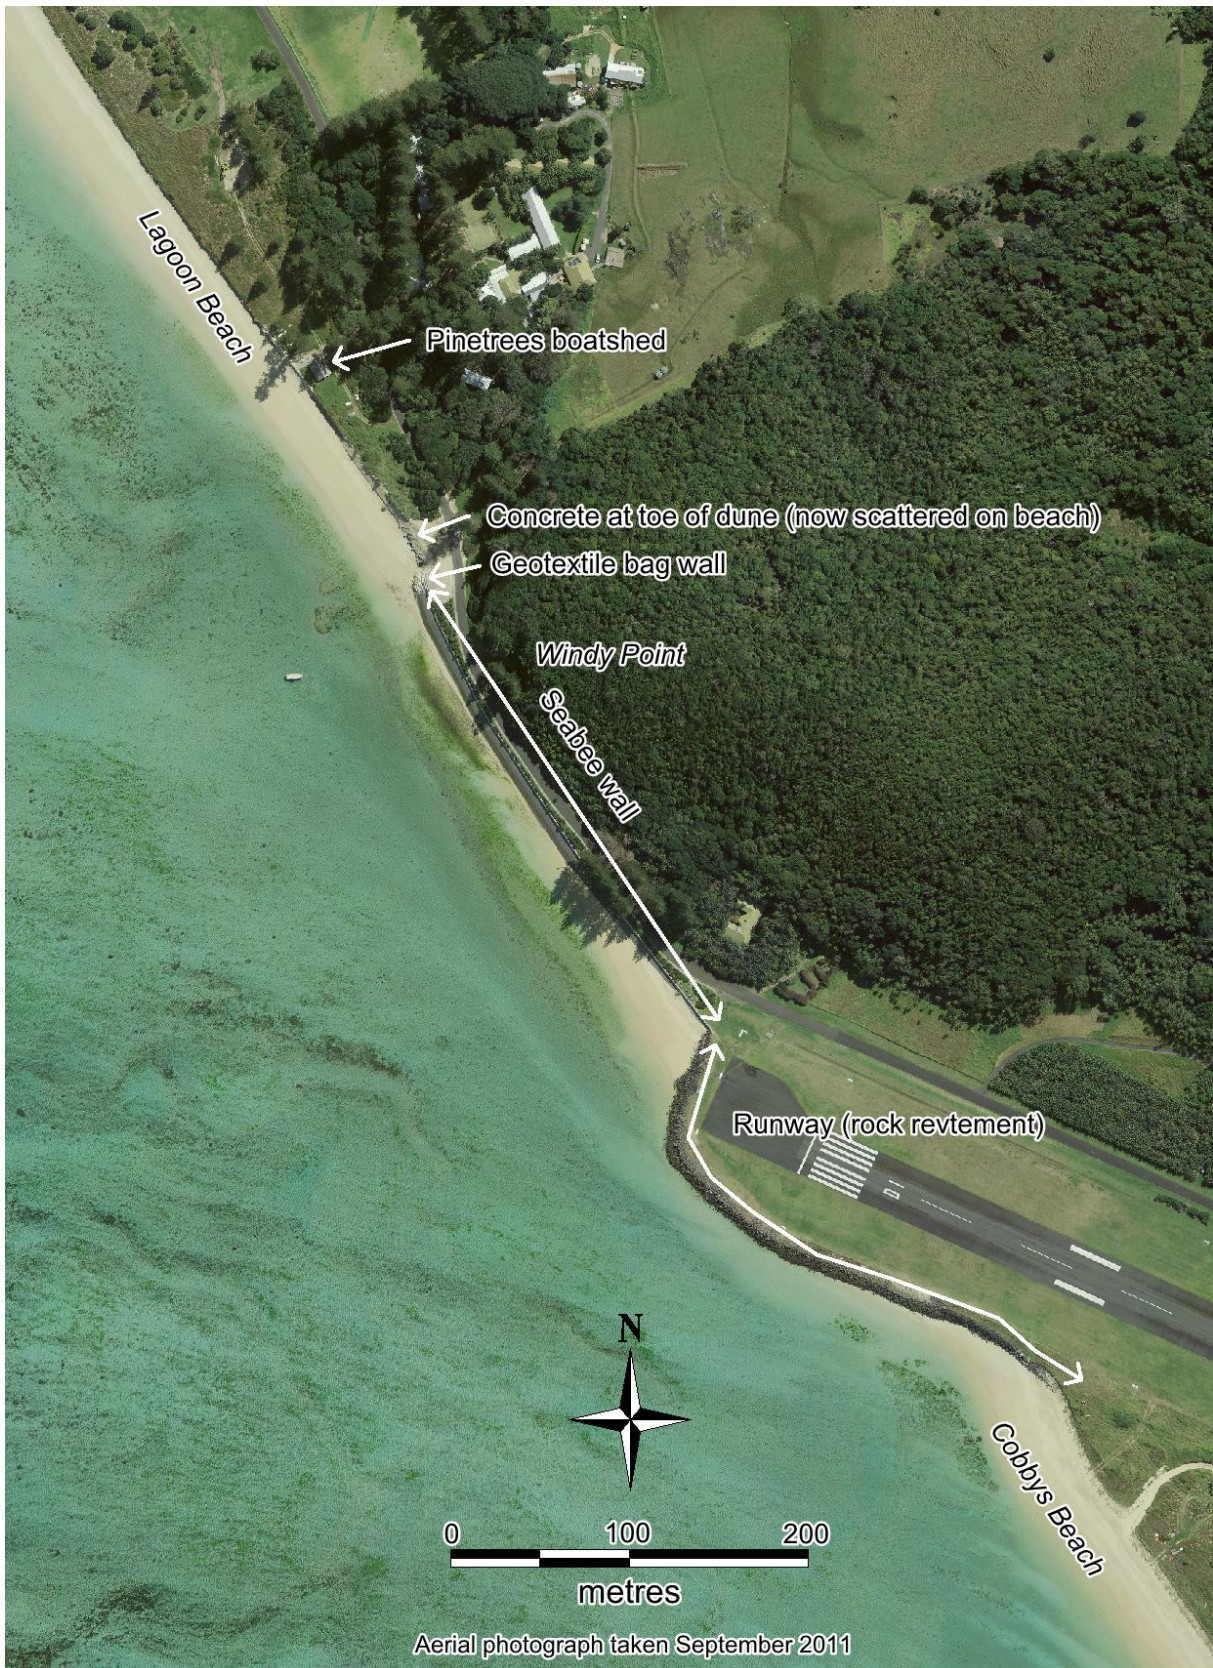
**Figure 8: Location of protective works near southern end of Lagoon Beach**

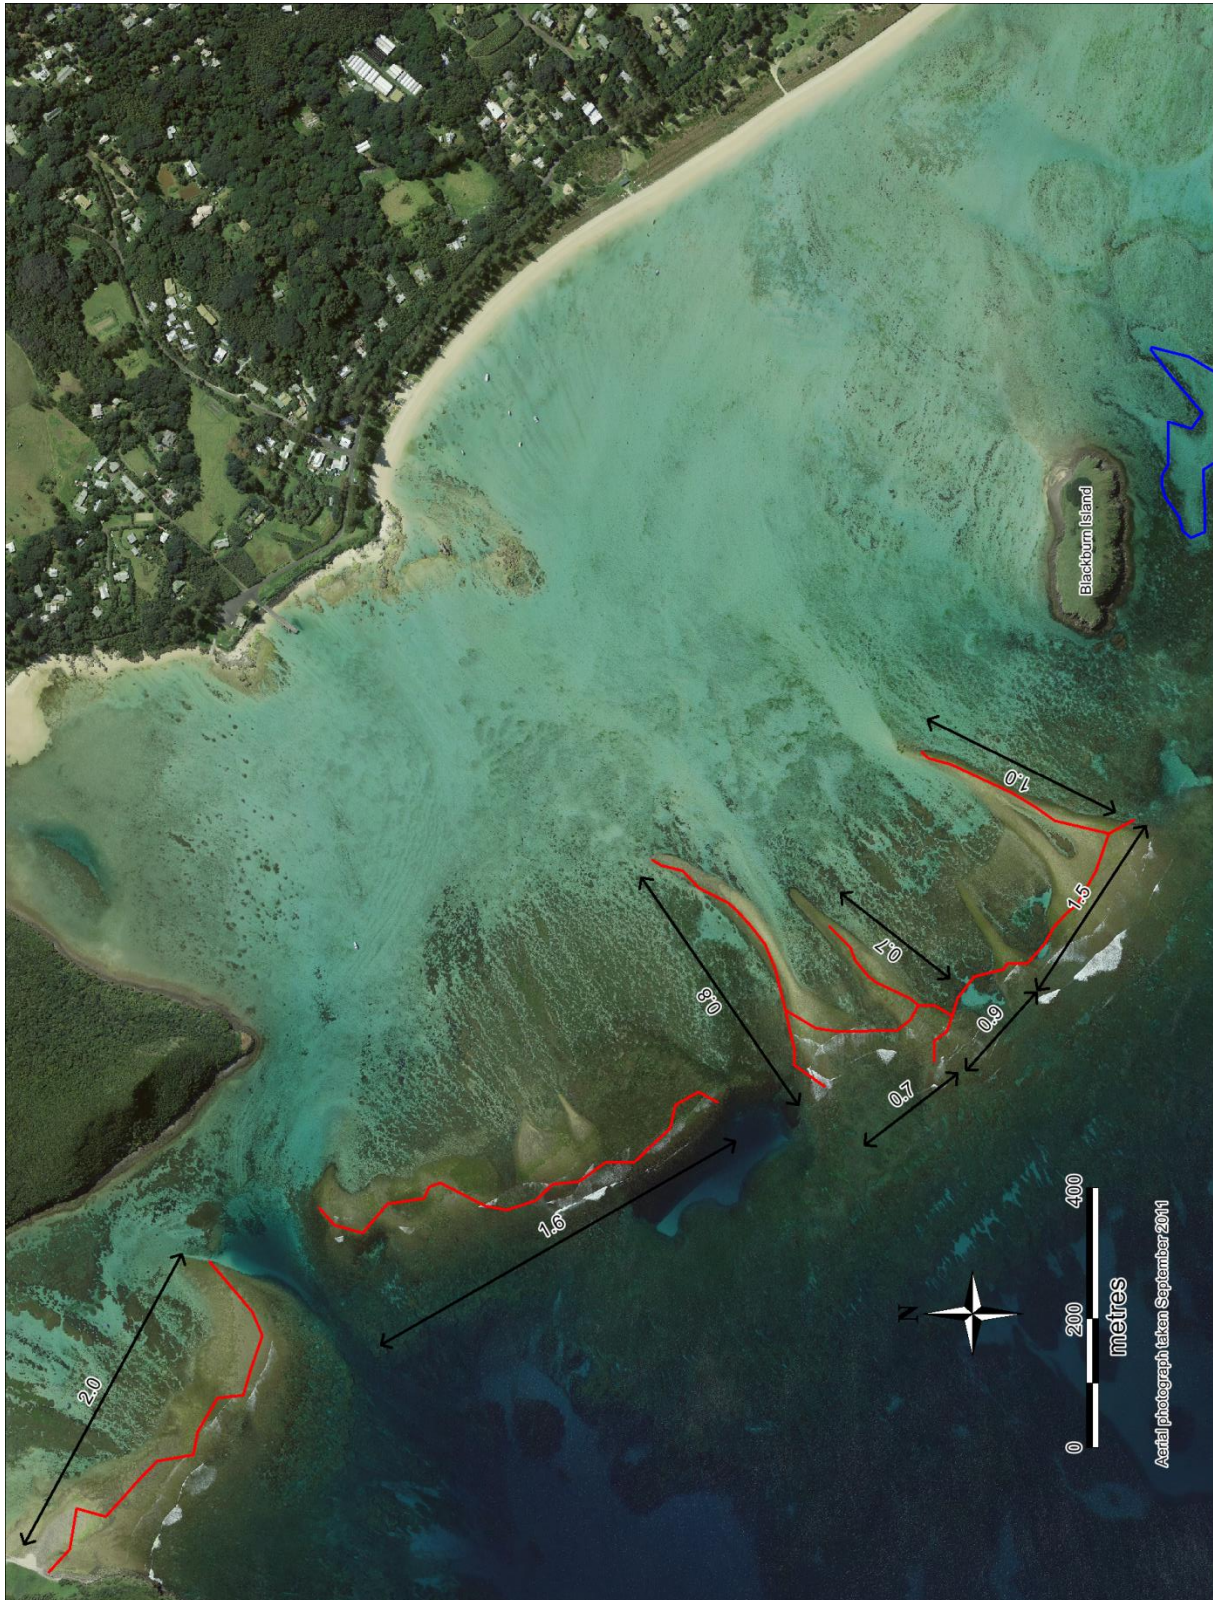
**Figure 10: Position and elevation (m AHD) of reef crests north of Blackburn Island (red), with portion of deeper Lagoon area shown in blue**

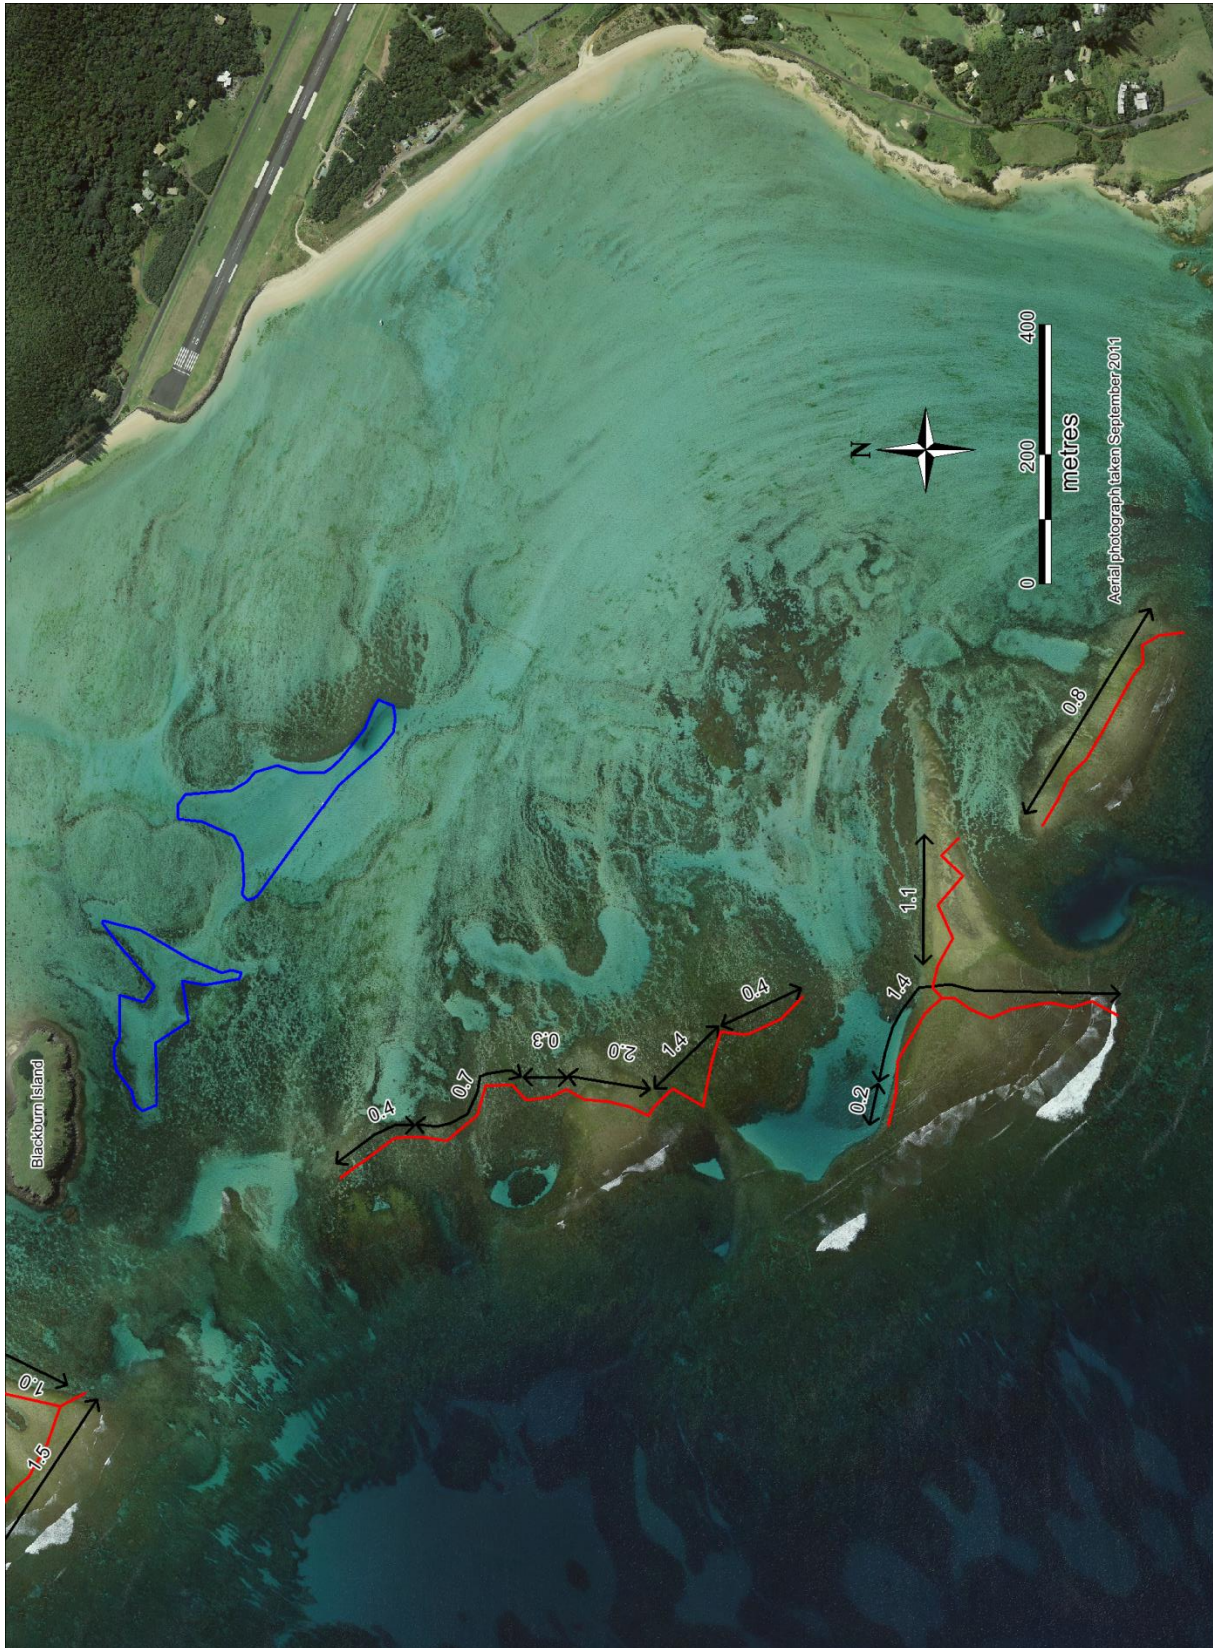
**Figure 11: Position and elevation (m AHD) of reef crests south of Blackburn Island (red), with deeper Lagoon areas shown in blue**

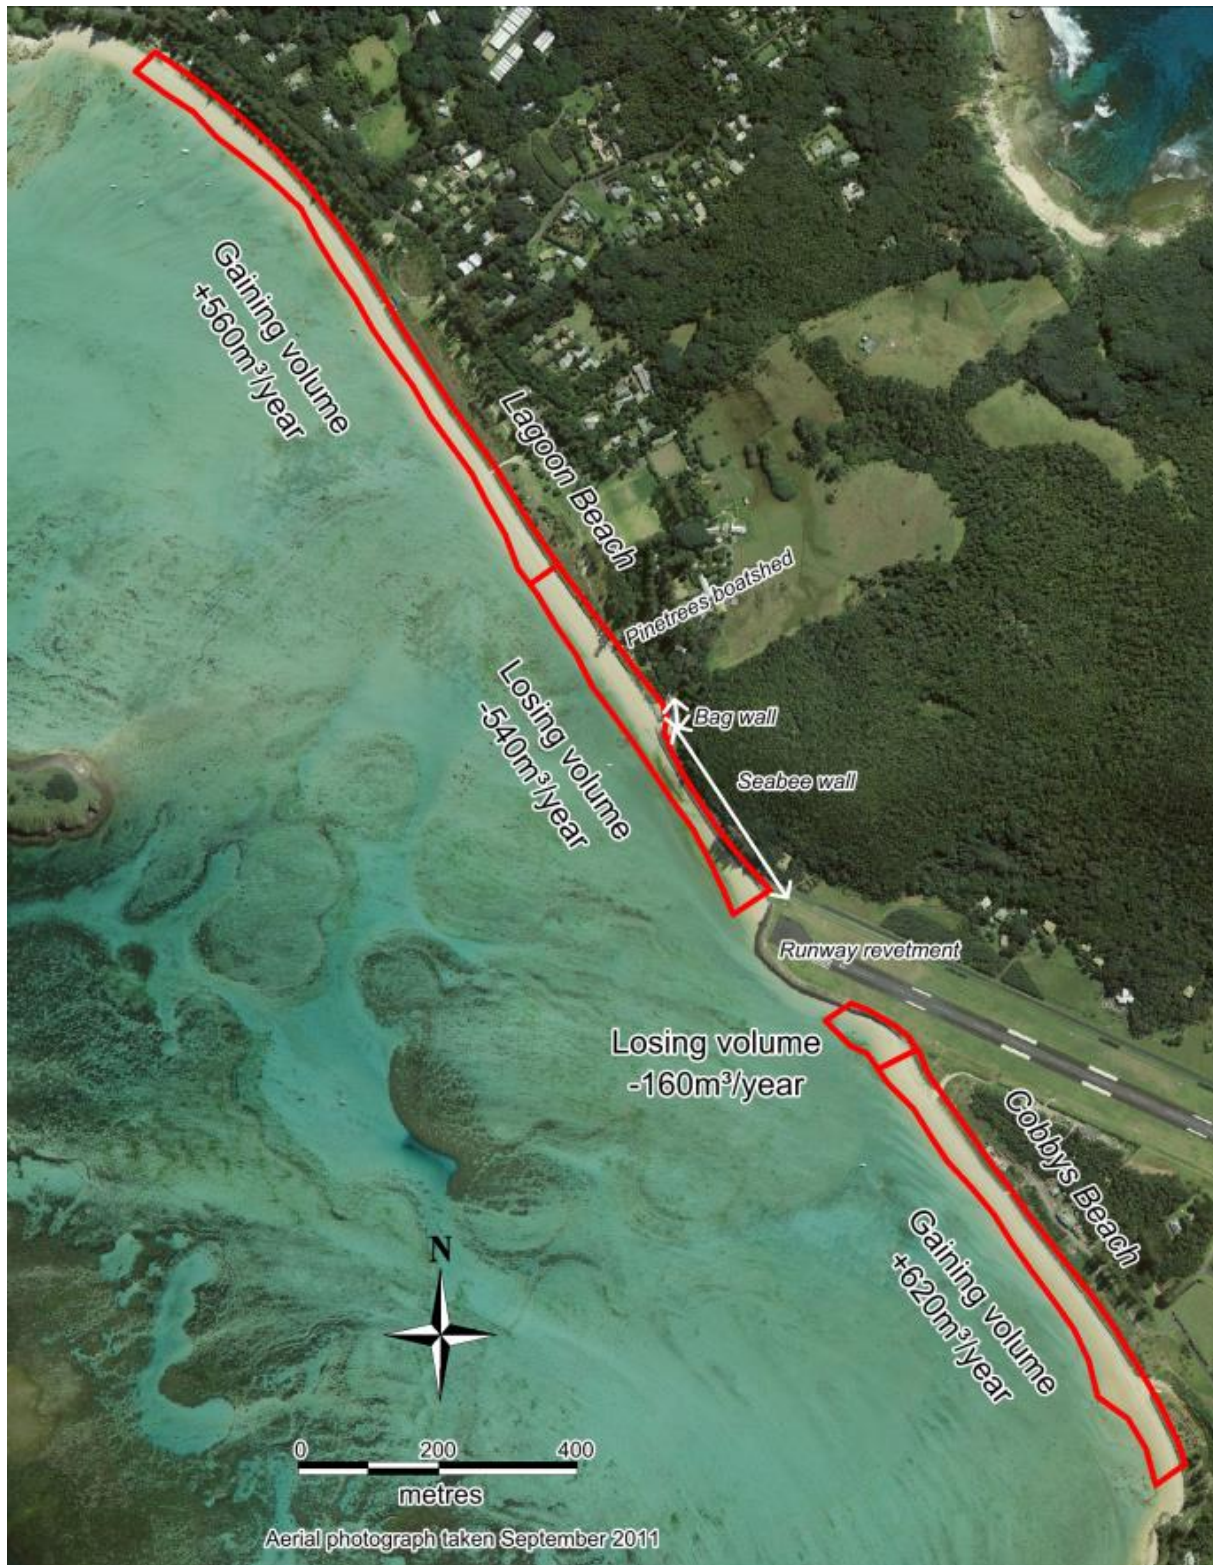
**Figure 12: Summary of long term (1965 to 2011) sand volume changes at Lagoon Beach and Cobbys Beach**

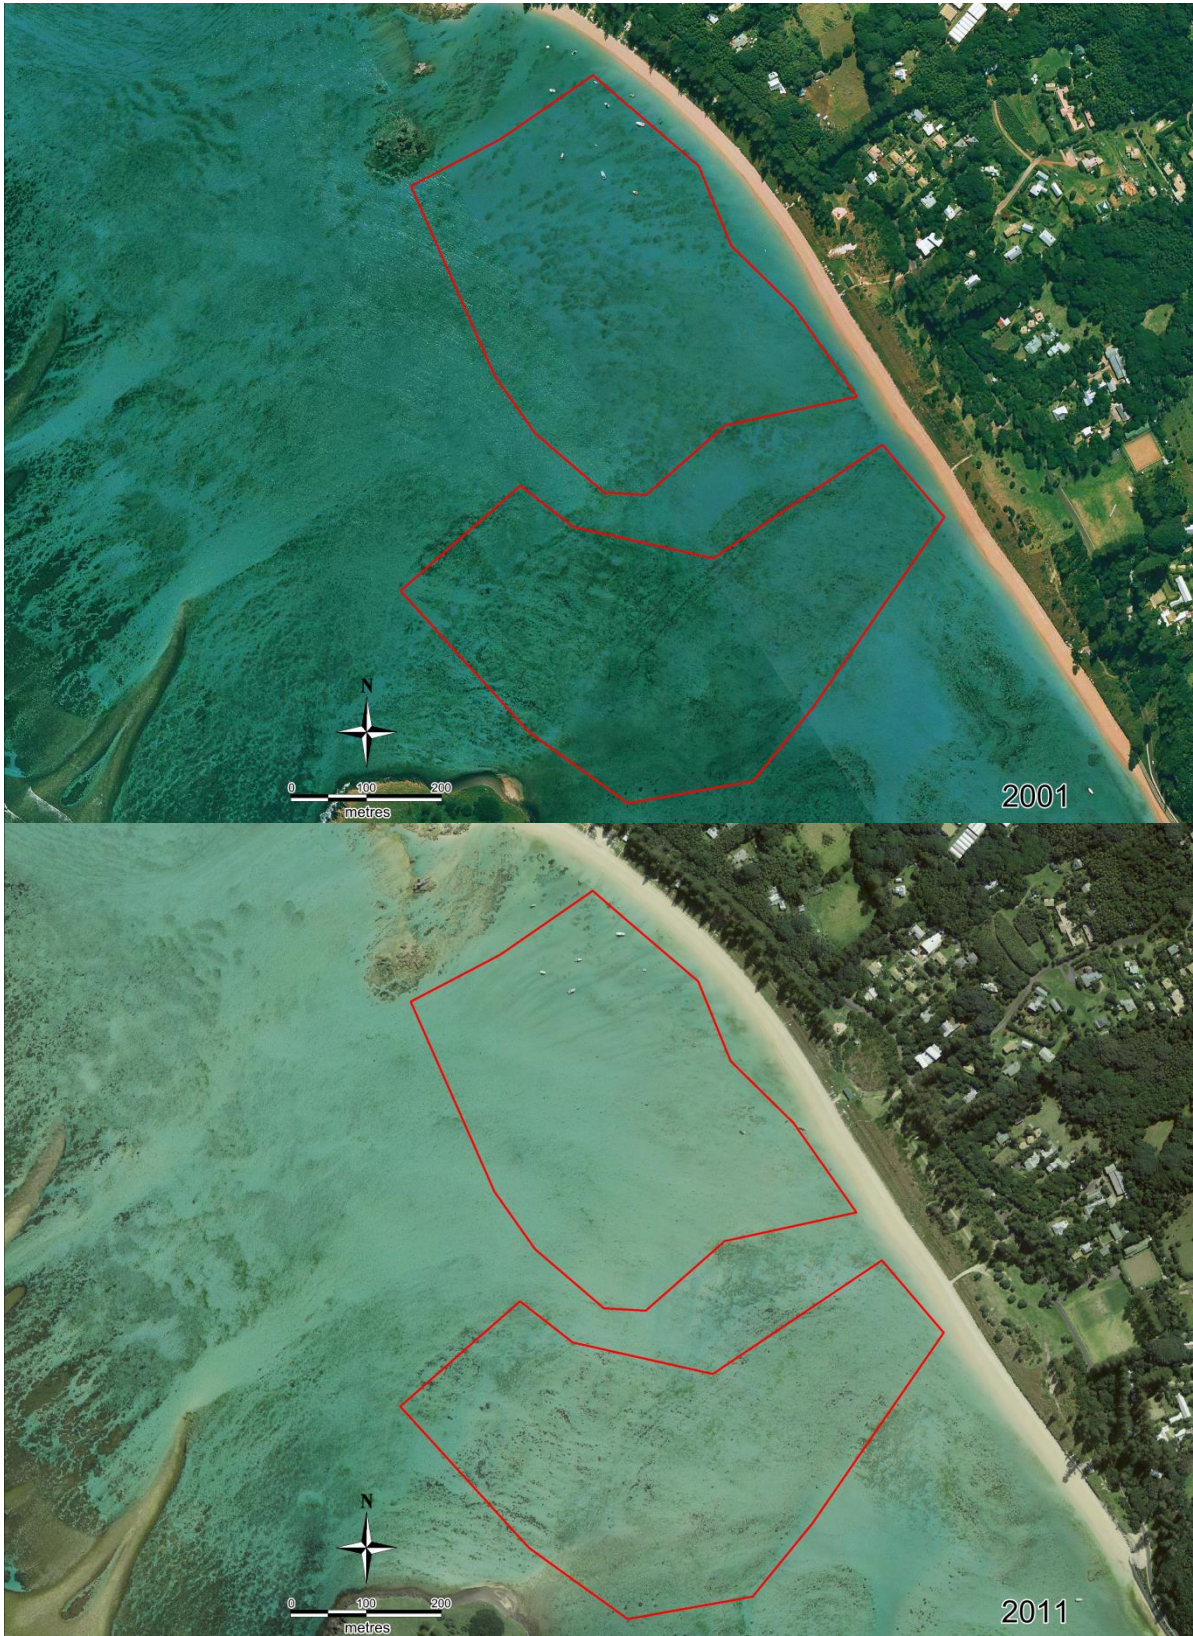
**Figure 13: Evidence of sediment smothering reef areas at northern end of Lagoon Beach (2001 top, and 2011 bottom), with main areas of potential smothering within red boxes**

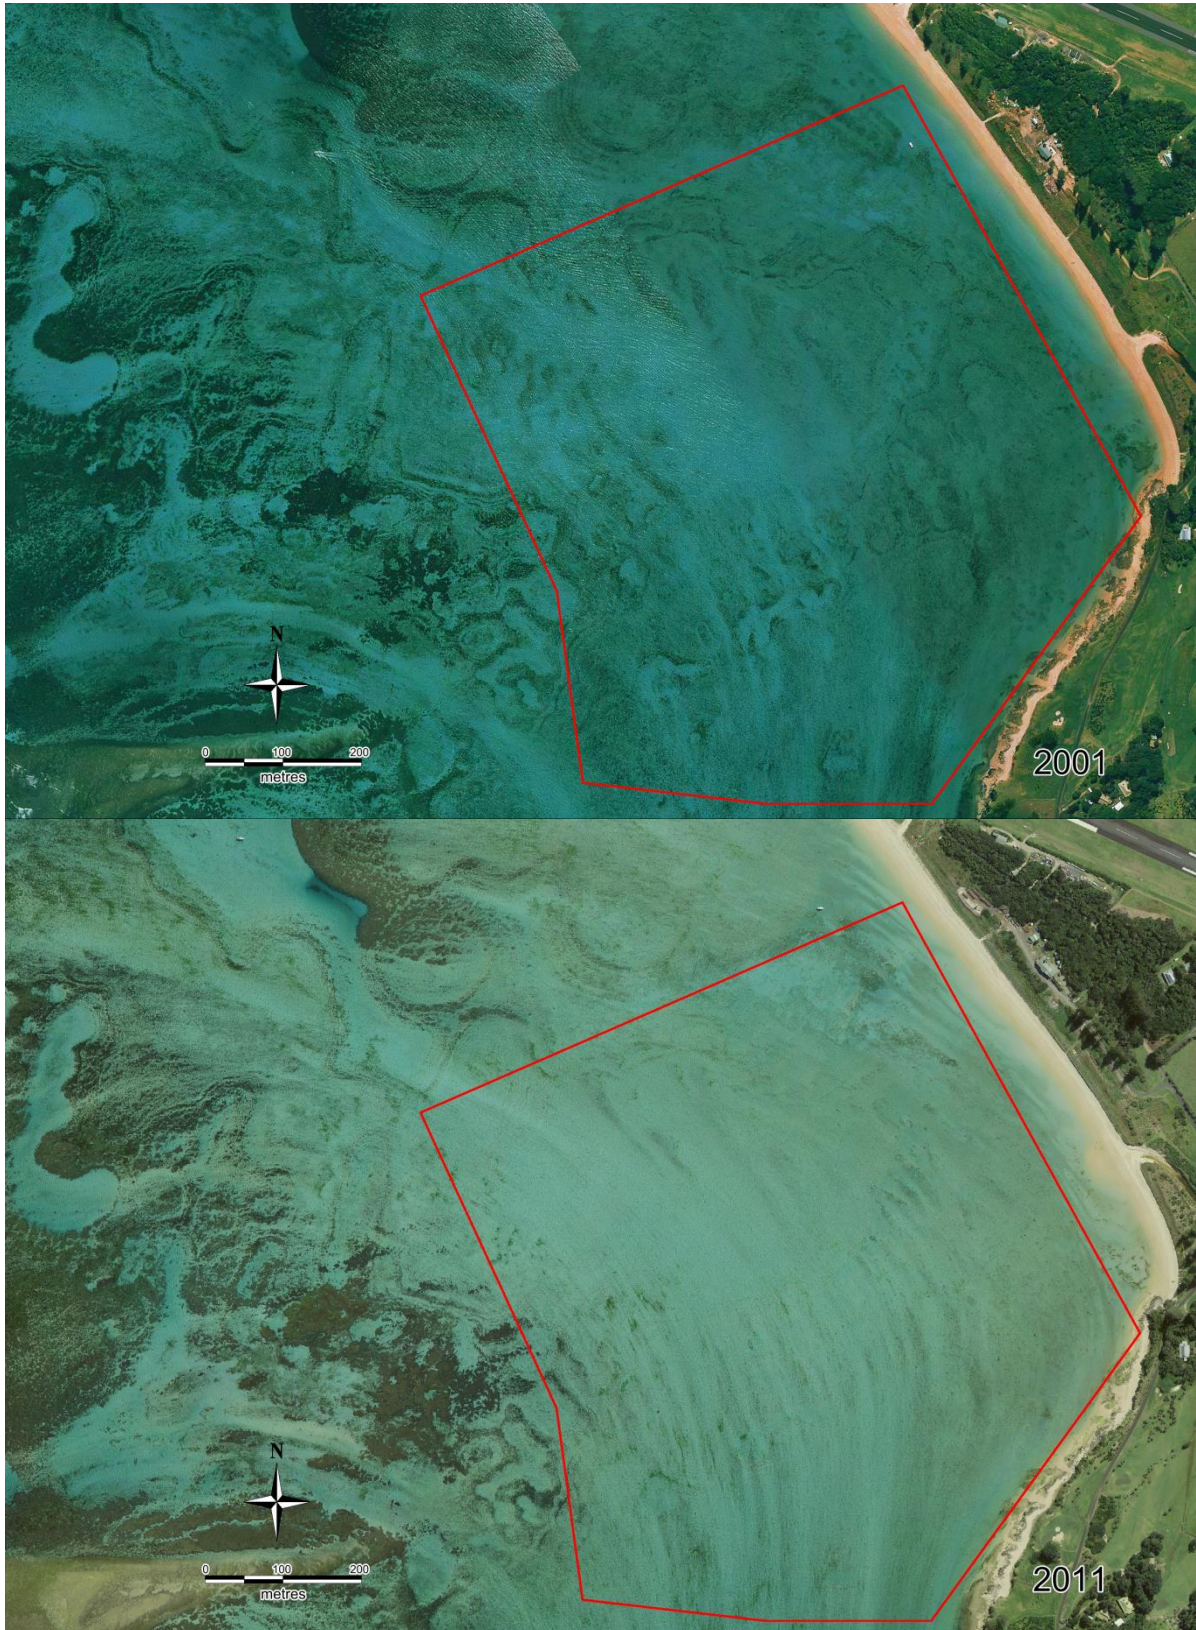
**Figure 14: Evidence of sediment smothering reef areas at Cobby's Beach (2001 top, and 2011 bottom), with main area of potential smothering within red box**

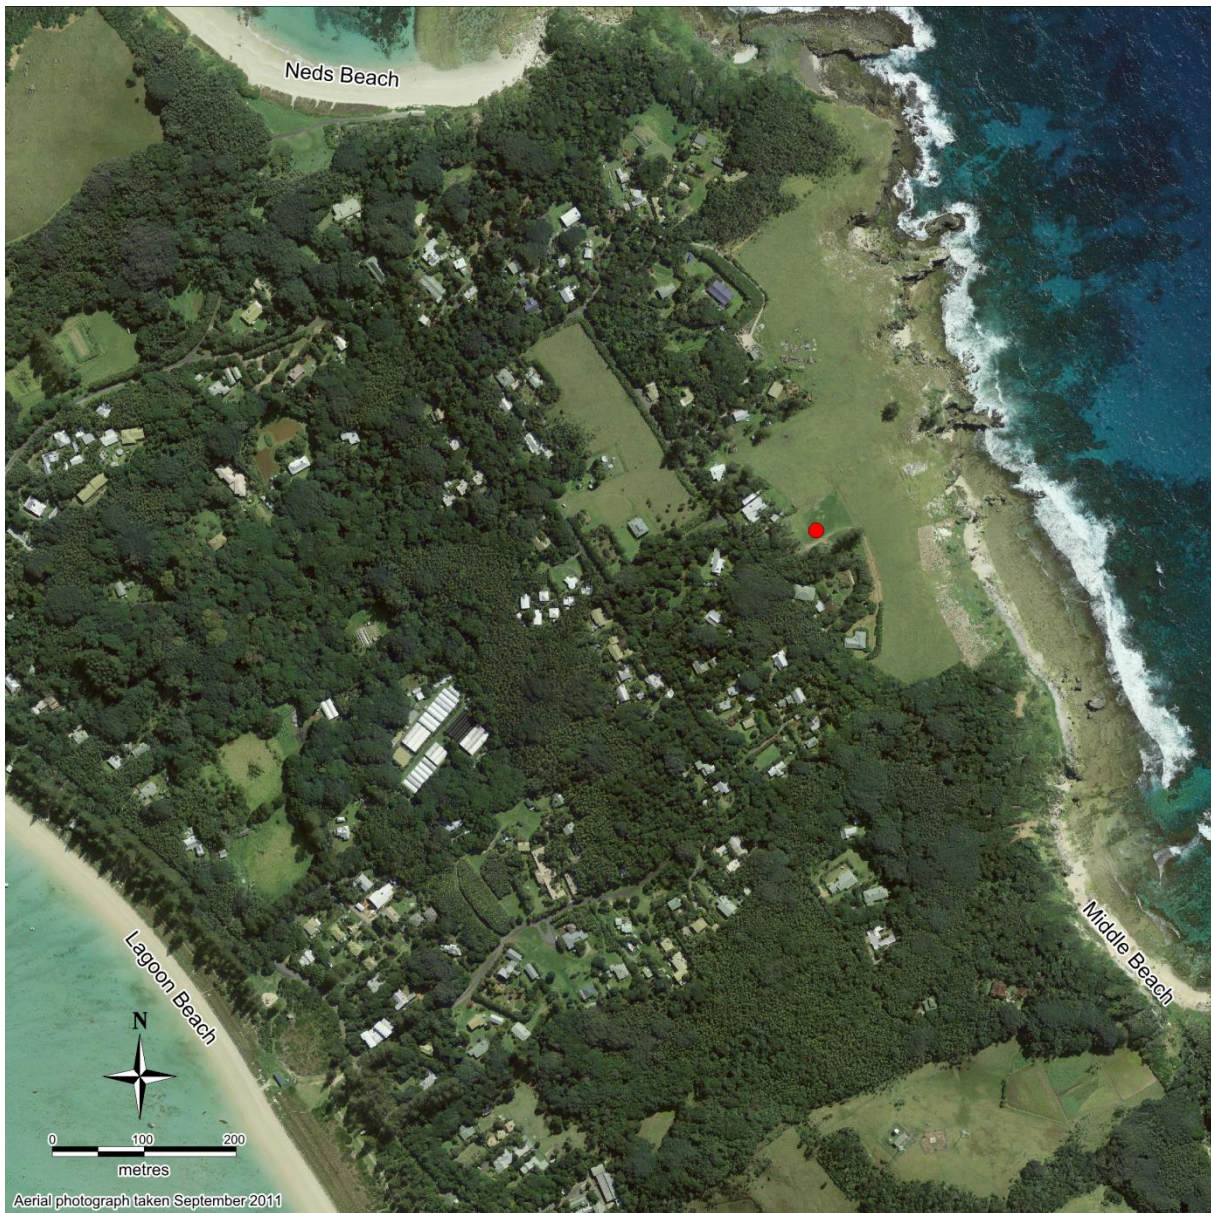
**Figure 27: Location of Jims Point Bureau of Meteorology station (used from 1954 to 1988)**

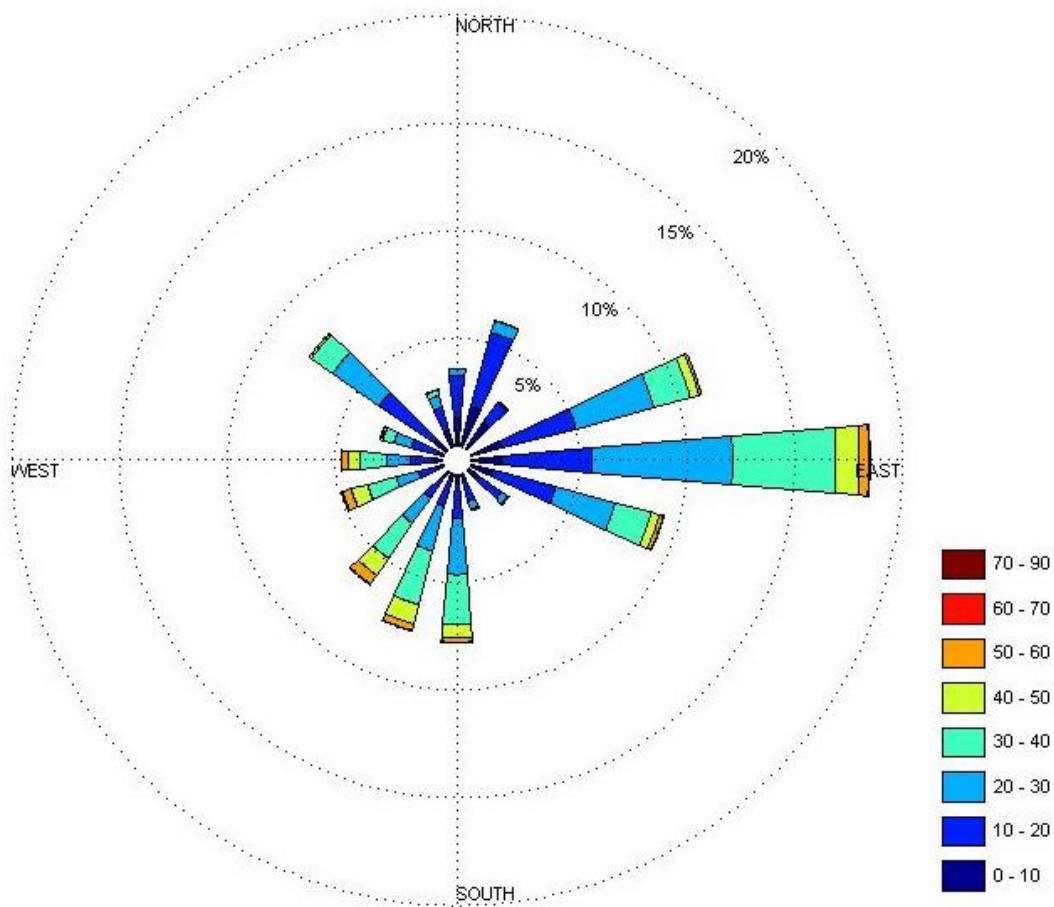
**Figure 29: Wind rose for Windy Point site based on hourly data from 2004 to 2014**

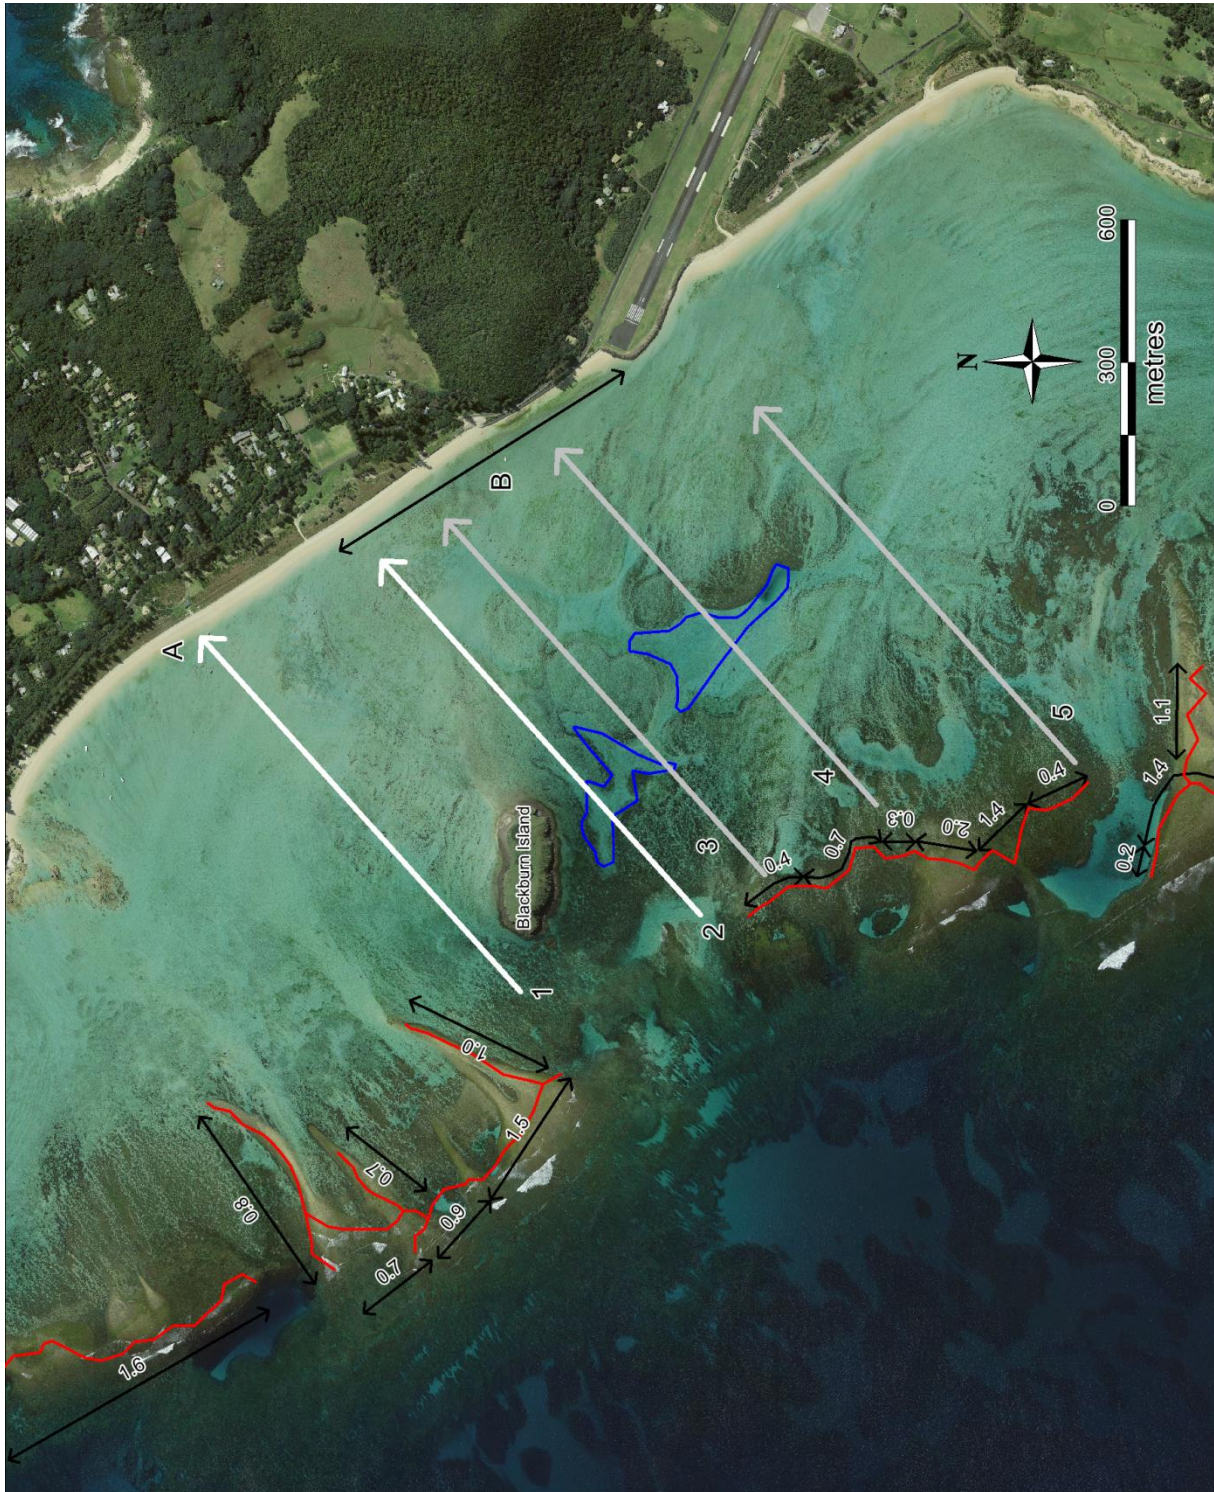
**Figure 30: Potential higher wave energy areas (A and B) impacting on Lagoon Beach and Cobbys Beach, with vector average offshore wave direction vectors shown (note that wave transformation in the Lagoon could alter these directions)**

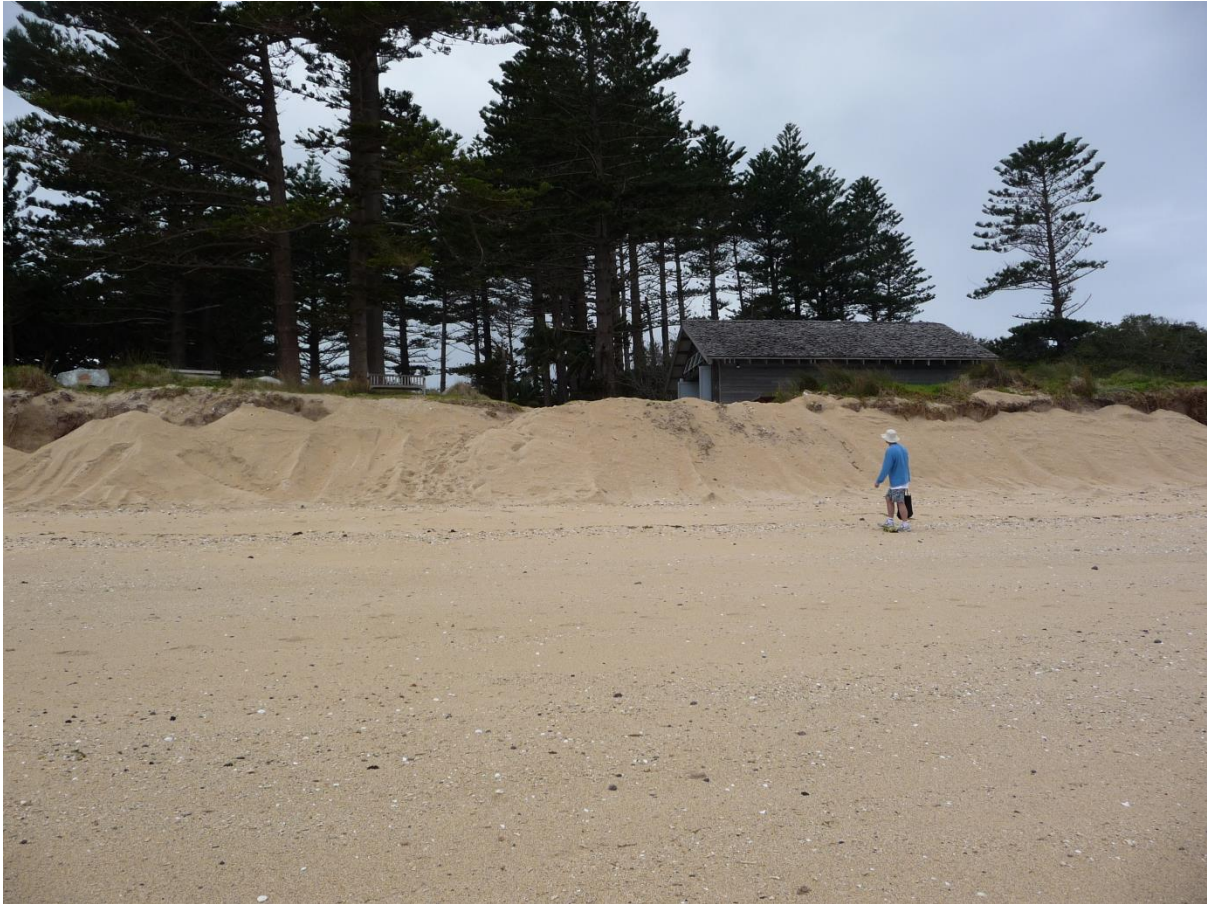
**Figure 31: Sand from beach scraping pushed against erosion escarpment at Pinetrees boatshed, 28 August 2012**
