# Lord Howe Island Coastline Hazard Definition and Coastal Management Study

Prepared for the Lord Howe Island Board by Haskoning Australia Pty Ltd

9 September 2014

Issue 5 (Final)

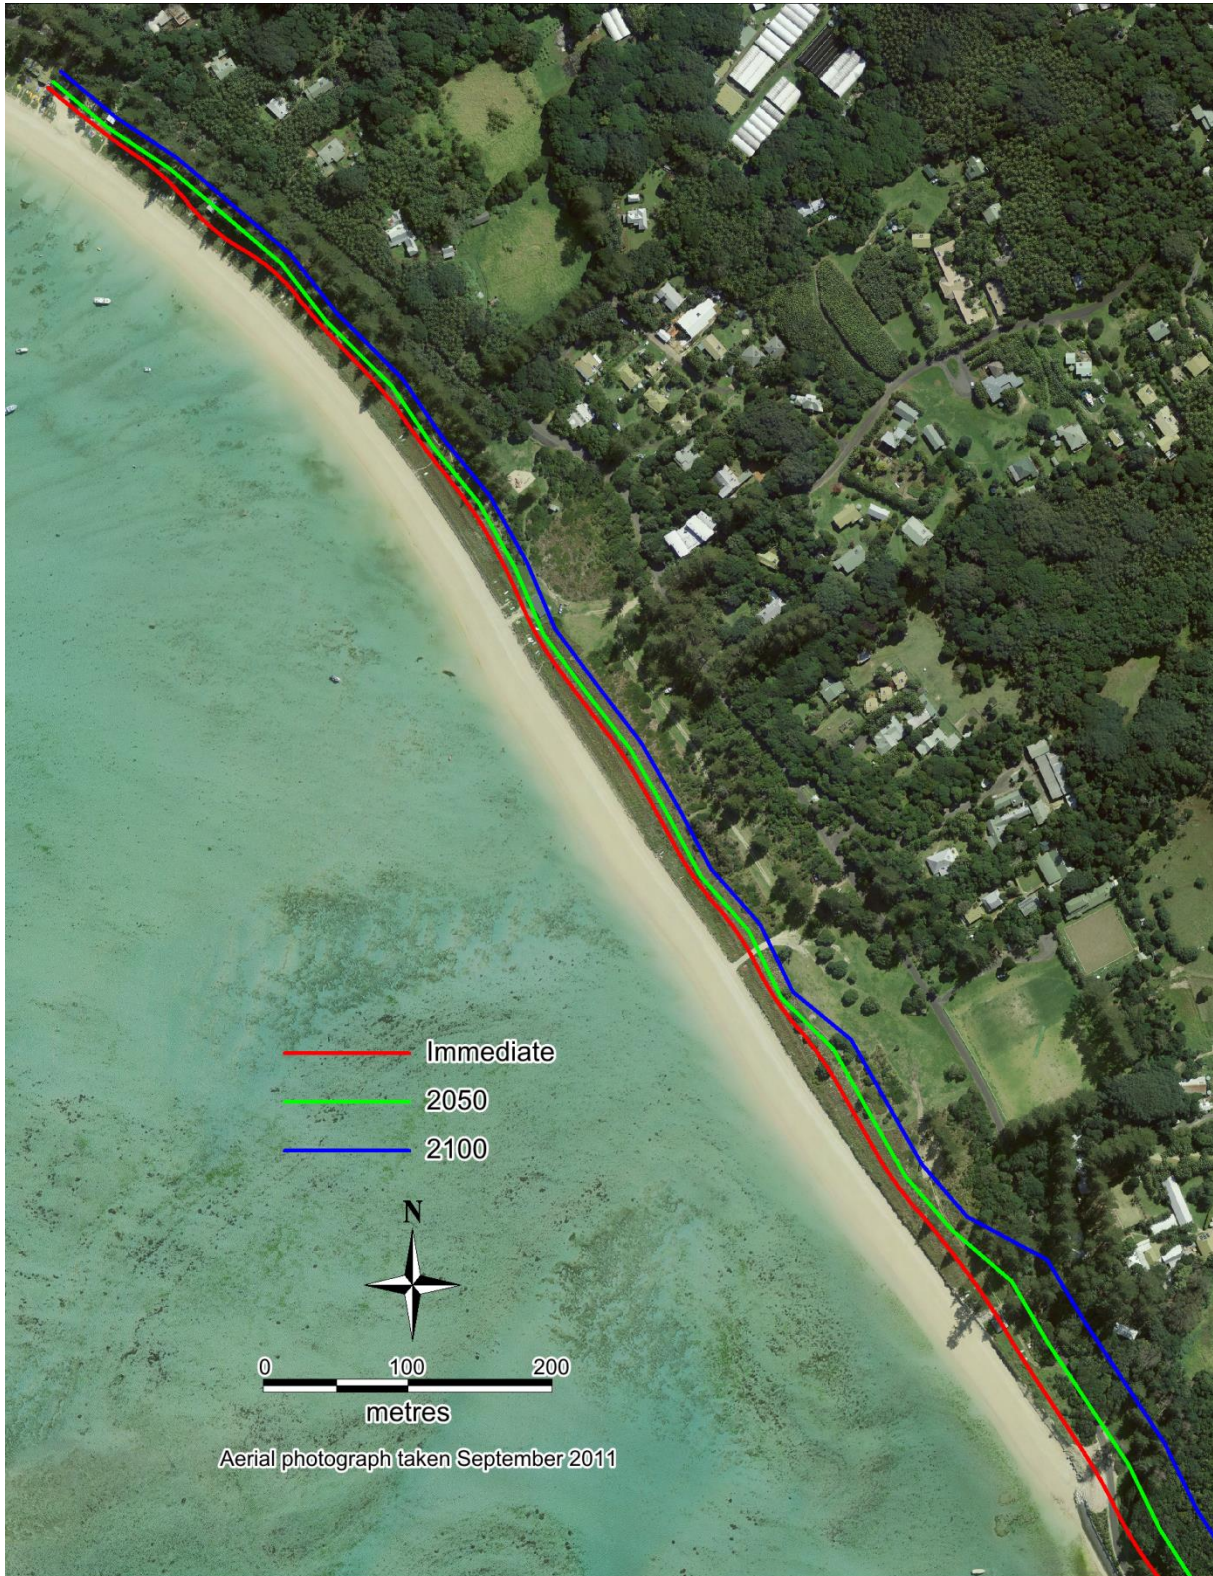
**Figure 36: Immediate, 2050 and 2100 Hazard Lines (at landward edge of ZSA) at Lagoon Beach (north of Seabee revetment)**

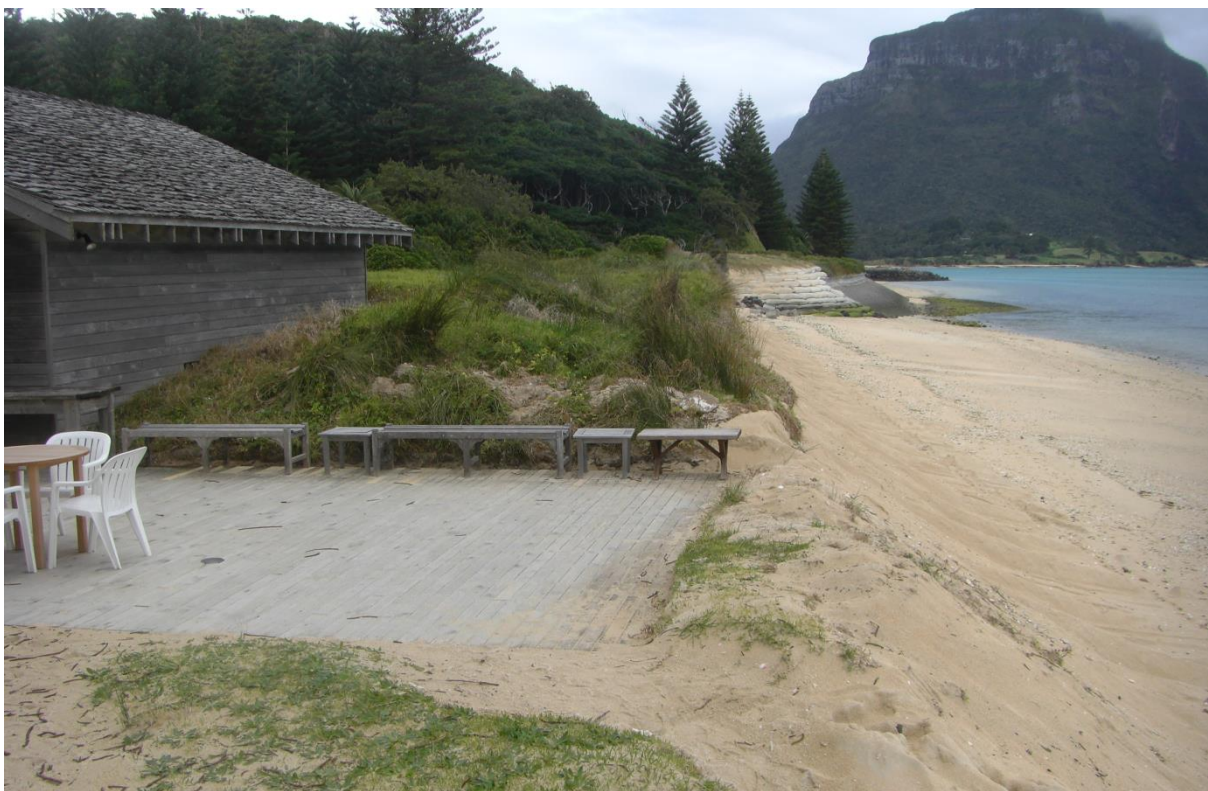
**Figure 38: Erosion escarpment adjacent to deck at Pinetrees boatshed in August 2012**

In August 2012, the erosion escarpment at Pinetrees boatshed was measured as being 7.6m from the seaward face of the structure, with the deck seaward of the boatshed within 1m of the escarpment (Figure 38).

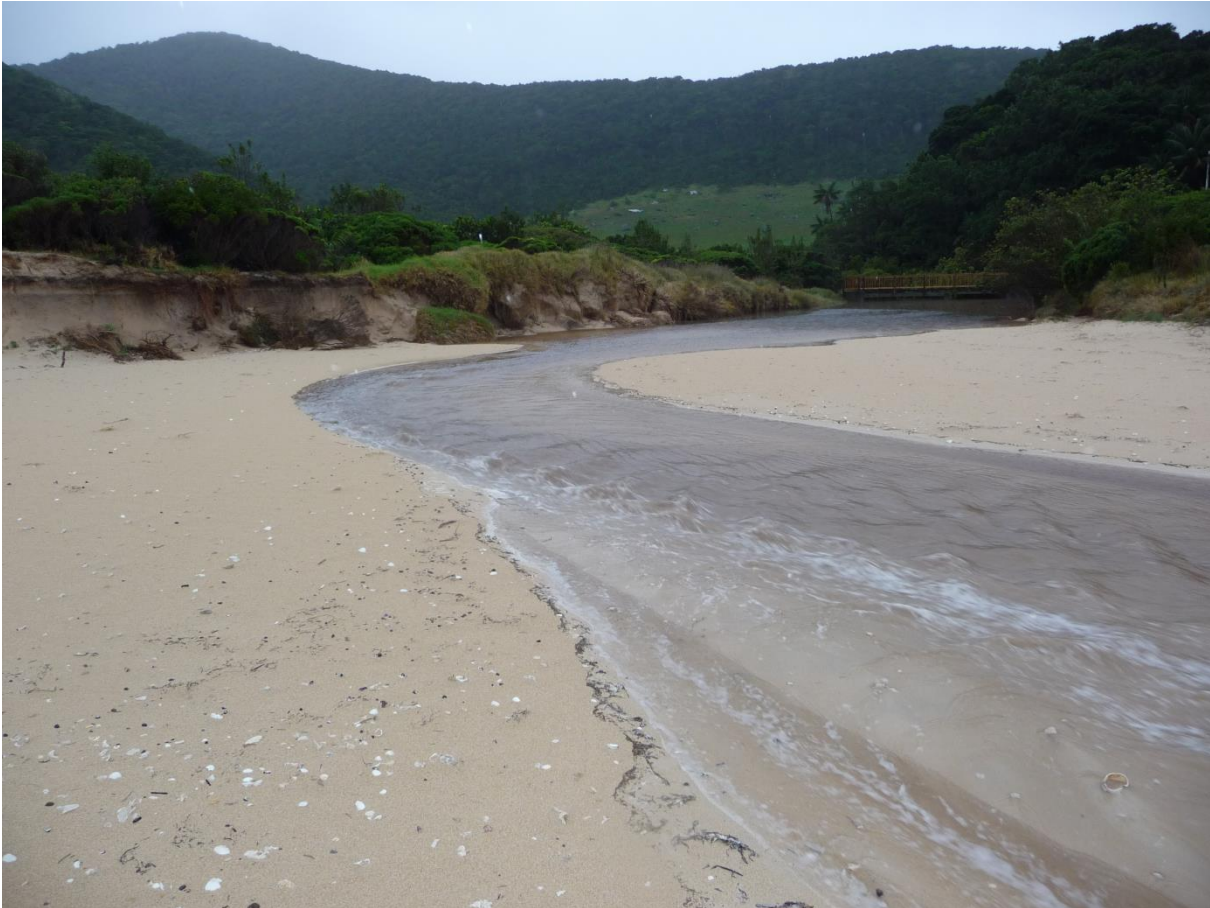
**Figure 40: Natural opening of Old Settlement Creek, 31 August 2012**

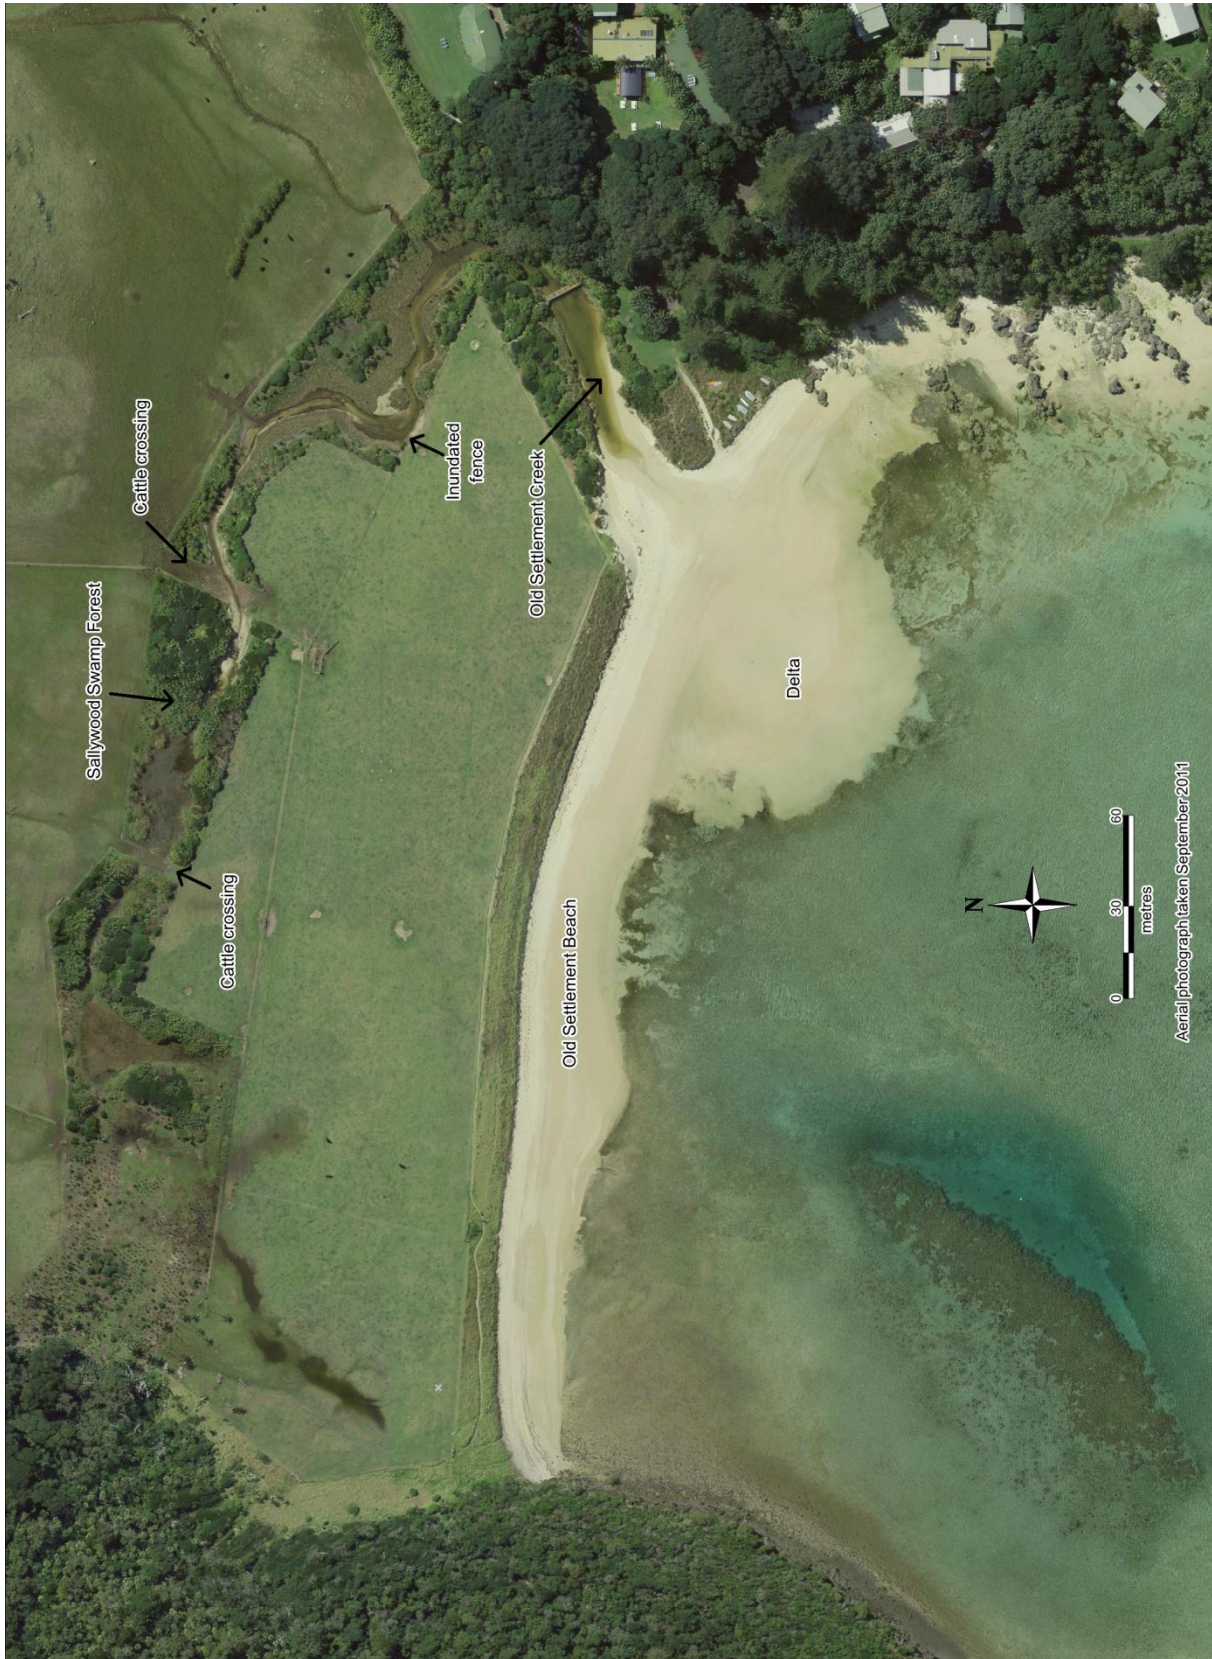
**Figure 41: Aerial photograph of Old Settlement Creek entrance, with delta evident**

There are two cattle crossings (muddy tracks) over Old Settlement Creek (see Figure 41) that, due to trampling and associated erosion, may be sources of sediment and nutrients to be mobilised into the creek. It is recommended that there is consideration of works (such as hardening the crossings) to reduce potential mobilisation of sediment in these areas.

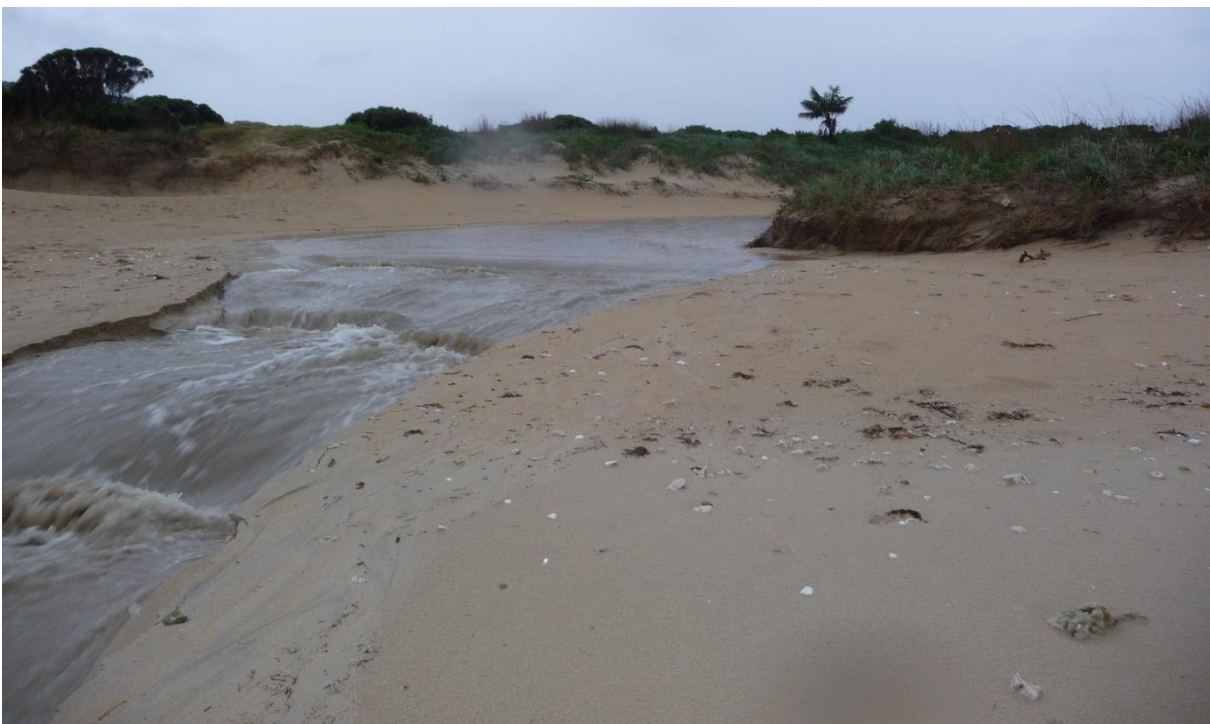
Figure 42: Natural opening of Cobbys Creek, 31 August 2012

The beach berm at the entrance to Cobbys Creek was at a level of about 2.8m to 2.9m AHD in October 2012 LiDAR data. It is understood that there is a Sallywood Swamp Forest community located upstream of where Lagoon Road crosses Cobbys Creek (Figure 43). A photograph of the creek entrance after a rainfall-runoff induced natural opening in August 2012 is provided in Figure 42.

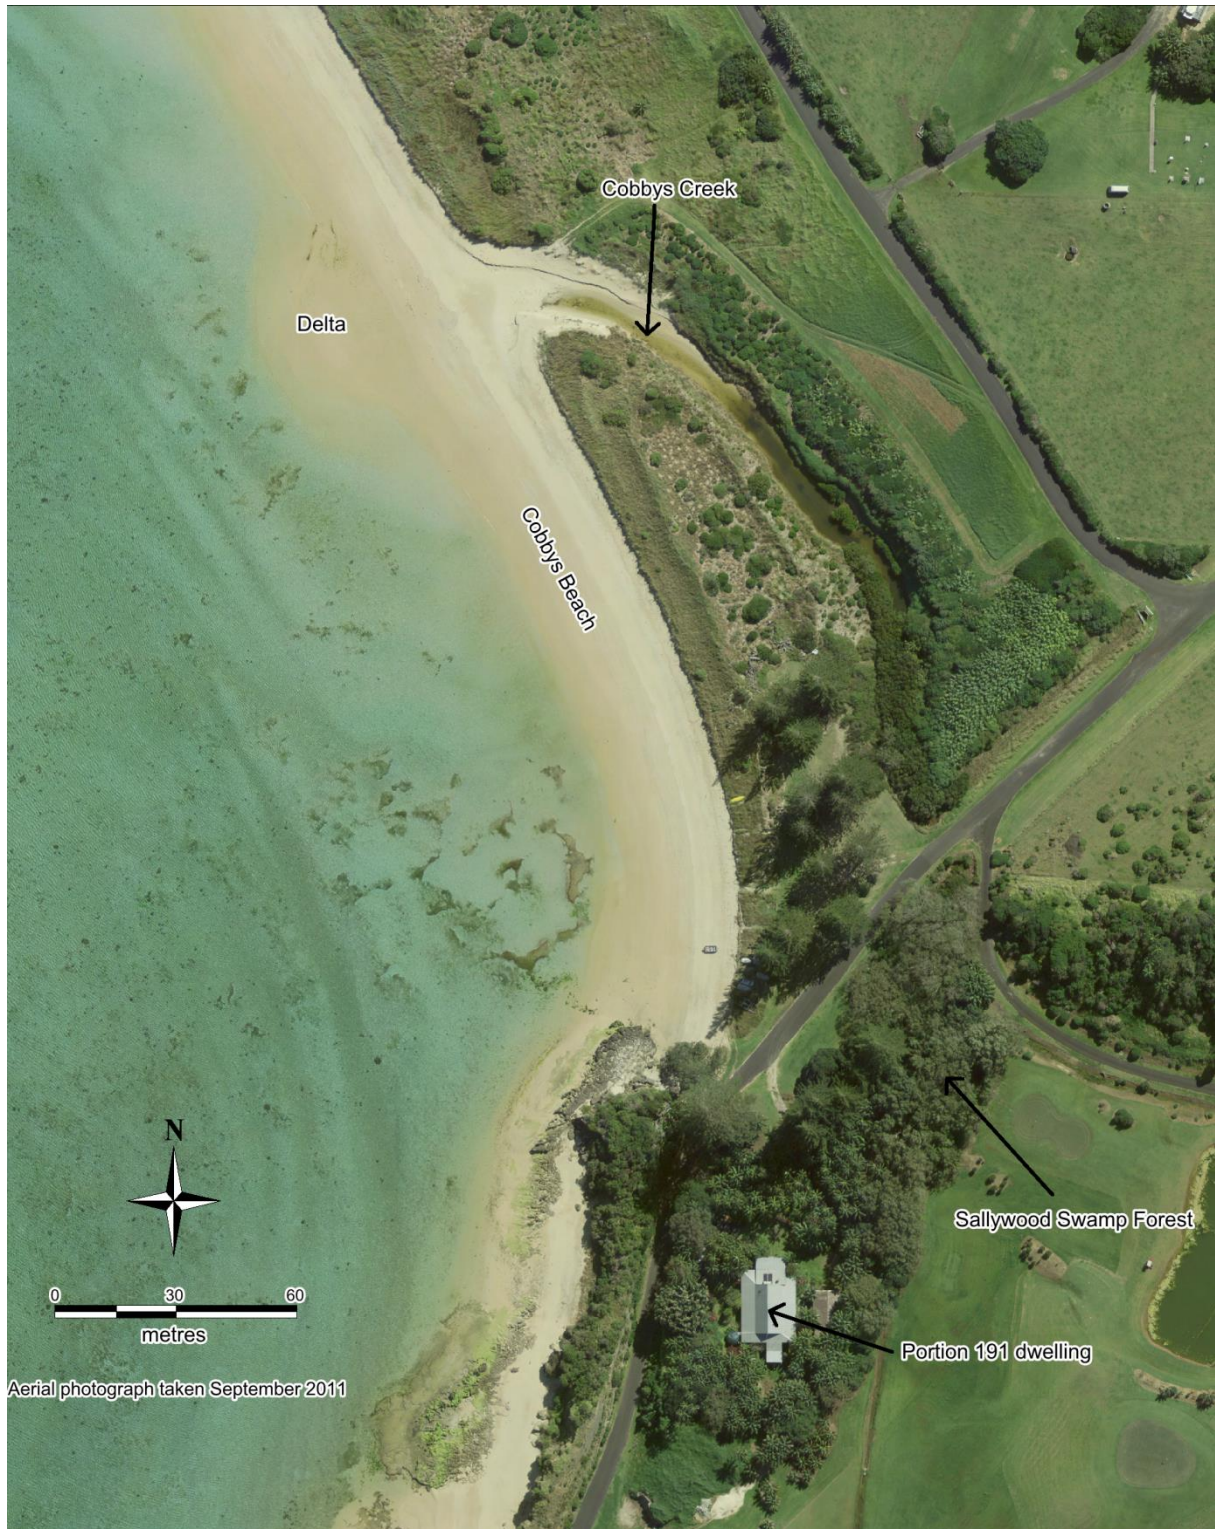
Figure 43: Aerial photograph of Cobbys Creek entrance, with delta evident

At Cobbys Creek, there is surrounding infrastructure below 4m AHD. This includes the area surrounding a dwelling on Portion 191 which is located south-west of the entrance (Figure 43). The floor level of the dwelling at Portion 191 is unknown, but surrounding ground levels are about 3.4m AHD to the north and south, 3.8m AHD to the east, and 4.0m AHD to the west (based on October 2012 LiDAR data). Lagoon Road is at a level of about 3.8m AHD where it crosses the creek.

There is a delta of sand formed within the Lagoon seaward of Cobbys Creek, extending about 30m offshore and 60m alongshore, as visible in 2011 aerial photography (Figure 43). The entrance migrated about 30m north from 1965 to 2011, an average rate of about 1.5m/year, although the entrance appears to have been relatively stable since 2001<sup>66</sup>. The delta has only been visible in aerial photography since 2011 (based on examination of 1965, 1975, 1984 and 2001 dates), but this may be a function of entrance closure at the time of earlier photographs, and the delta at Cobbys Beach being a transient feature due to longshore sand transport.

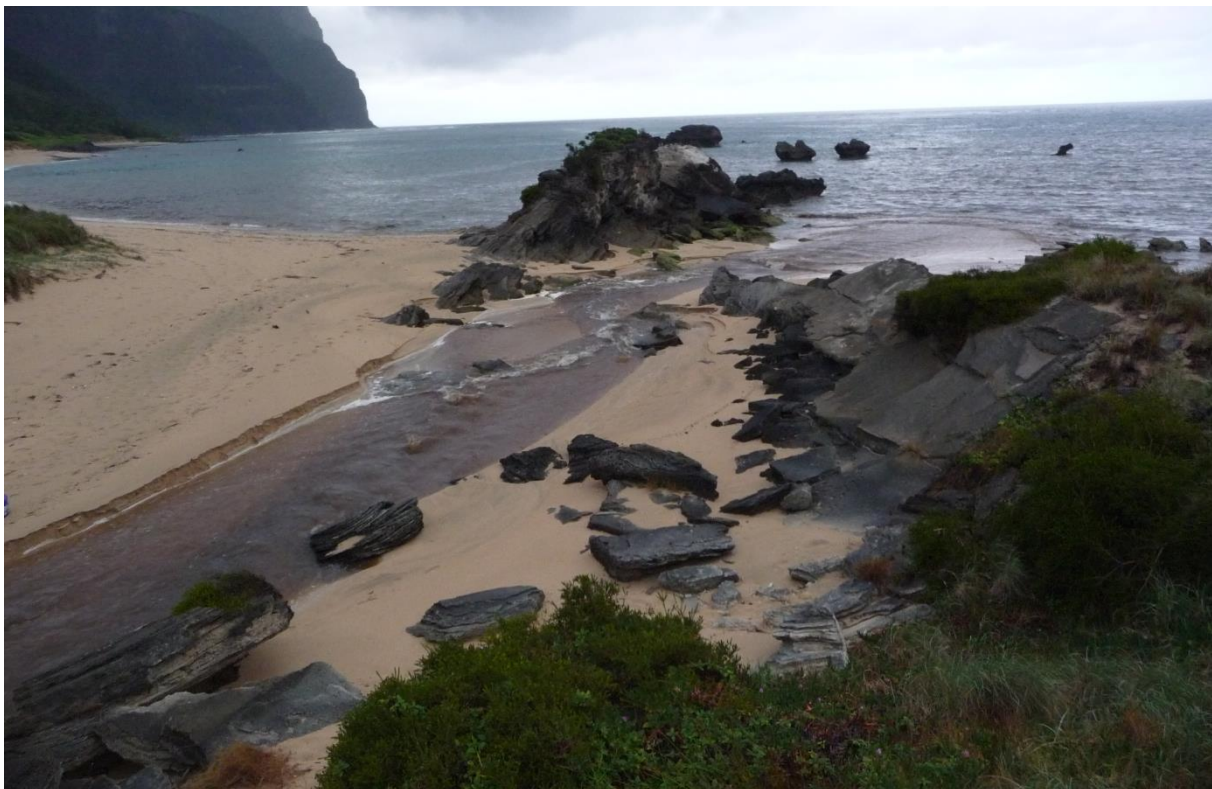
**Figure 44: Natural opening of Soldiers Creek, 31 August 2012**

The beach berm at the entrance to Soldiers Creek was at a level of about 2.4m AHD in October 2012 LiDAR data. It is understood that there is a Sallywood Swamp Forest community located on the western side of Lagoon Road in the northern arm (Figure 45). A photograph of the creek entrance after a rainfall-runoff induced natural opening in August 2012 is provided in Figure 44.

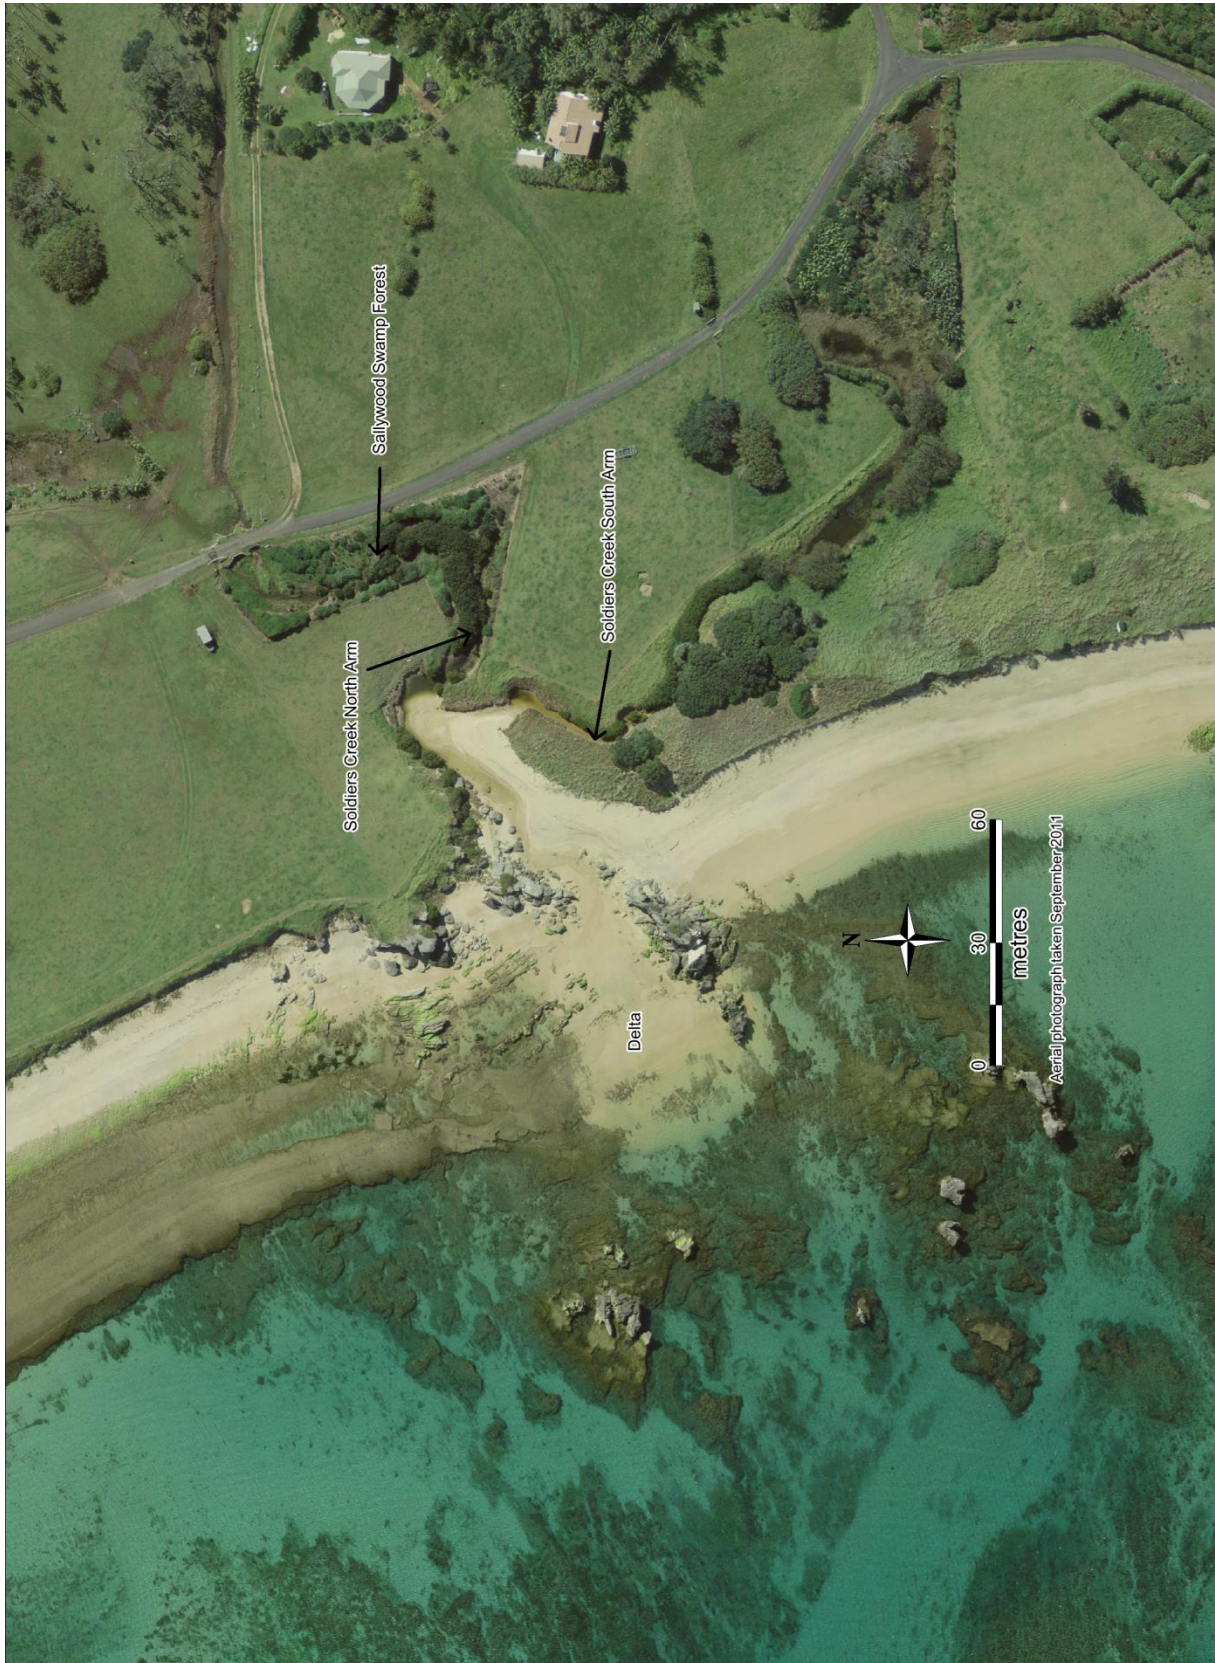
**Figure 45: Aerial photograph of Soldiers Creek entrance, with delta evident**

There is a delta of sand formed within the Lagoon seaward of Soldiers Creek, extending about 30m offshore and 30m alongshore, as visible in 2011 aerial photography (Figure 45). Given the surrounding rocks, and that this delta may only be a veneer of sand over rock, using this sand as a beach nourishment source is unlikely to be considered in preference to the Old Settlement Creek and Cobbys Creek sites.

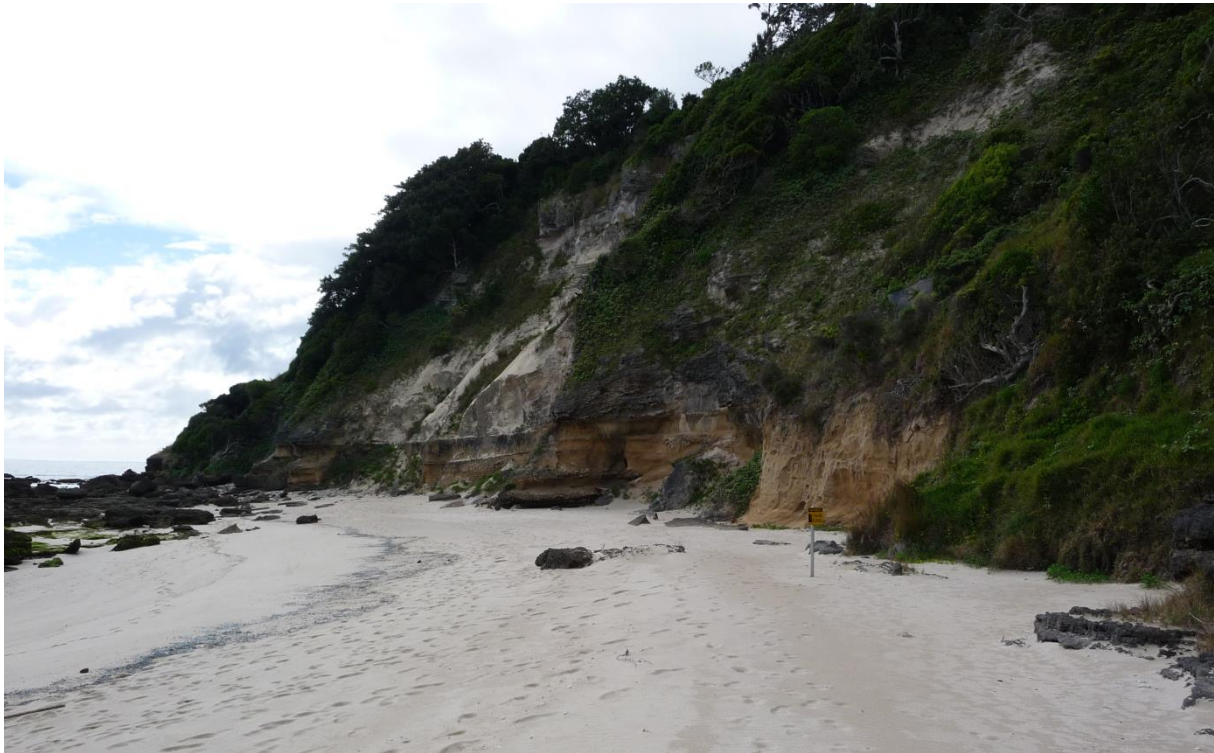
**Figure 47: Cliff area at southern end of Neds Beach, with warning sign evident**

At Neds Beach, the area of historical instability is located at the southern end of the beach. At the time of the site visit, there was a single warning sign located just north of this cliff area (Figure 47). There were some boulders and finer material deposited at the base of the cliff at several locations (known as scree or talus), see Figure 48, but there was no evidence of widespread instability. Immediately north of the area of minor instability (or weathering), the lower portion of the cliff face had some graffiti etched into the cliff face (behind the warning sign in Figure 47).

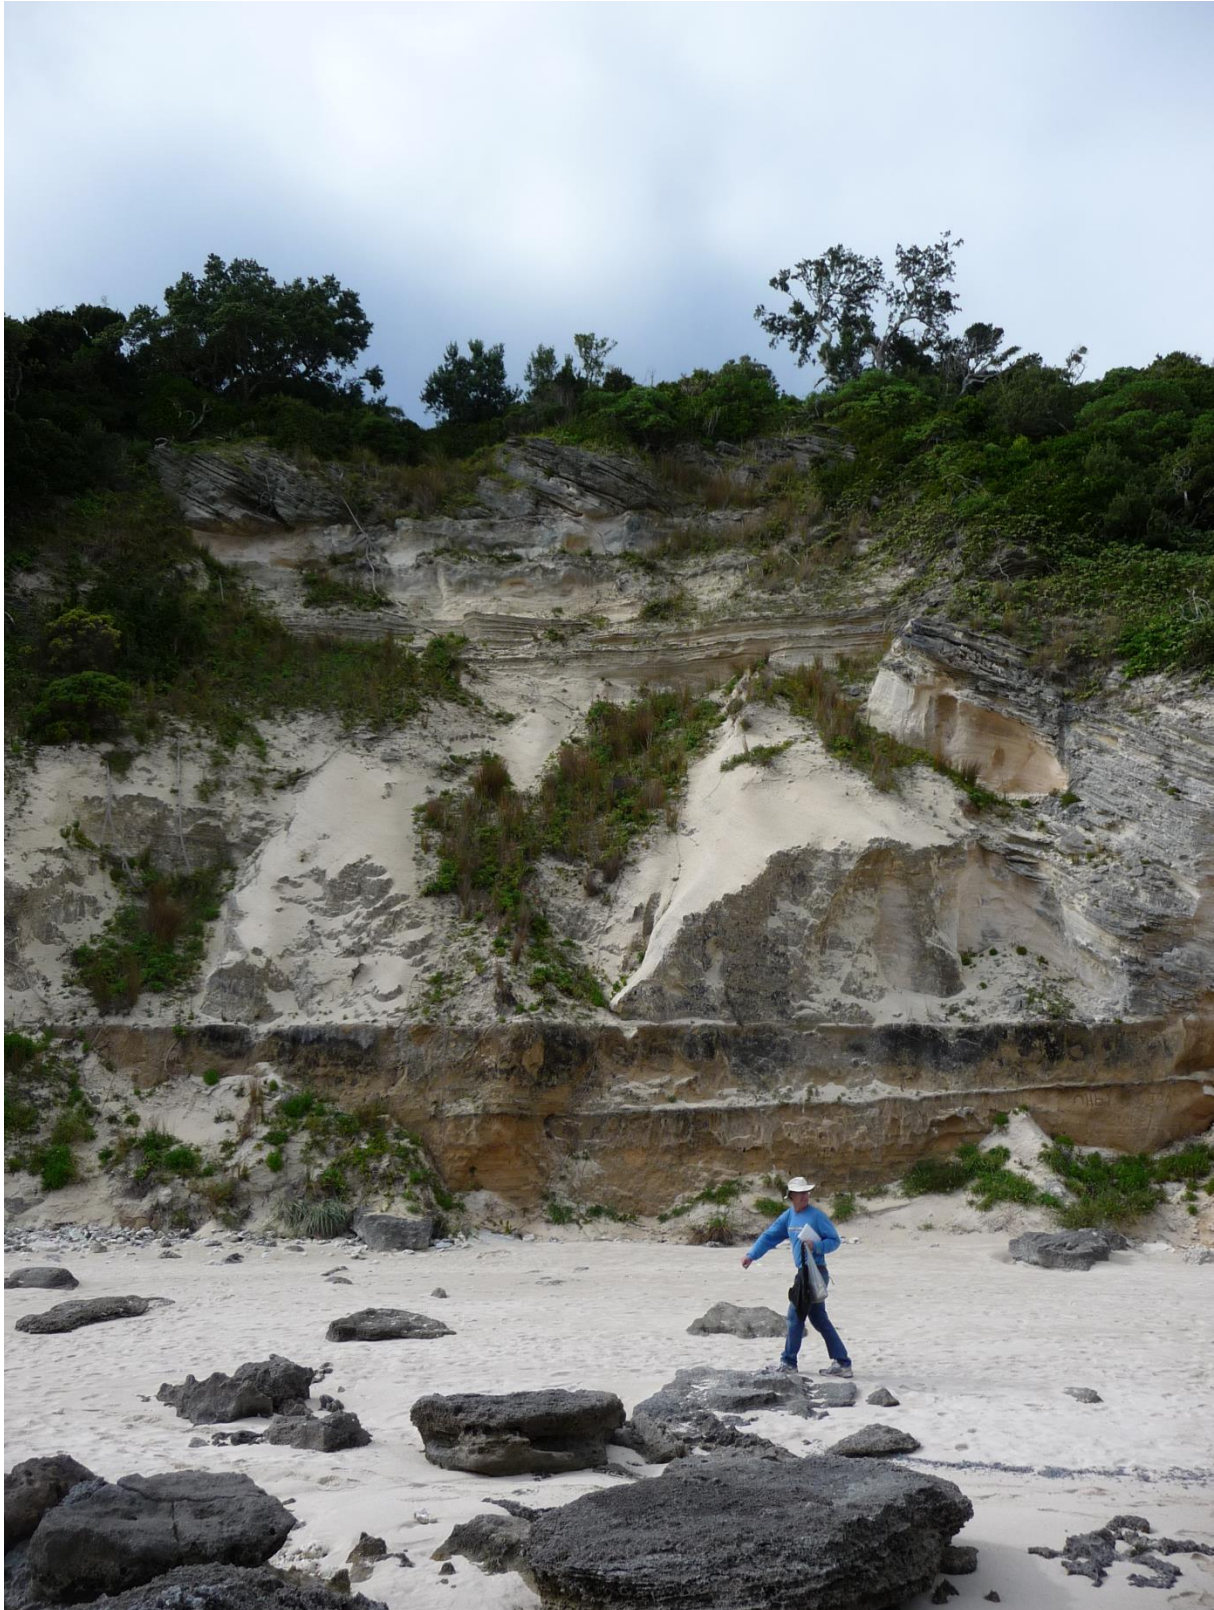
**Figure 48: Area of some cliff instability at southern end of Neds Beach**

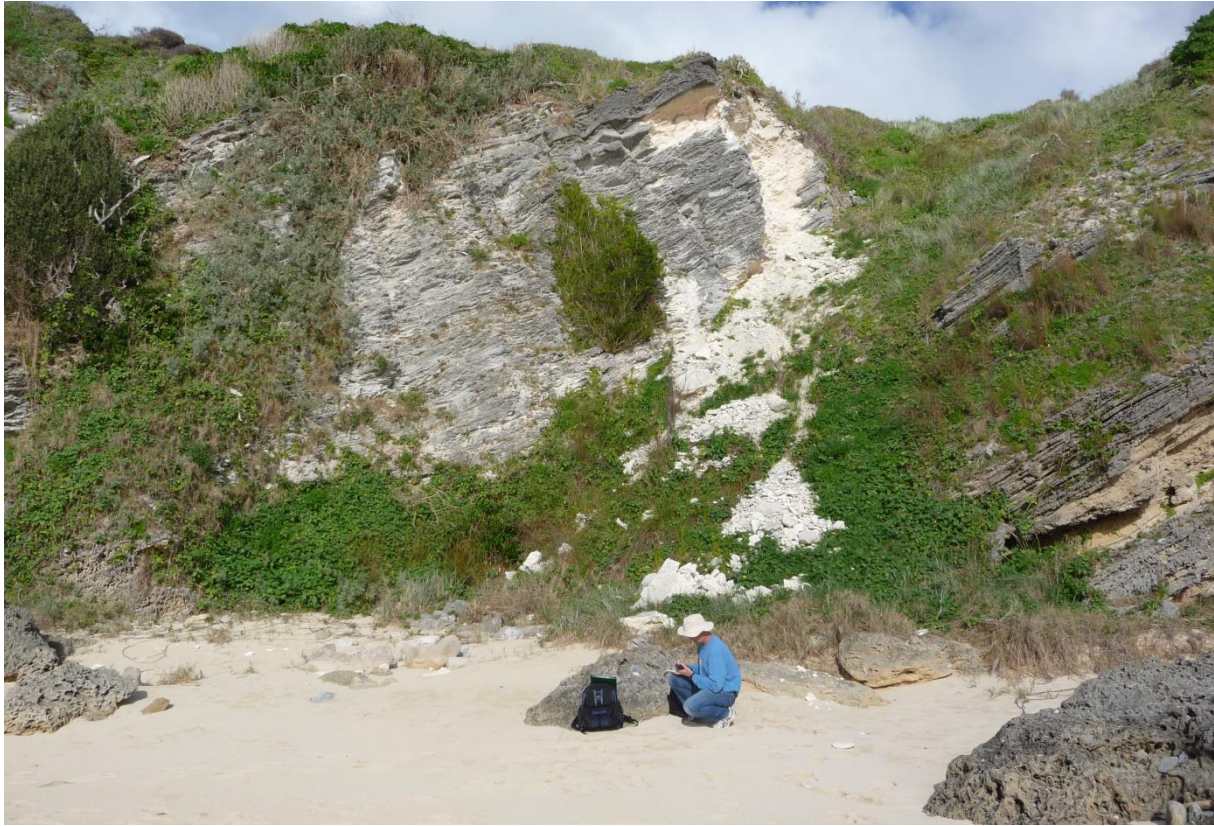
**Figure 49: Cliff “failure” at northern end of Middle Beach, 28 August 2012**

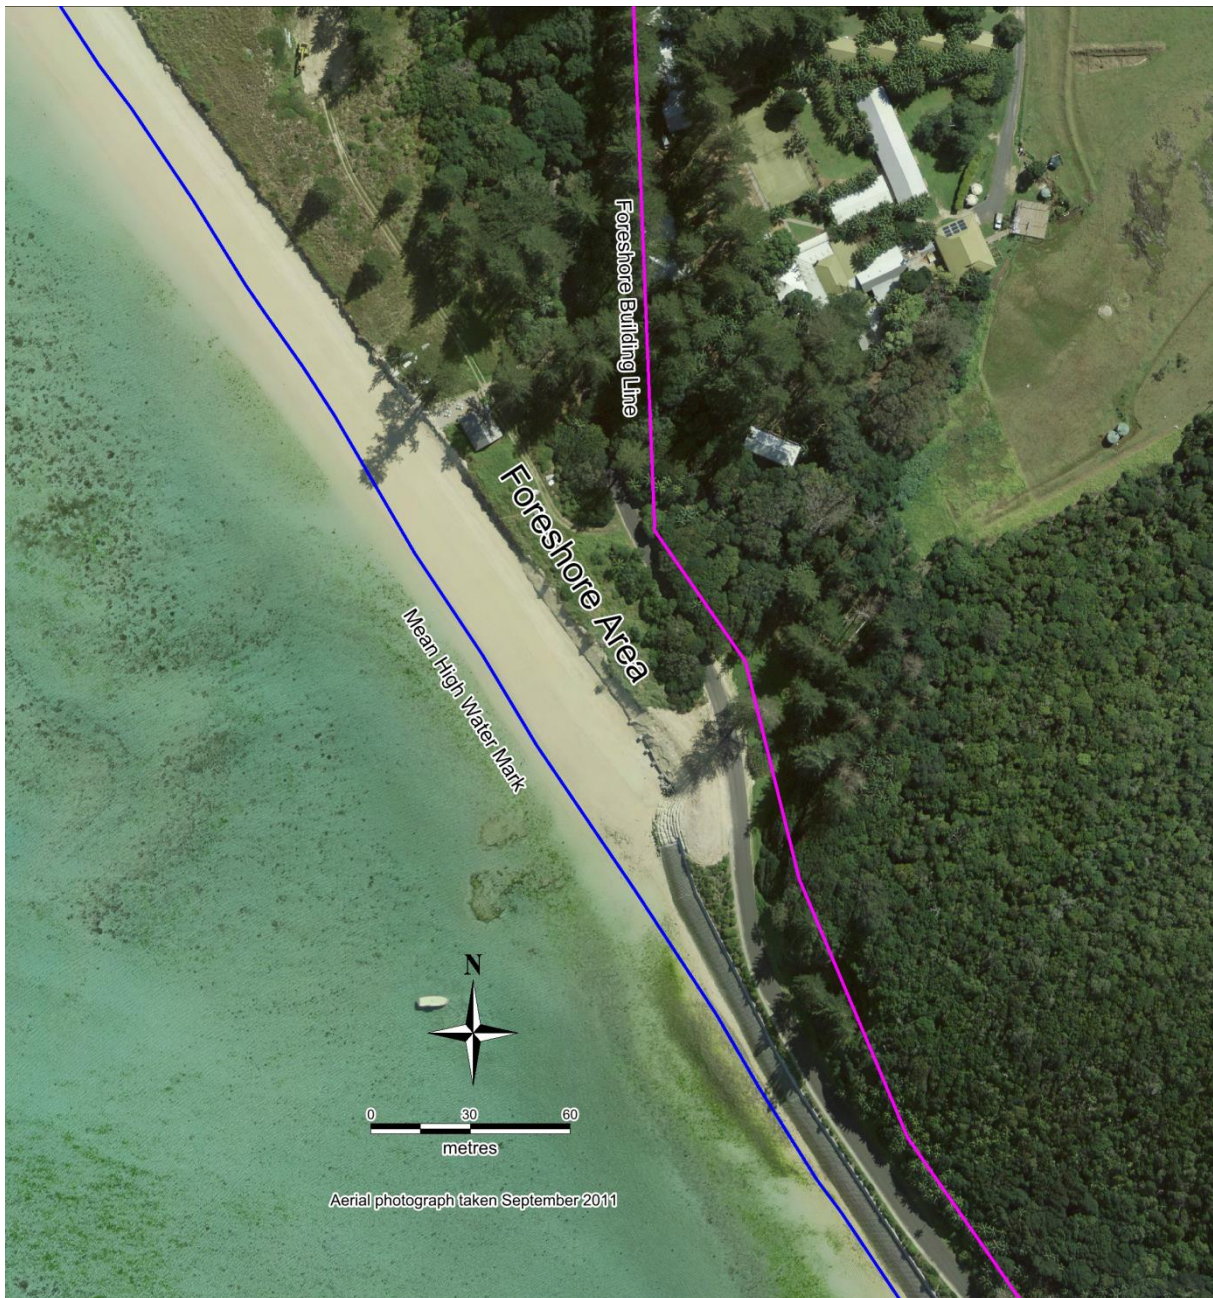
**Figure 50: Foreshore area in vicinity of Pinetrees boatshed**

The Pinetrees boatshed is within a "foreshore area" as defined in the *Lord Howe Island Local Environmental Plan 2010* (Figure 50). The foreshore area means the land between the Foreshore Building Line and the mean high water mark.

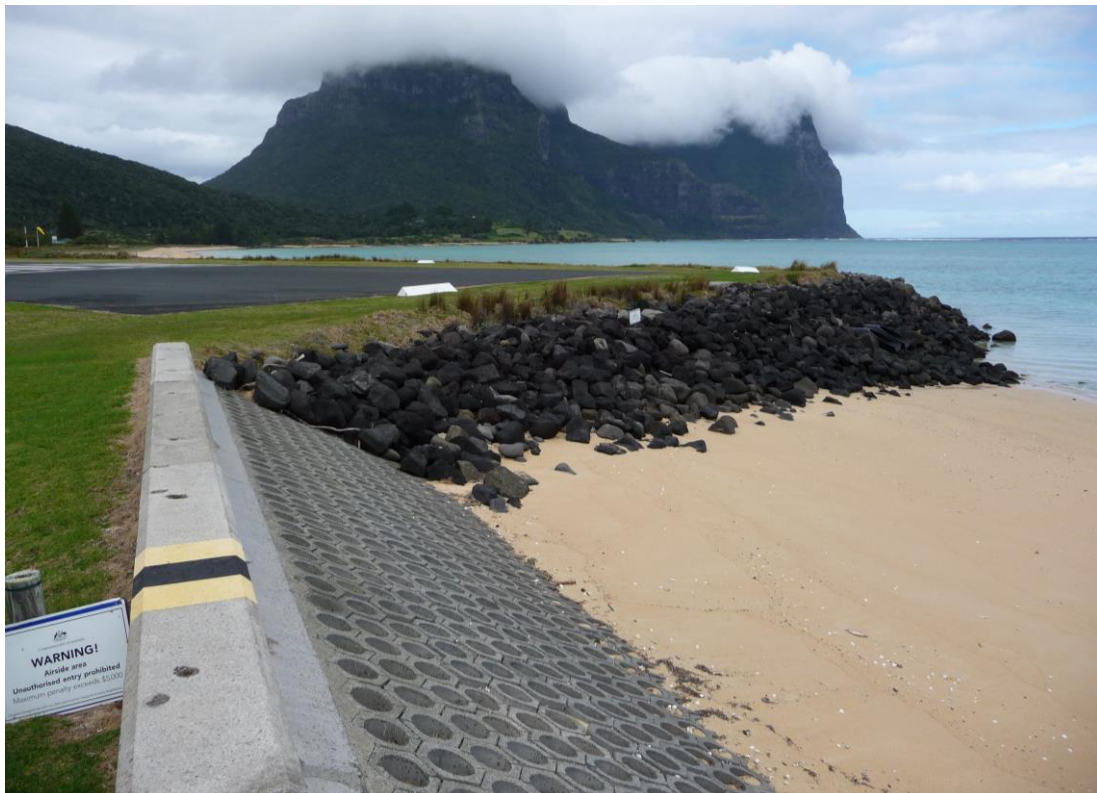
**Figure A1: Southern end of Lagoon Beach at junction between airport revetment and Seabee wall, looking south**

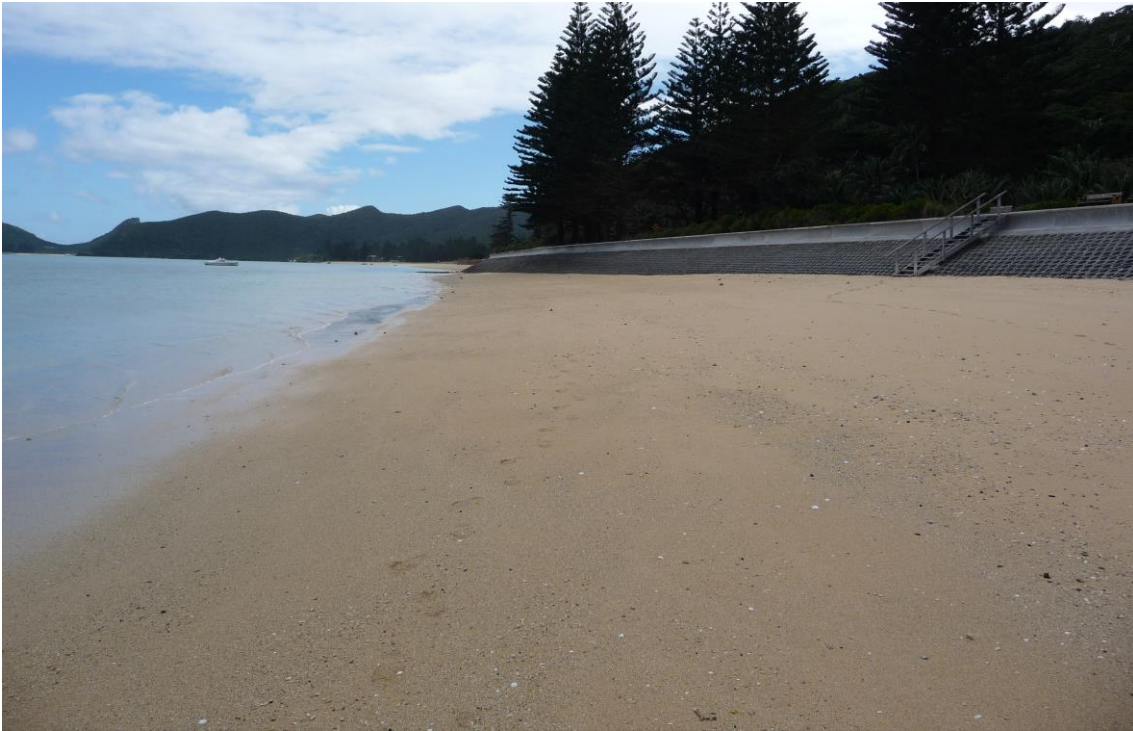
**Figure A2:** Looking north along Seabee wall at southern end of Lagoon Beach

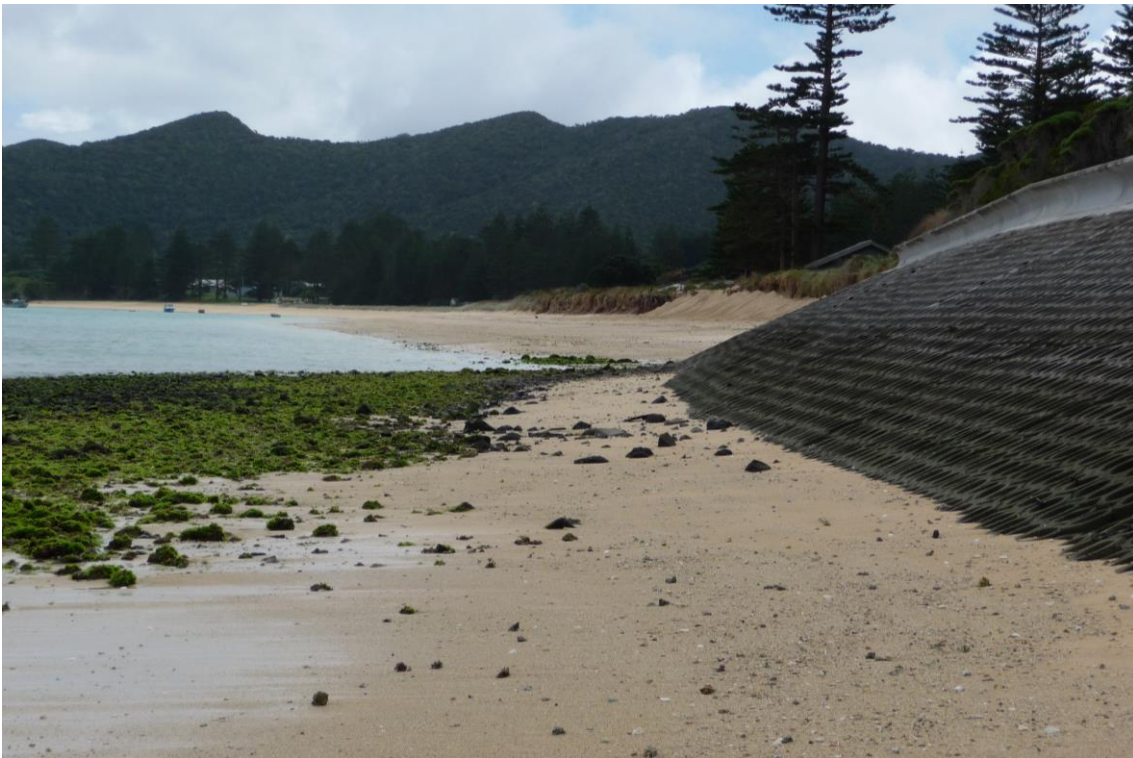
**Figure A3:** Northern end of Seabee wall at Lagoon Beach, looking north

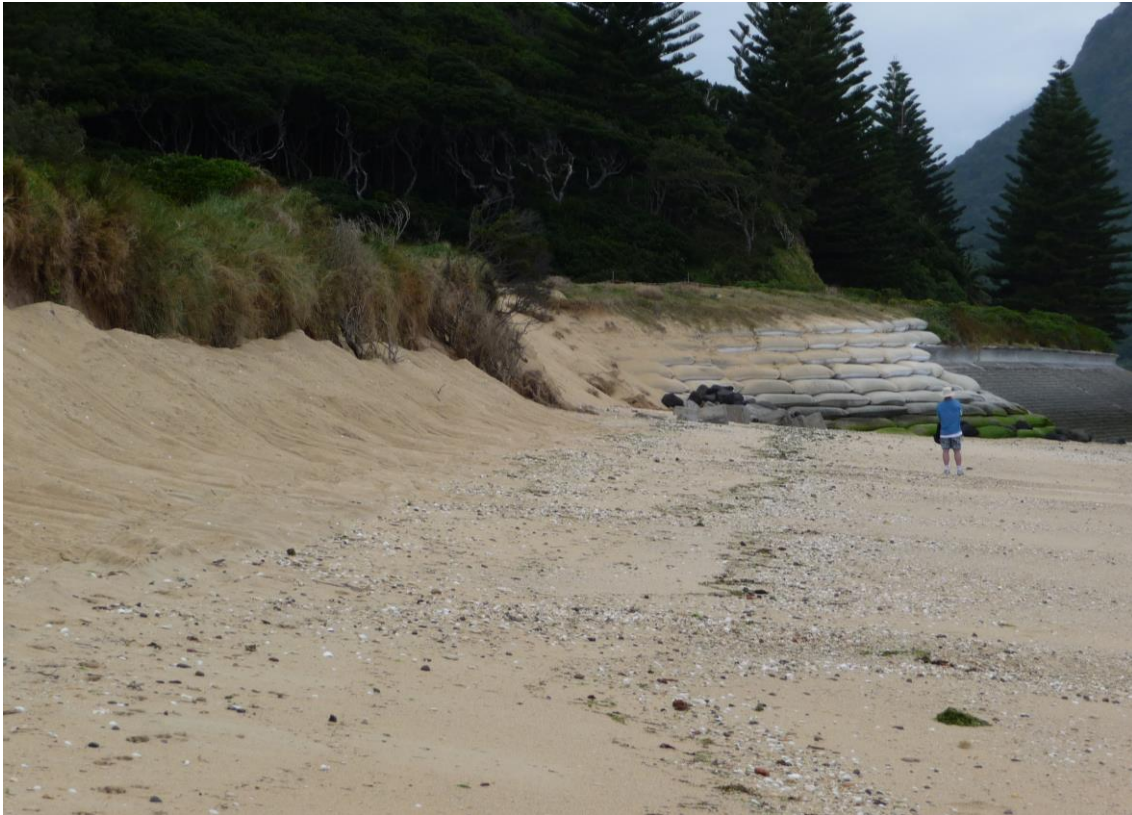
**Figure A4: Sand-filled geotextile containers north of Seabee wall at Lagoon Beach**

A series of photographs taken from south to north along Lagoon Beach is provided in Figure A1 to Figure A7. Note that the mounded sand visible seaward of the erosion escarpment in Figure A4 and Figure A5 had recently been mechanically placed (it had been sourced by beach scraping from about 100m to 300m north at around the low tide level).

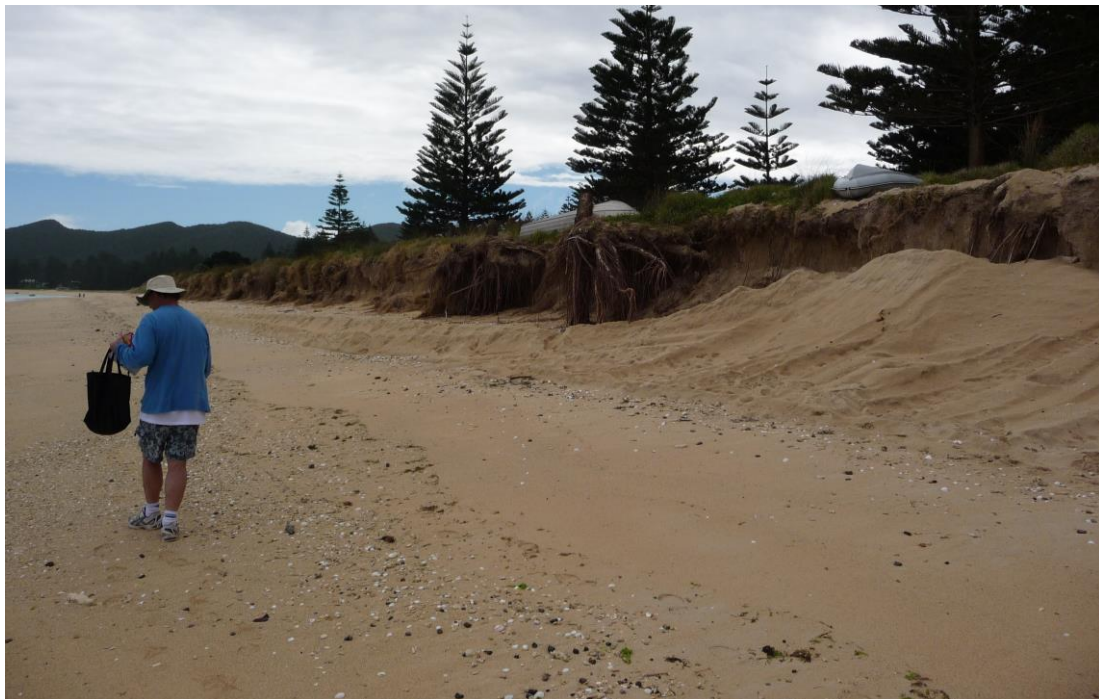
**Figure A5: View of beach erosion escarpment north of Pinetrees boatshed**
