# Lord Howe Island Coastline Hazard Definition and Coastal Management Study

Prepared for the Lord Howe Island Board by Haskoning Australia Pty Ltd

9 September 2014

Issue 5 (Final)

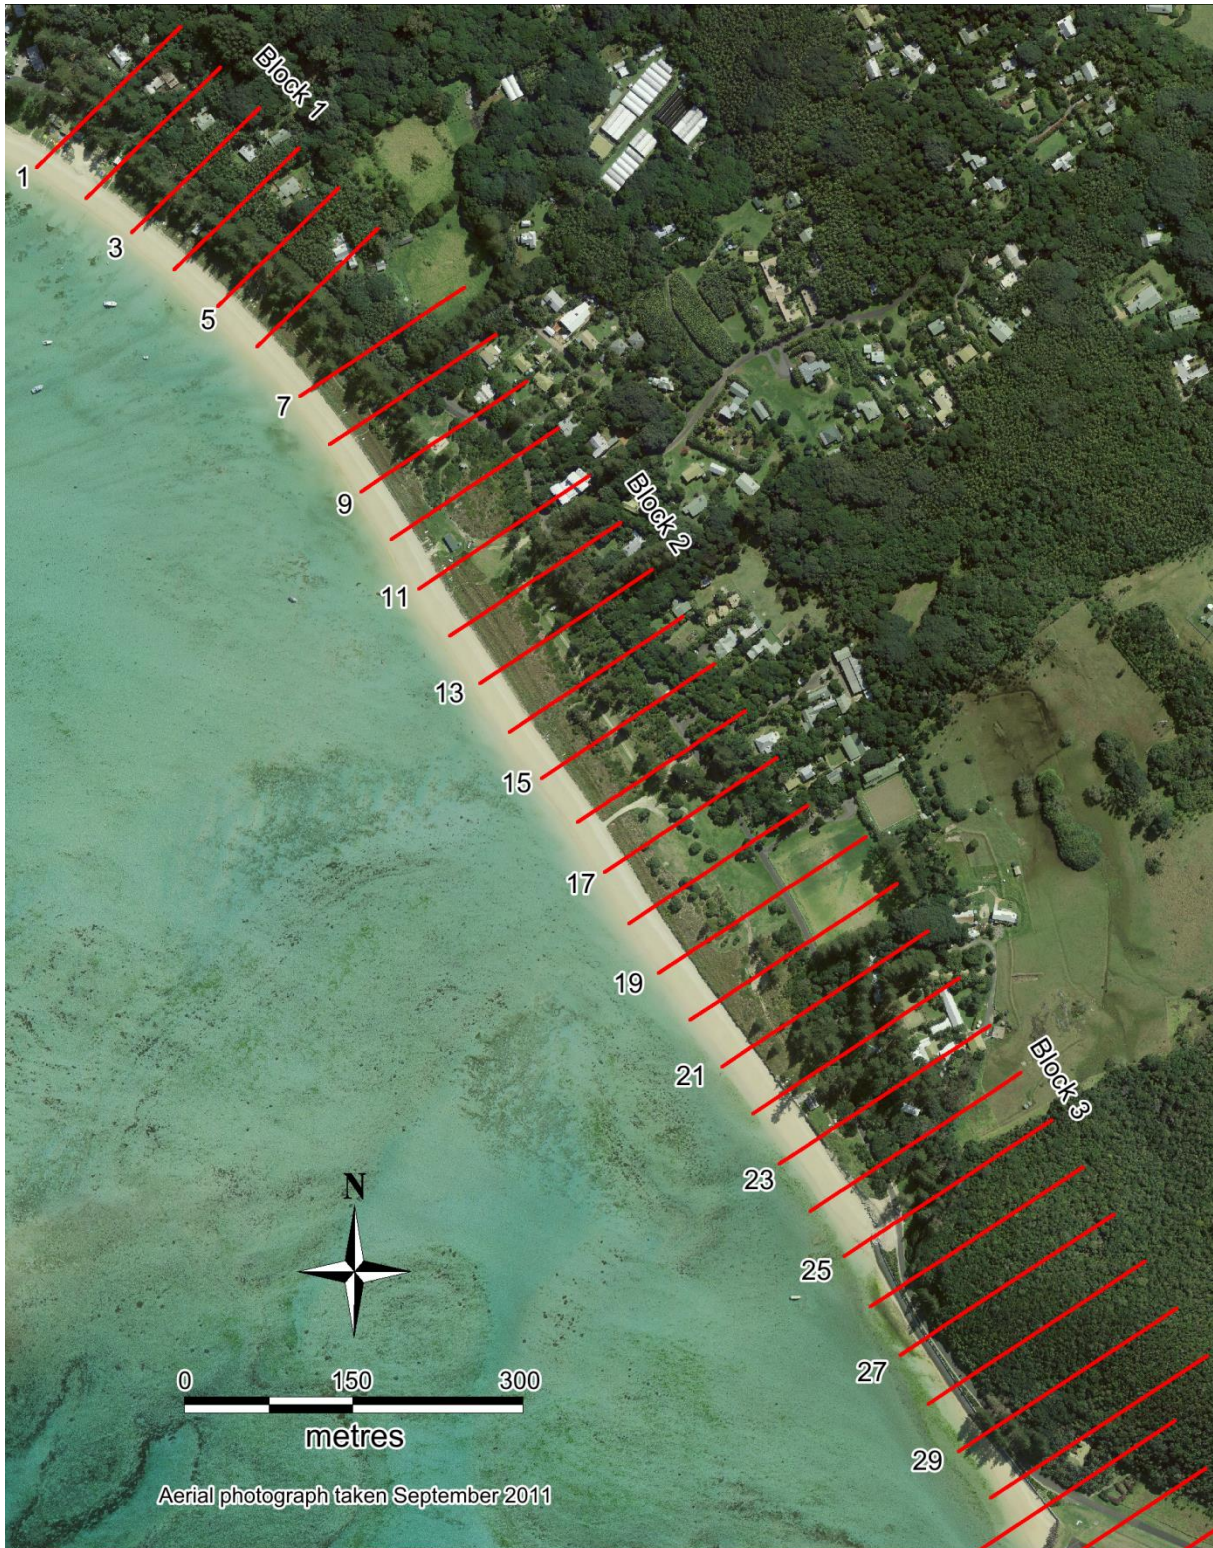
**Figure B1: Arrangement of photogrammetric profiles at Lagoon Beach and along Seabee seawall**

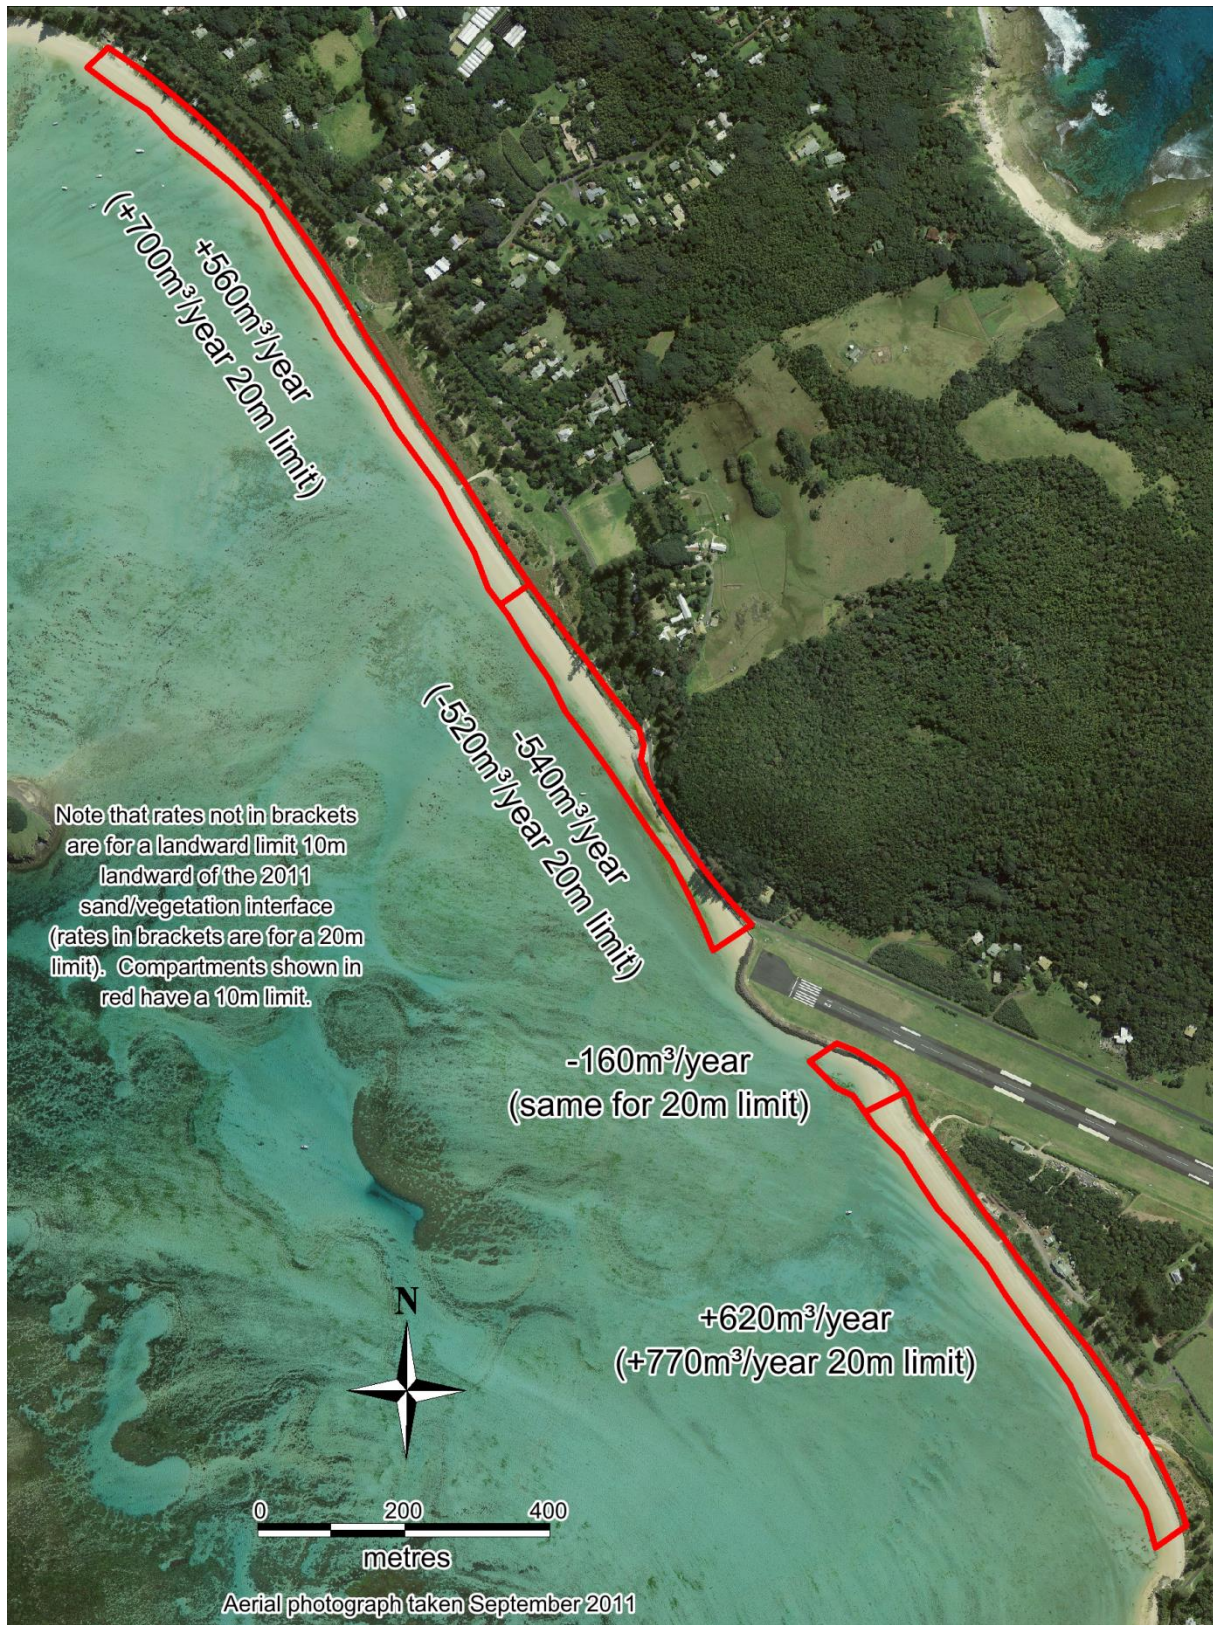
**Figure B9: Summary rates of change of volume per year in various compartments along Lagoon Beach and Cobbys Beach (based on 1965 to 2011 rate in compartment)**

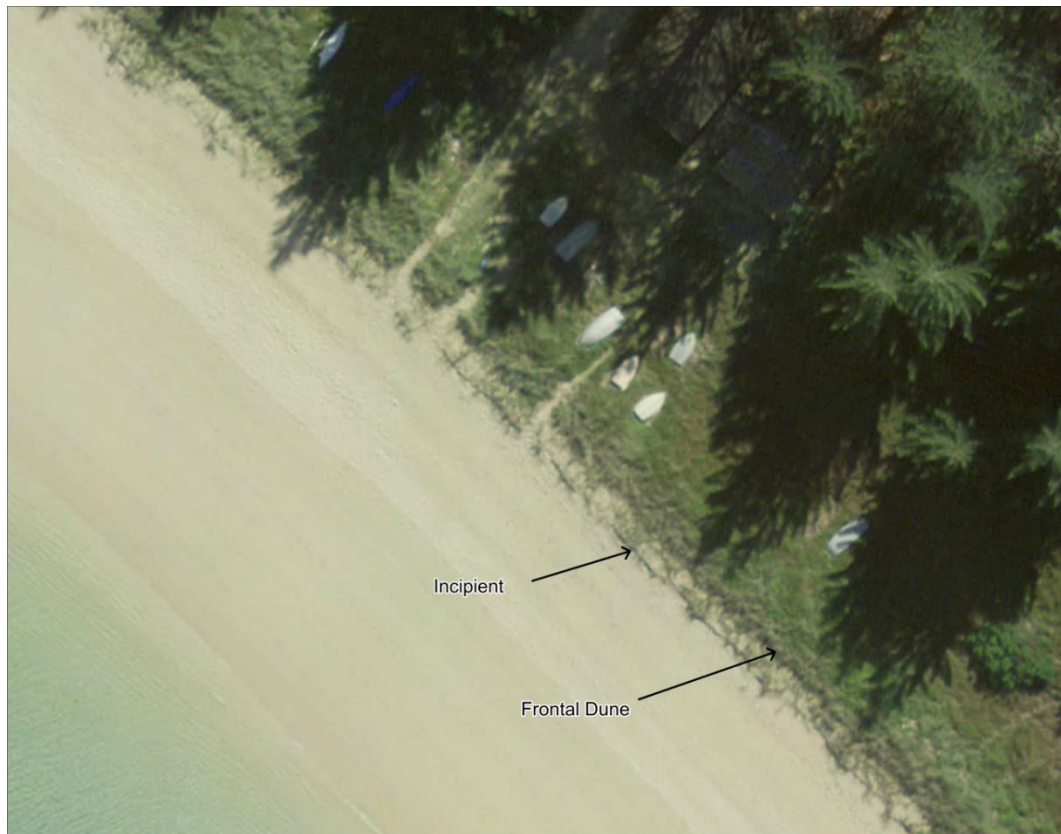
**Figure B12: Example definition of incipient and frontal dune sand/vegetation interfaces**

A technique that provides an indication of whether beaches have receded (shifted landwards or reduced in volume) or prograded (shifted seawards or increased in volume) is tracking the position of the sand/vegetation interface over time. Where visible, two interfaces were mapped, namely the incipient sand/vegetation interface (with light coverage of grasses and creepers landward of the interface) and the main frontal dune sand/vegetation interface (more densely vegetated landward). An example of these positions is depicted in Figure B12 (as visible on Lagoon Beach in 2011 near the Dignam/Crombie boatsheds).

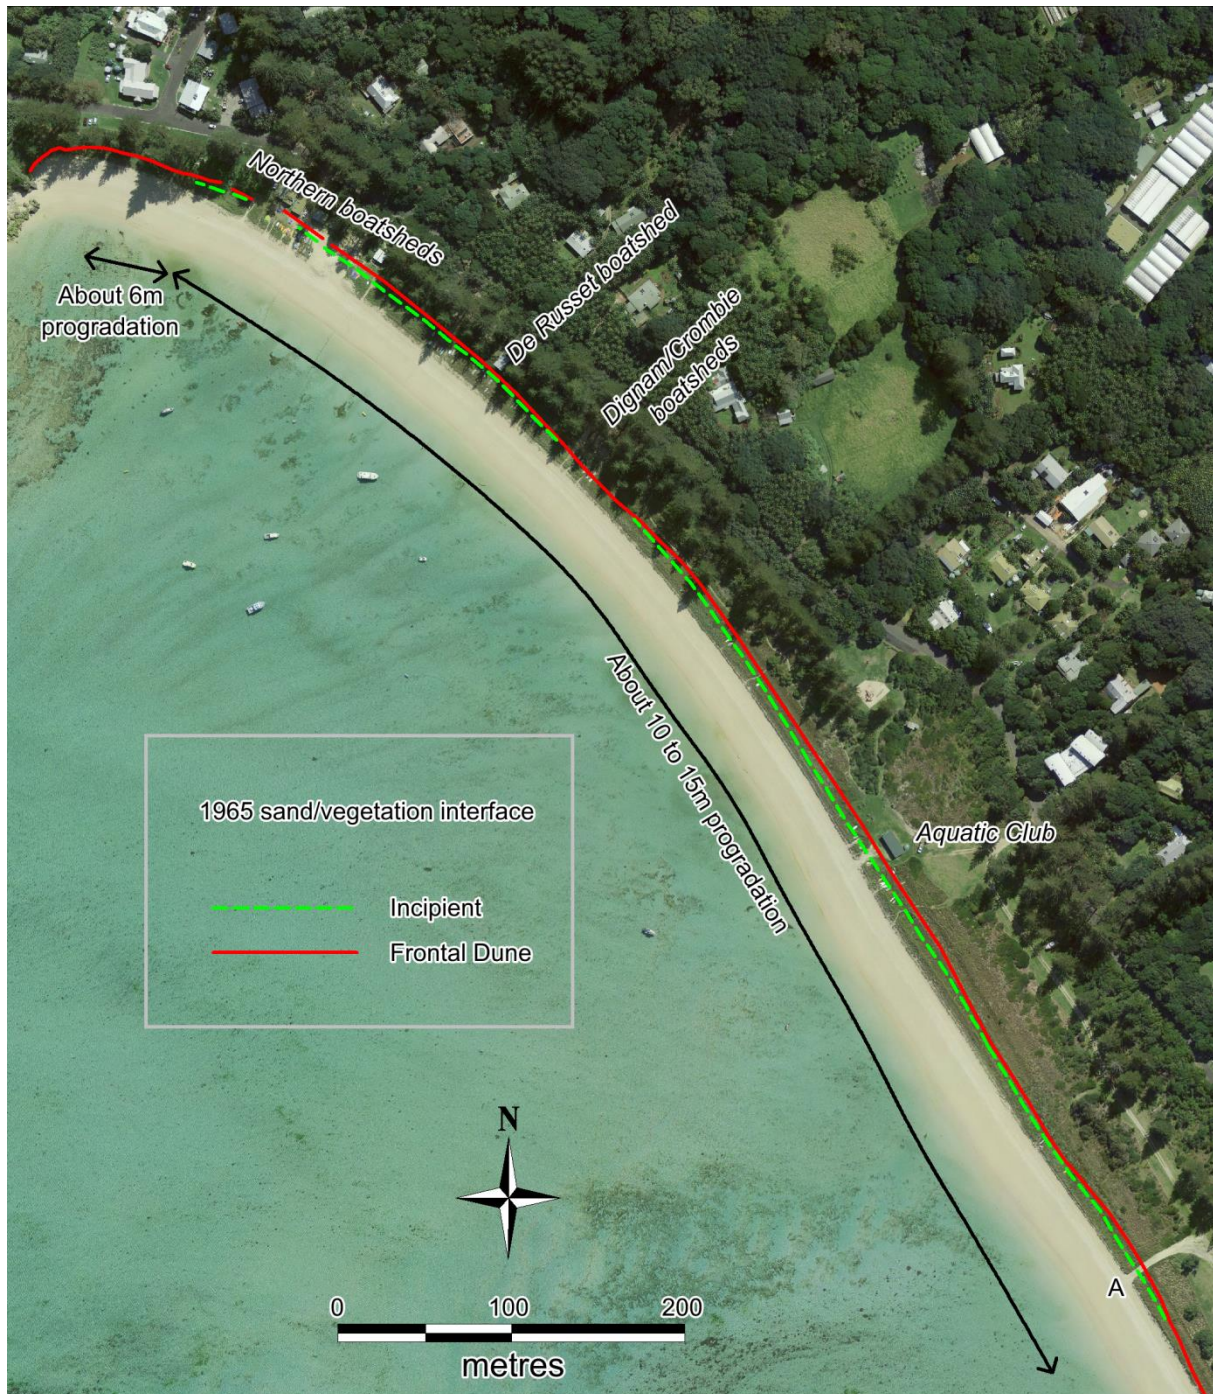
**Figure B13: Position of 1965 sand/vegetation interfaces at northern end of Lagoon Beach overlaid on 2011 aerial photograph**

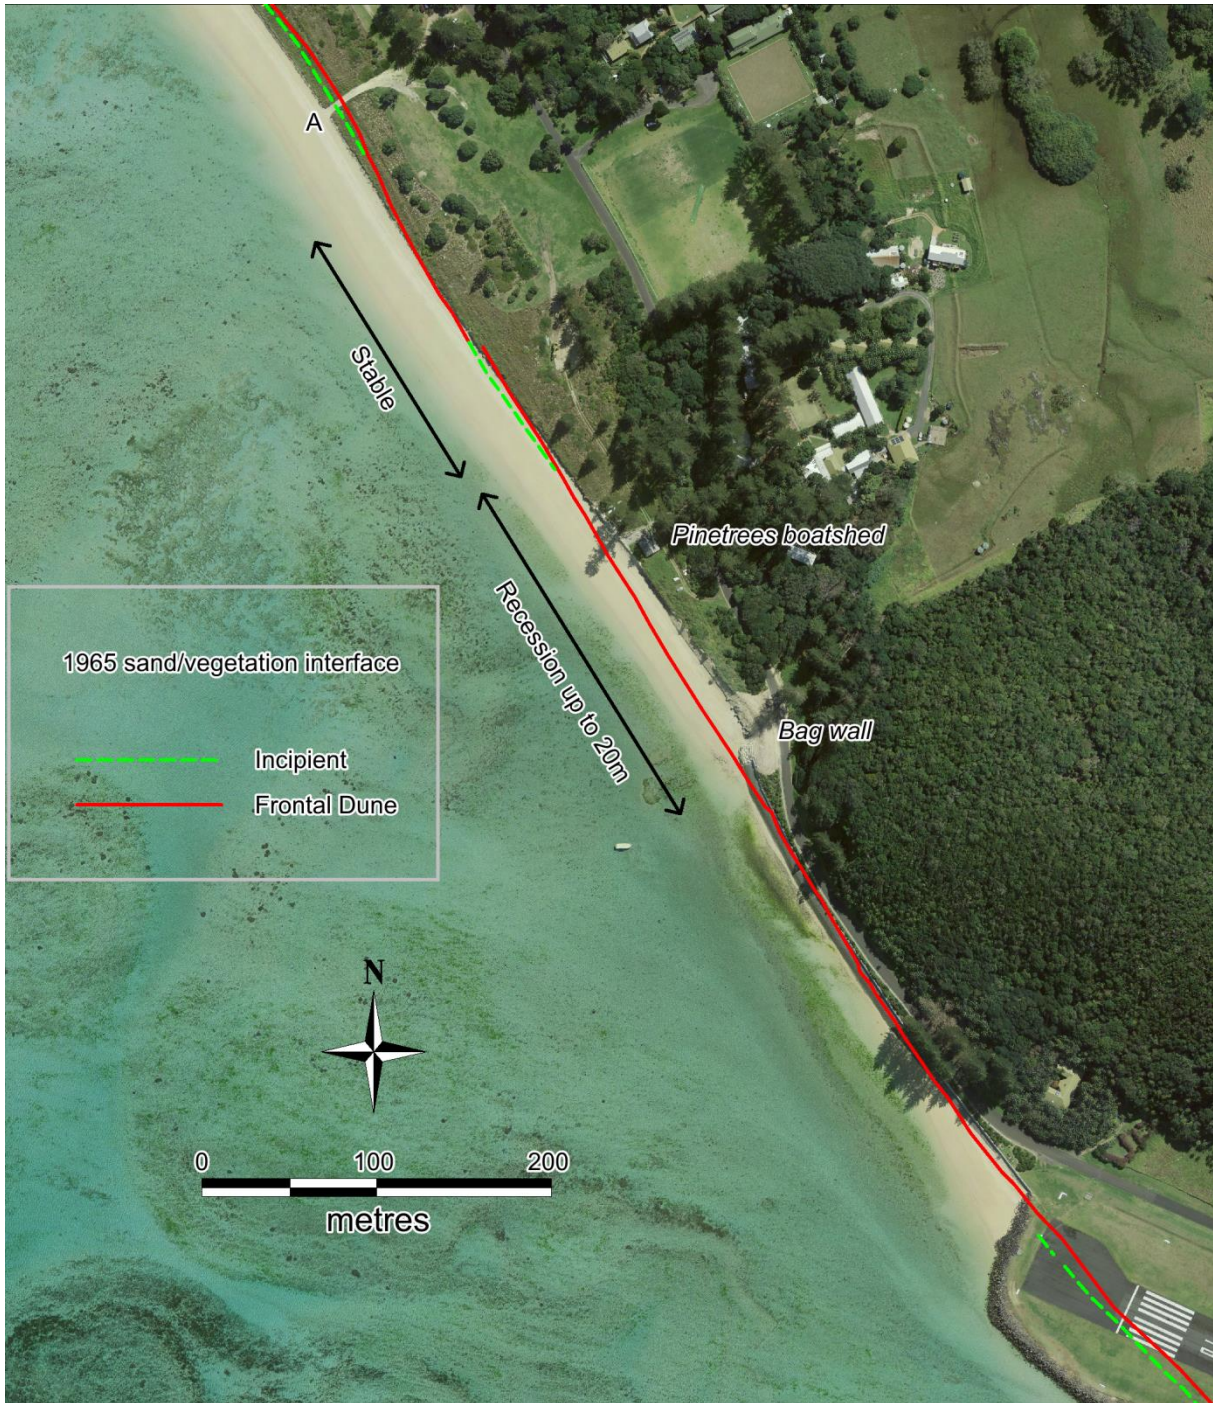
**Figure B14: Position of 1965 sand/vegetation interfaces at southern end of Lagoon Beach overlaid on 2011 aerial photograph**

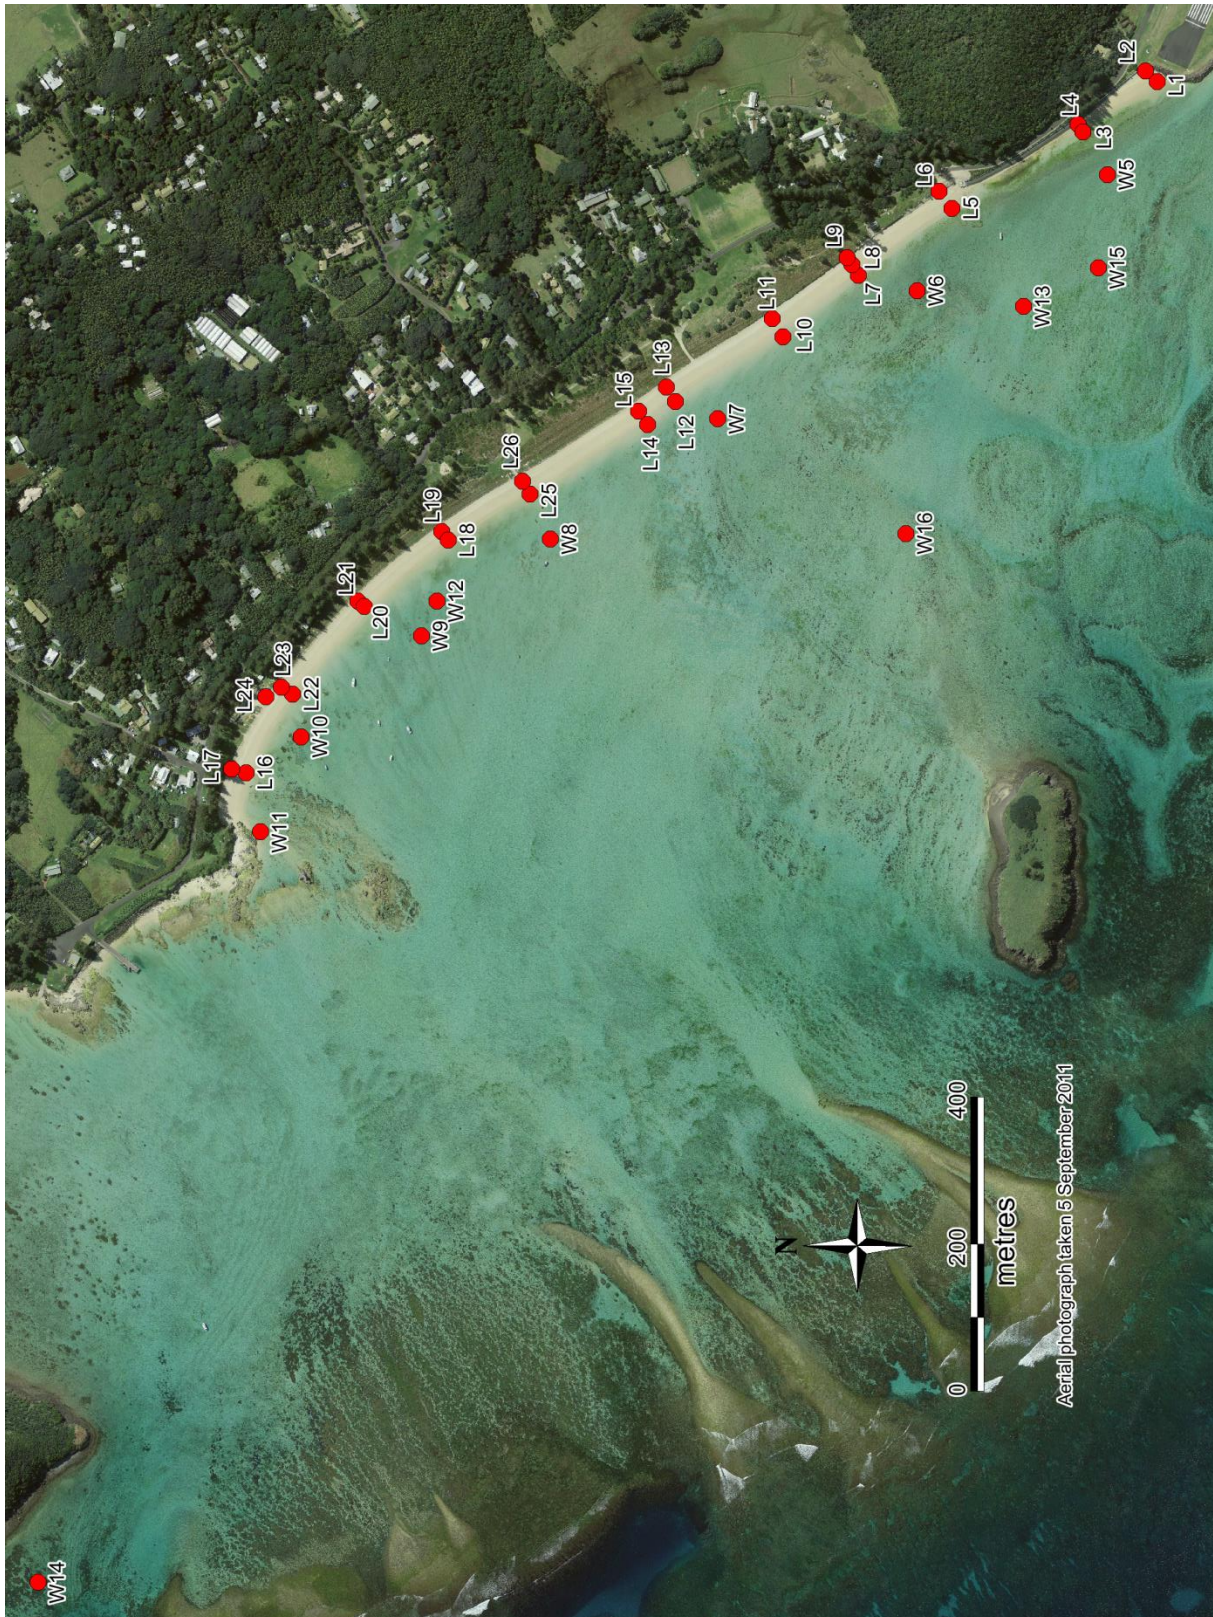
**Figure C1: Lagoon Beach and northern Lagoon waterway sediment sampling locations**

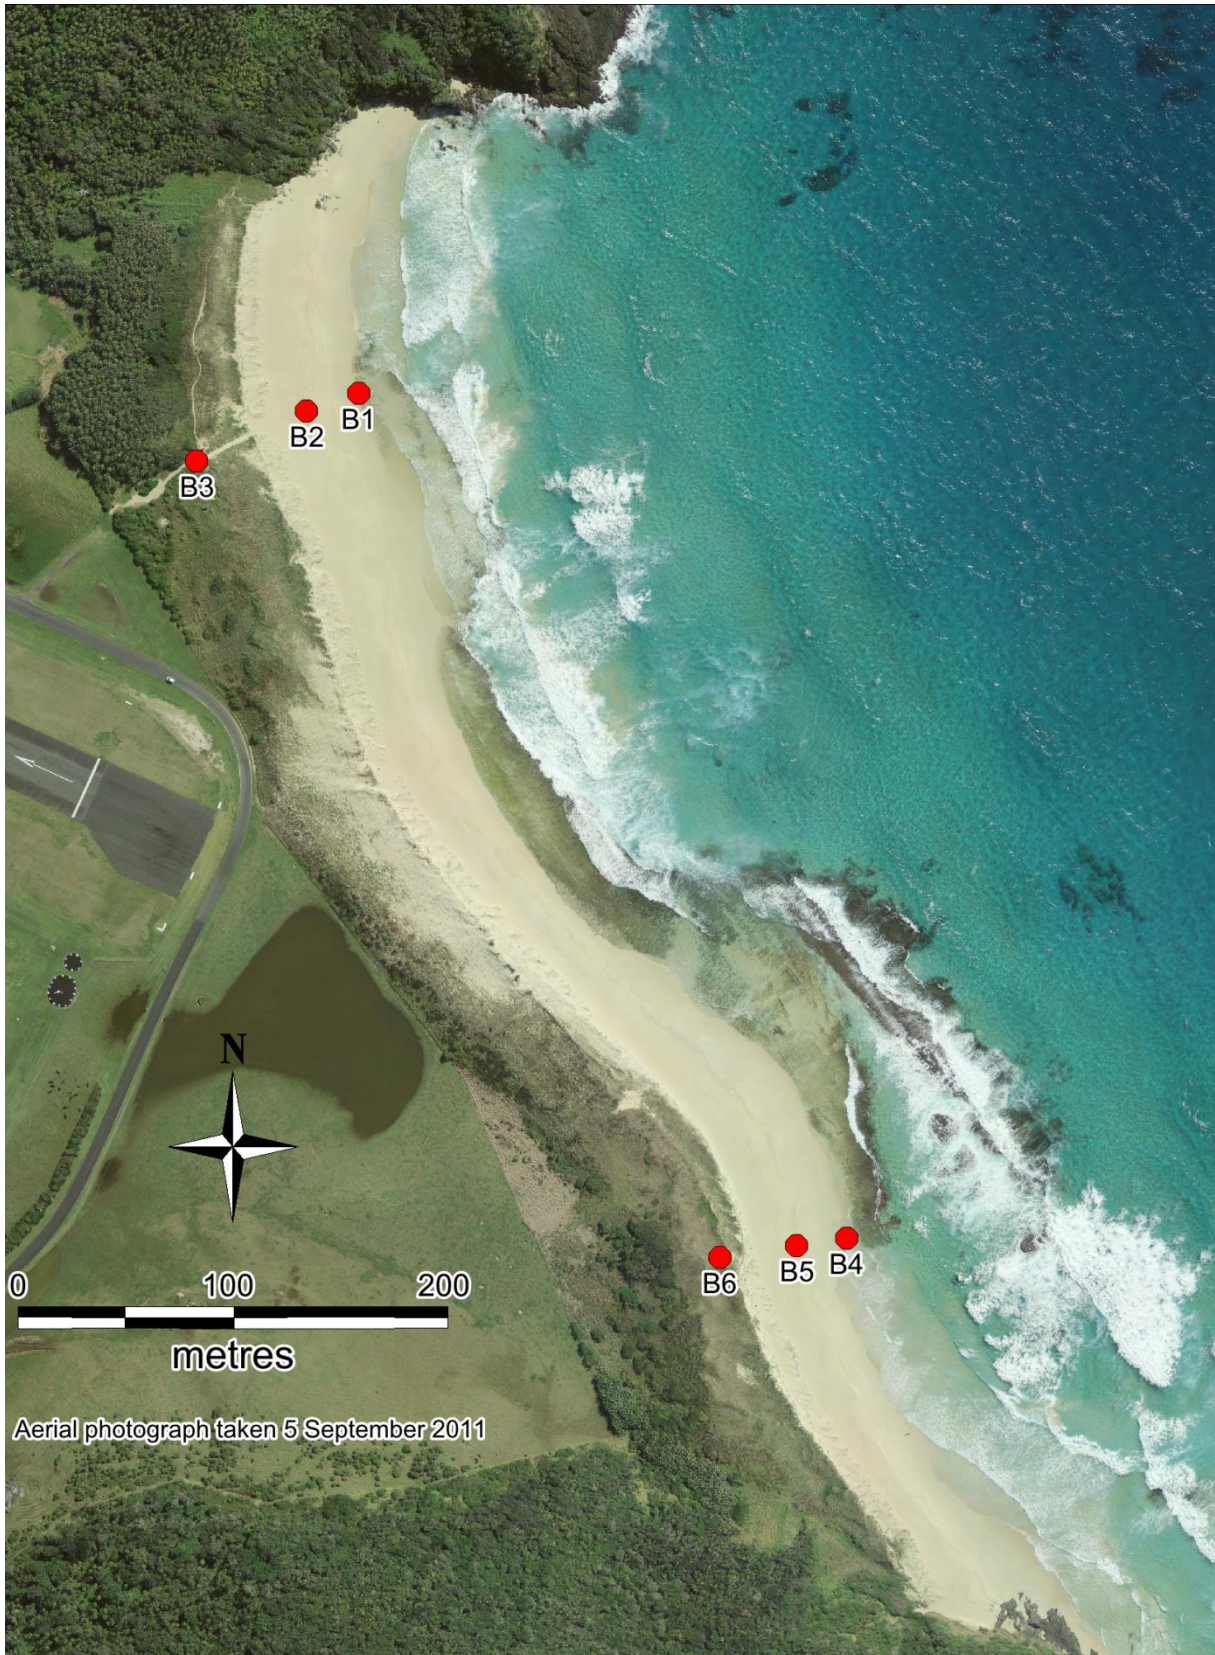
**Figure C3: Blinky Beach sediment sampling locations**

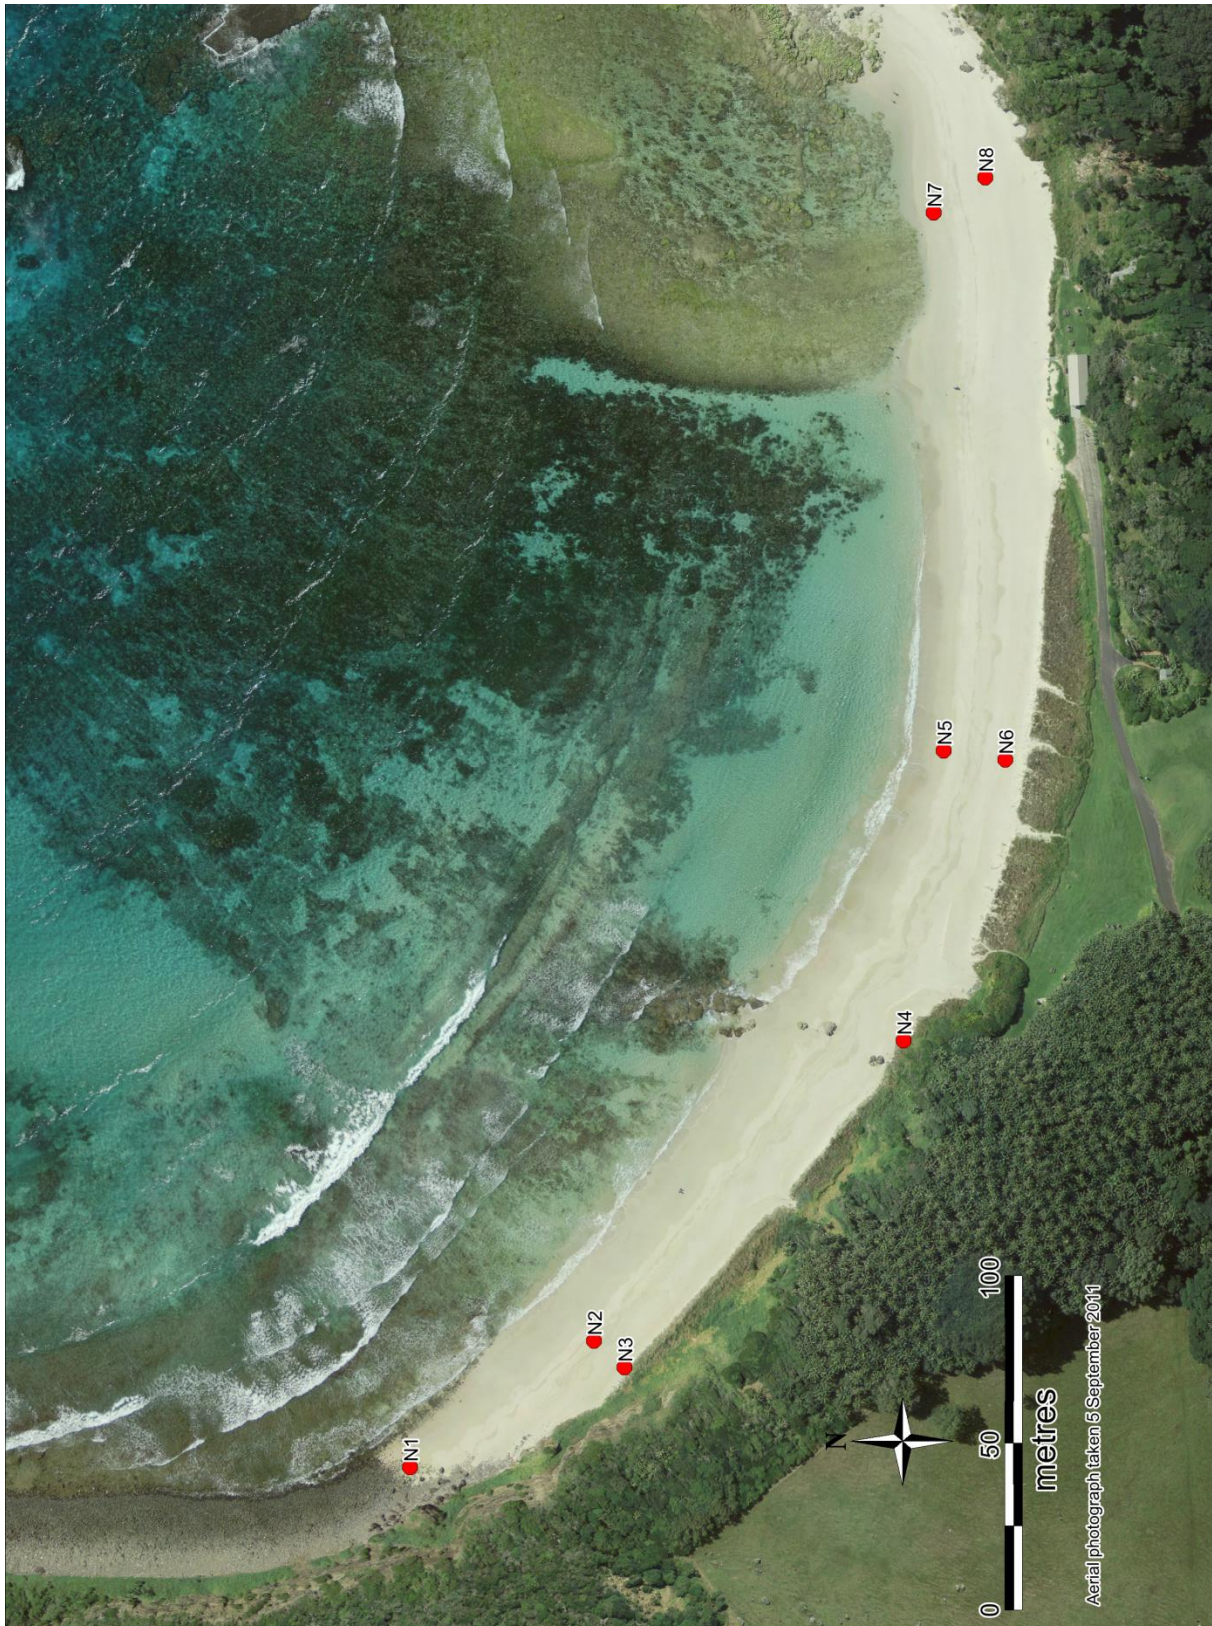
Figure C4: Neds Beach sediment sampling locations

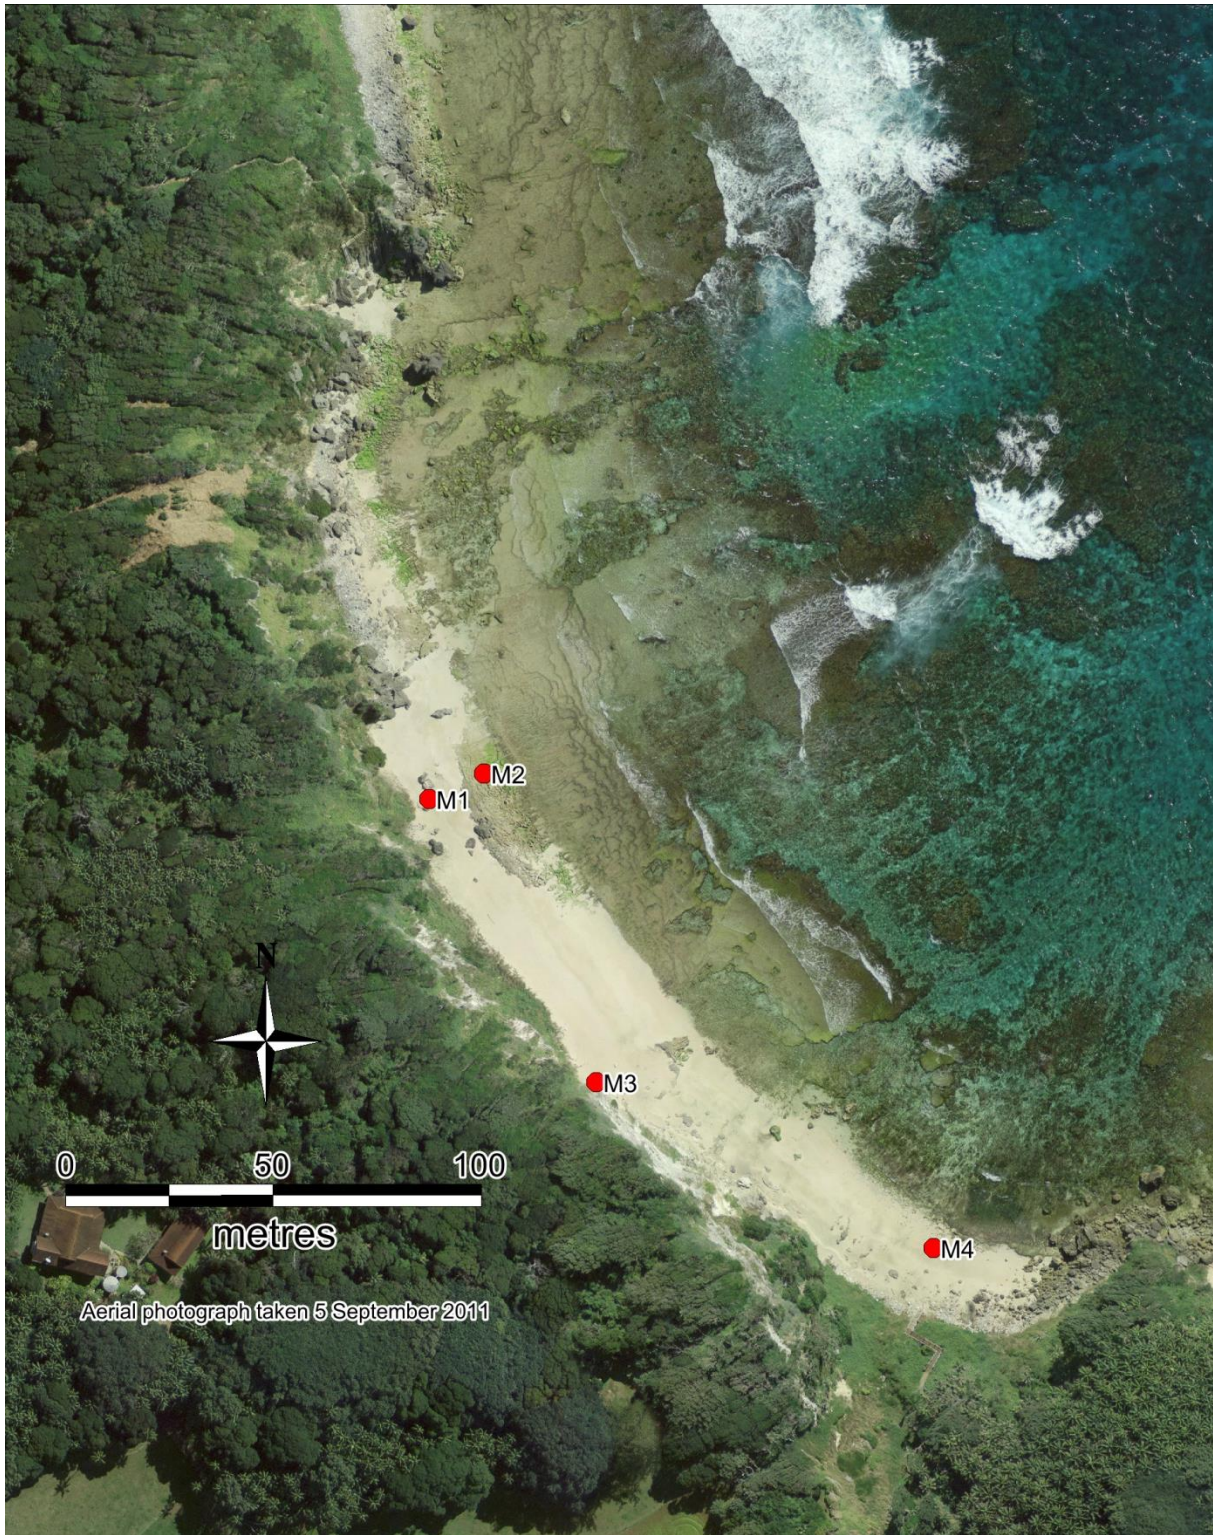
**Figure C5: Middle Beach sediment sampling locations**

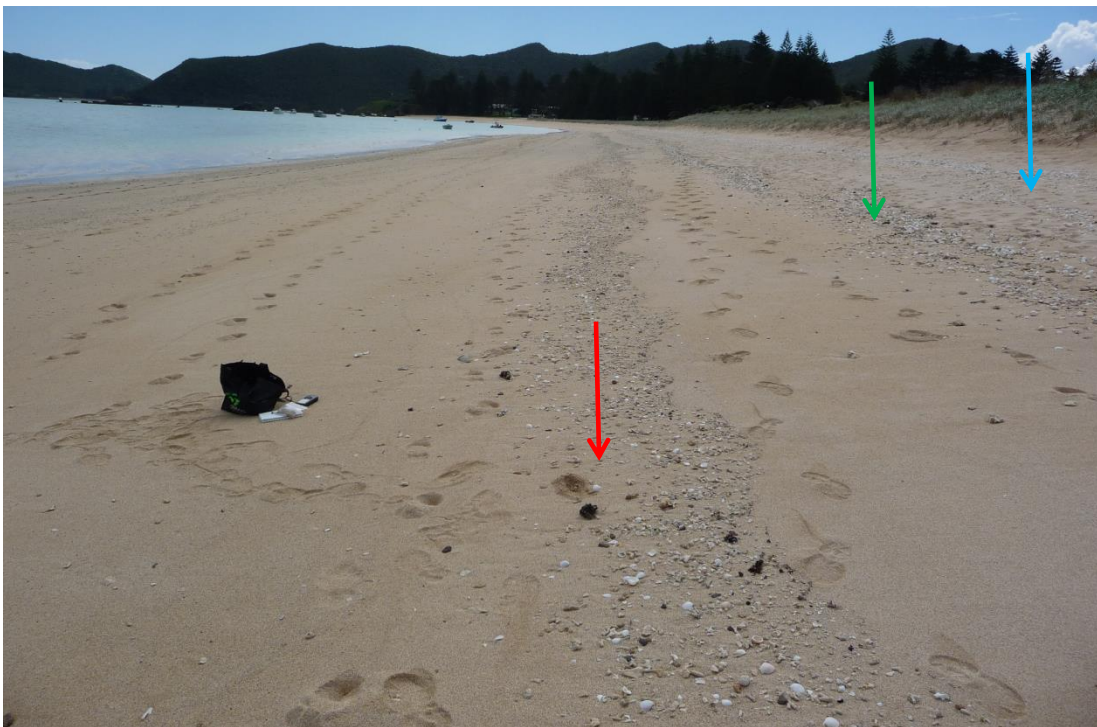
Figure C7: L15 sampling location at red arrow (note two more landward lines of shells at green and blue arrows respectively)

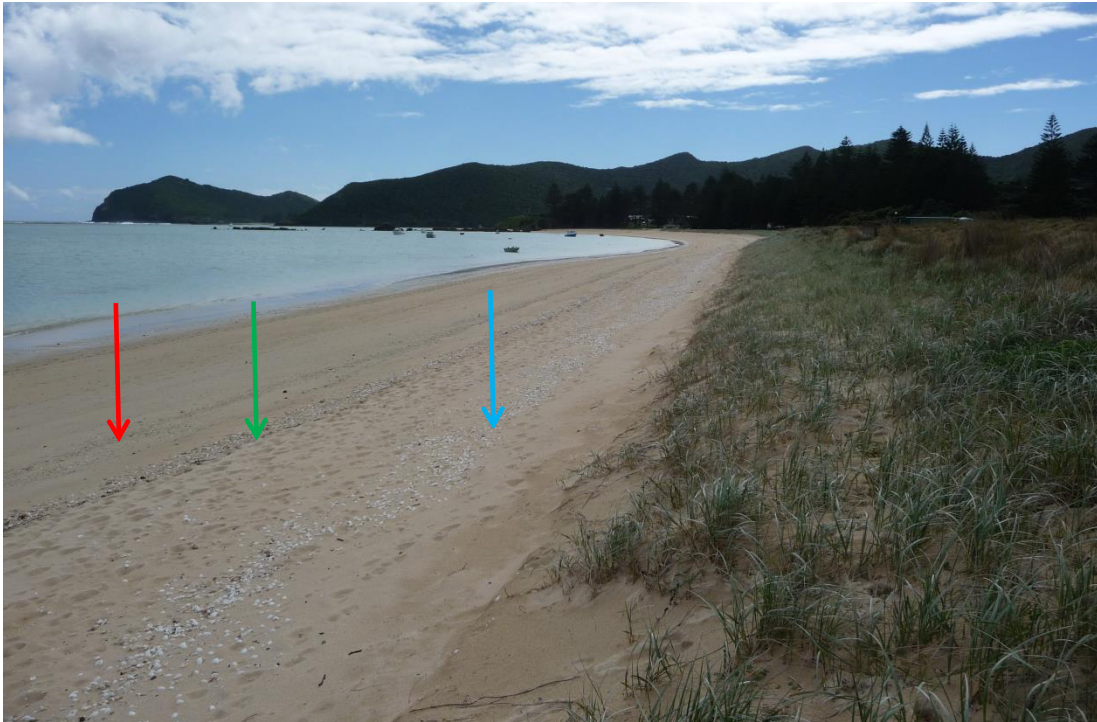
**Figure C8: Elevated view of L15 sampling area with three lines of shells**

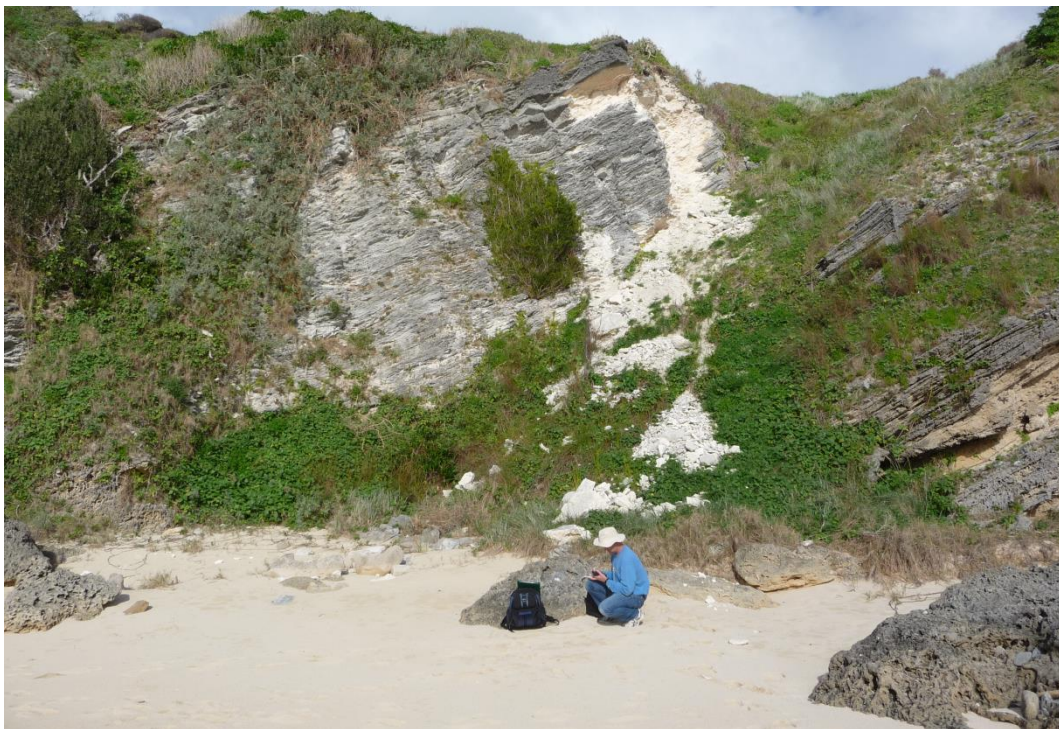
**Figure C13: M1 sampling area (scree at base of slope)**
