## 8.7 Risk to Assets

Haskoning Australia Pty Ltd was engaged by the Lord Howe Island Board to complete a Coastal Hazard Definition and Coastal Management Study for Lord Howe Island, as has been set out herein. There are a number of coastline management issues at Lord Howe Island, in particular erosion/recession threatening Lagoon Road (and underground cables) at Lagoon Beach near Windy Point.

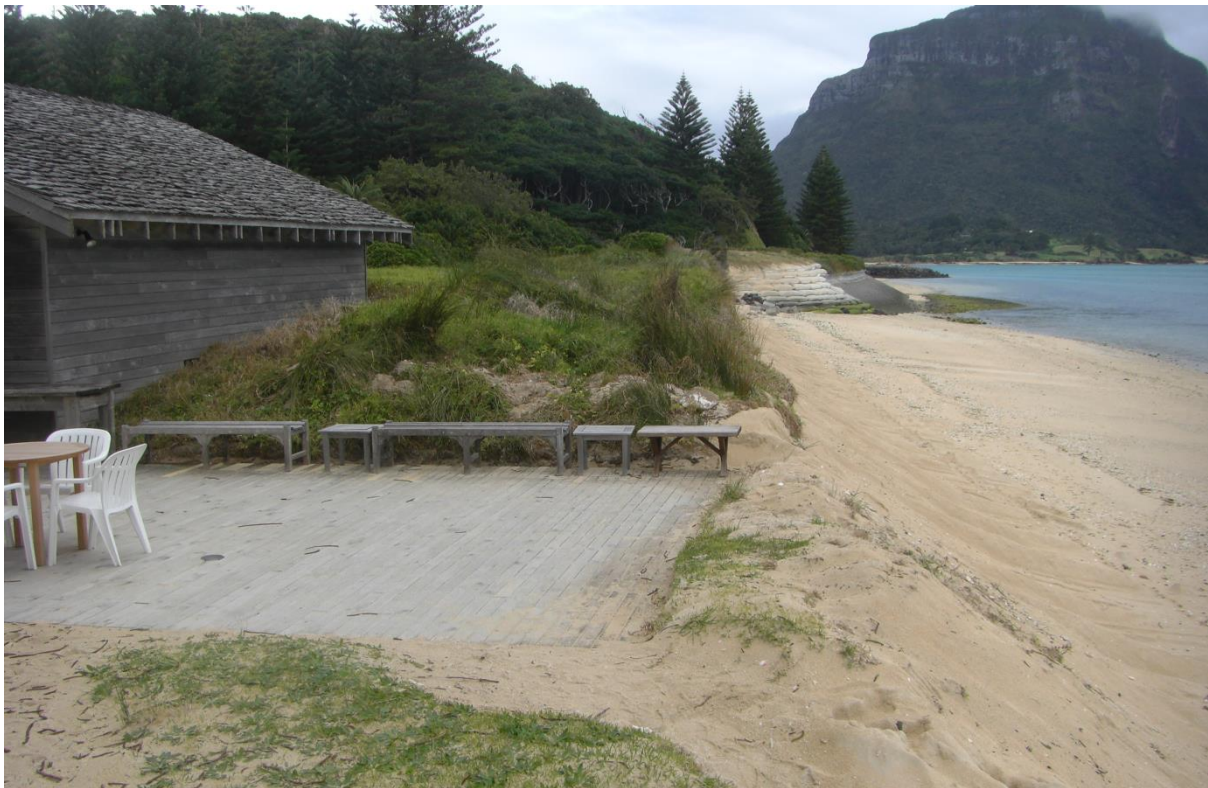
In August 2012, the erosion escarpment at Pinetrees boatshed was measured as being 7.6m from the seaward face of the structure, with the deck seaward of the boatshed within 1m of the escarpment (Figure 38).

**Figure 38: Erosion escarpment adjacent to deck at Pinetrees boatshed in August 2012**

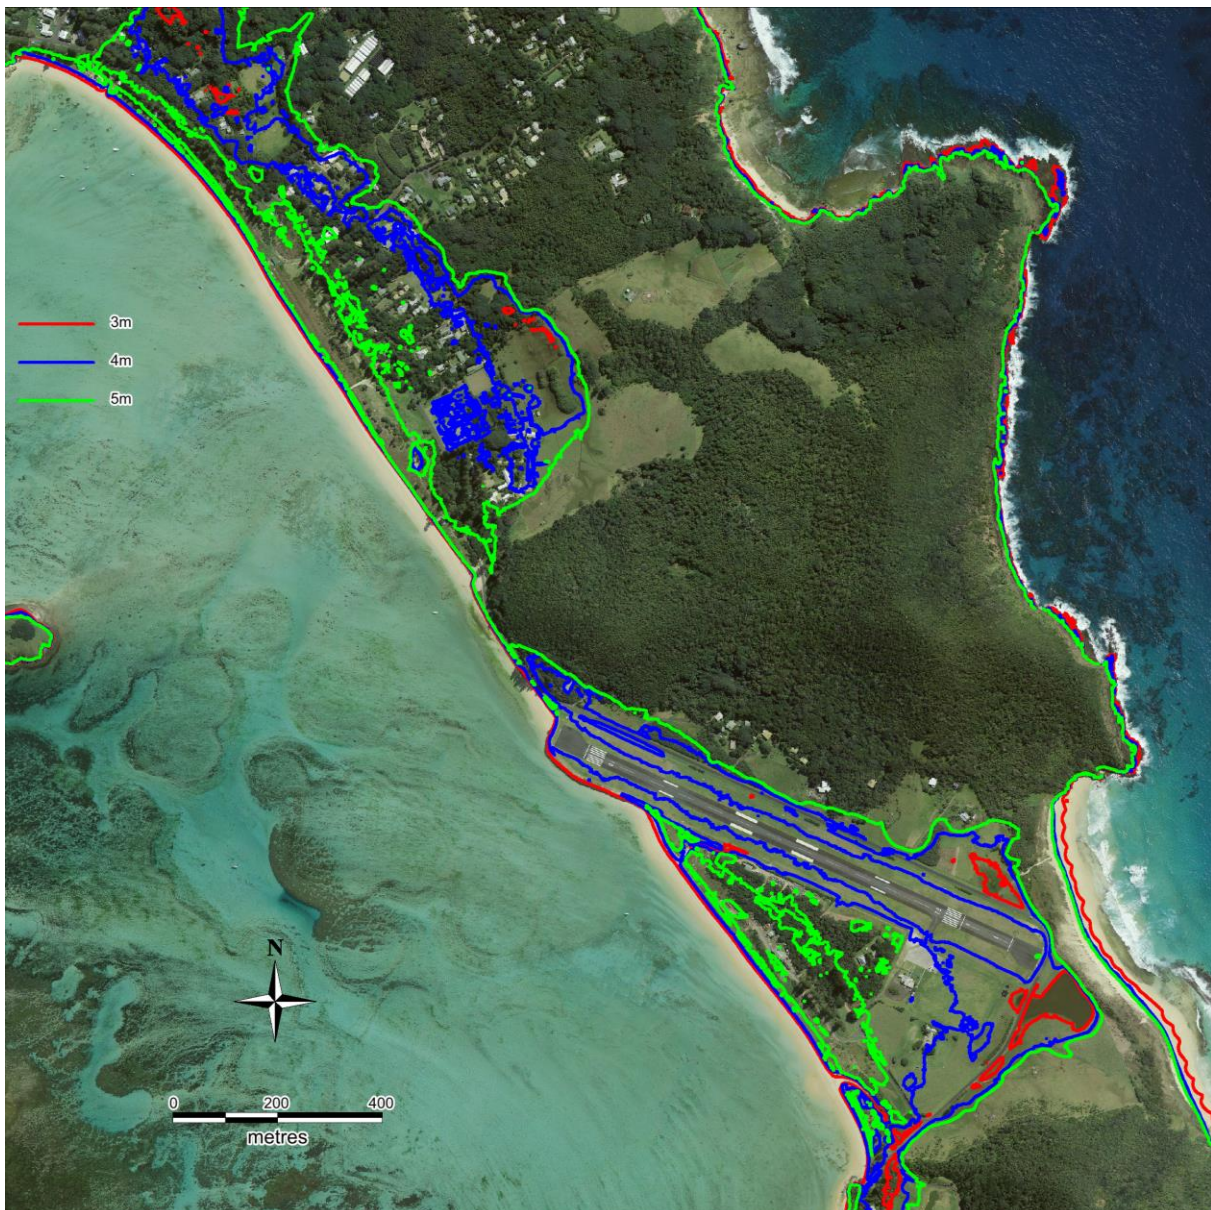
The 3m, 4m and 5m AHD contours along the Lagoon Beach and Cobbys Beach shoreline are depicted in Figure 39.

It is evident that the airport is the most extensive area with elevations around 4m AHD.

**Figure 39: 3m, 4m and 5m AHD contours along the Lagoon shoreline**

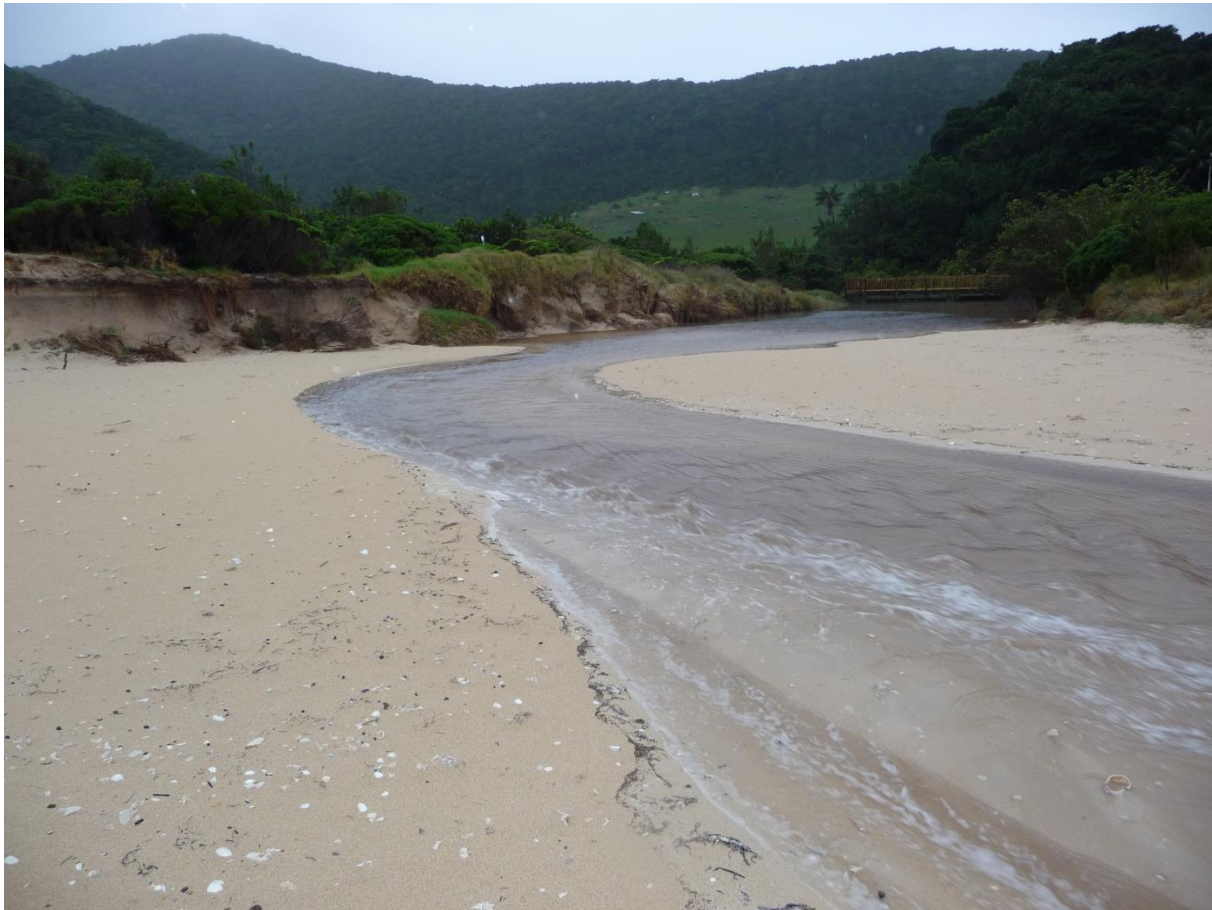
**Figure 40: Natural opening of Old Settlement Creek, 31 August 2012**

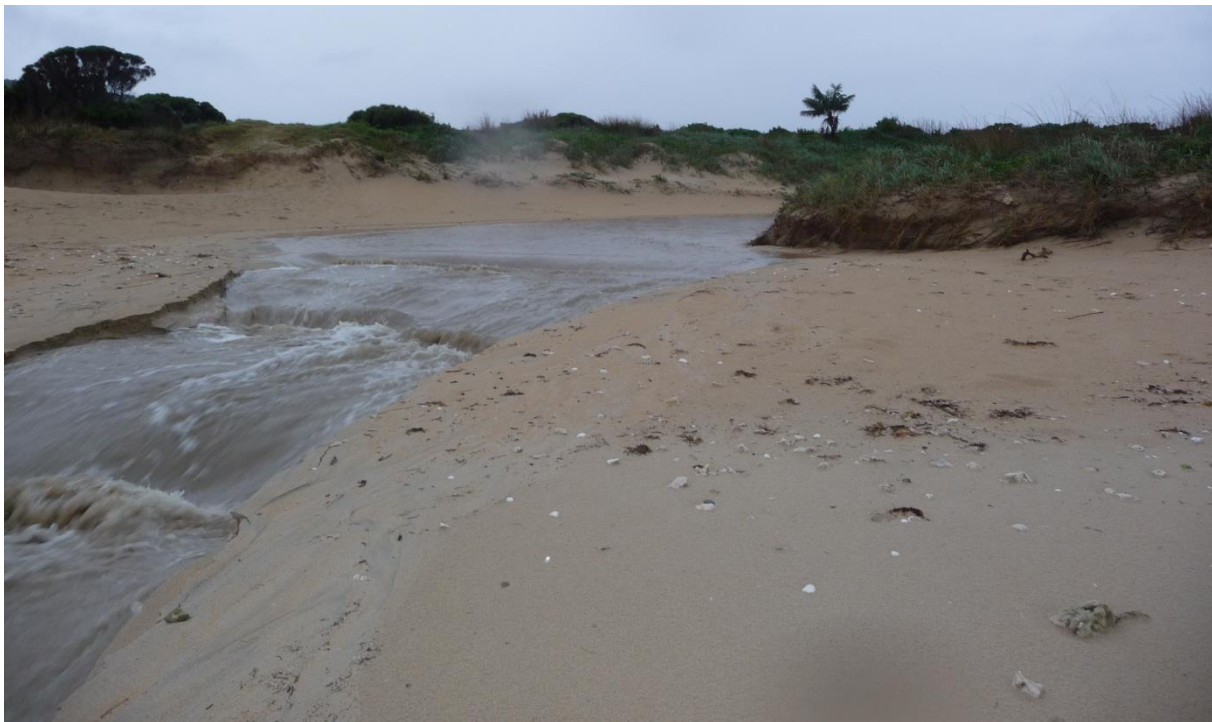
Figure 42: Natural opening of Cobbys Creek, 31 August 2012

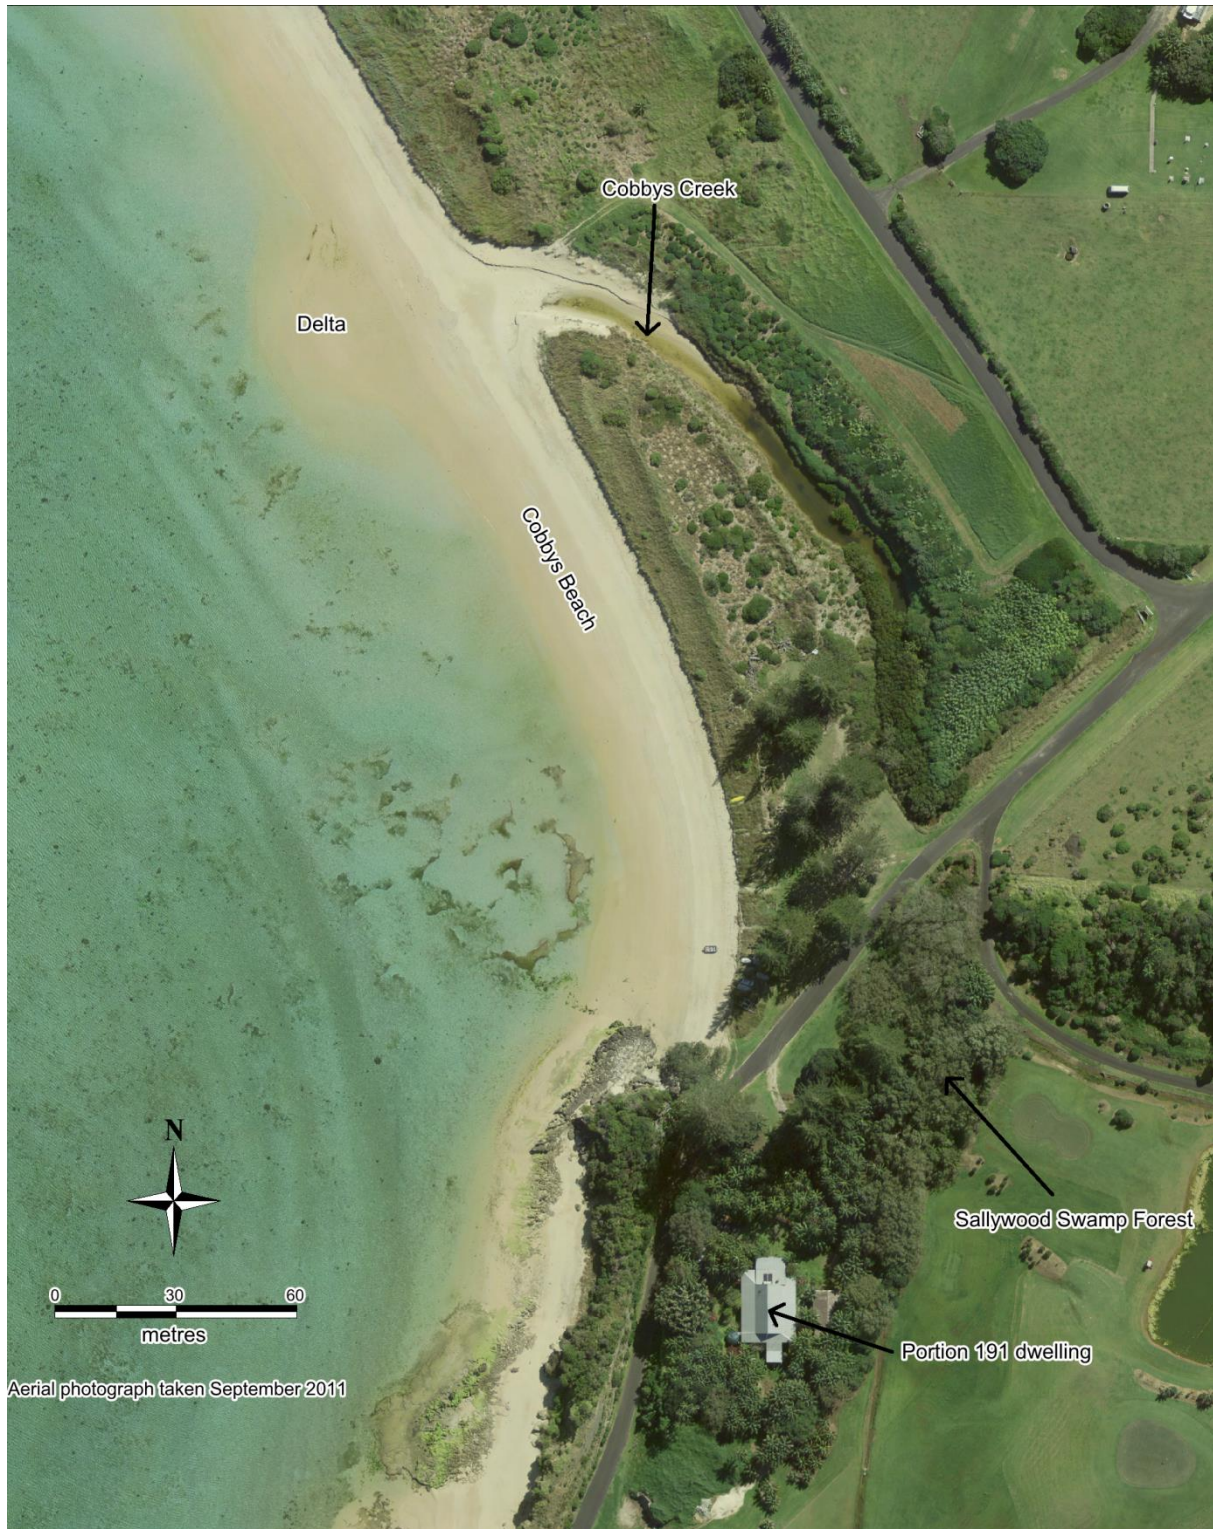
There is a delta of sand formed within the Lagoon seaward of Cobbys Creek, extending about 30m offshore and 60m alongshore, as visible in 2011 aerial photography (Figure 43). The entrance migrated about 30m north from 1965 to 2011, an average rate of about 1.5m/year, although the entrance appears to have been relatively stable since 2001<sup>66</sup>. The delta has only been visible in aerial photography since 2011 (based on examination of 1965, 1975, 1984 and 2001 dates), but this may be a function of entrance closure at the time of earlier photographs, and the delta at Cobbys Beach being a transient feature due to longshore sand transport.

Figure 43: Aerial photograph of Cobbys Creek entrance, with delta evident

As for Old Settlement Creek, there may be consideration of using the Cobbys Creek delta as a source of sand for beach nourishment. There is likely to be in the order of 1,000m<sup>3</sup> metres of sand in the delta that could potentially be removed without adversely impacting on coastline hazards at Cobbys Beach or other areas.

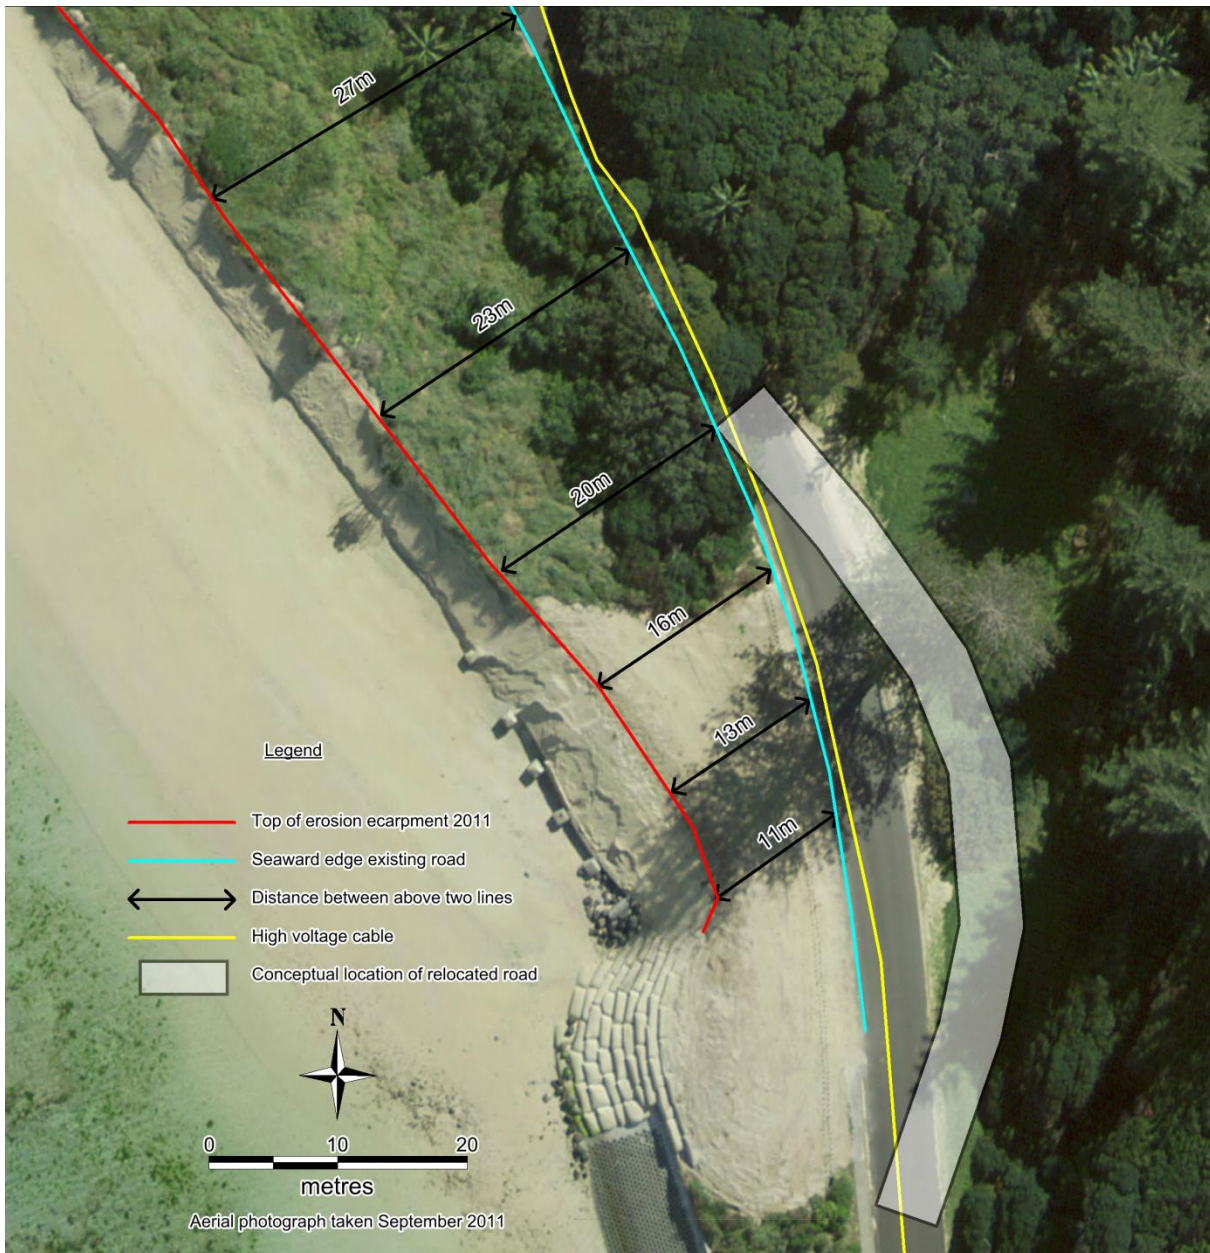
If it is found that the risk of damage to Lagoon Road and adjacent cables cannot be managed through alongshore sand relocation and/or beach nourishment (eg if sufficient suitable sand sources cannot be accessed), there could be consideration given to moving Lagoon Road landward. A conceptual layout of a potential relocated road position is provided in Figure 46, assuming adoption of a minimum 20m distance from the 2011 erosion escarpment position (as derived from photogrammetric data) to the relocated road. The total area of relocated road as depicted is about 350m<sup>2</sup>, over a length of about 70m.

**Figure 46: Conceptual layout of potential relocated Lagoon Road in vicinity of bag wall**

Based on advice from the Board's Administration, the cost of this option would be in the order of \$350,000 (using Board staff and equipment)<sup>72</sup>. A disadvantage of this option (in isolation) would be that there would be no restriction on continuing recession at the southern end of Lagoon Beach. That is, there would be expected to be continuing loss of habitat of the Lord Howe Island skink and wedge-tailed shearwater, and no reduction in coastline hazard risk to Pinetrees boatshed. The relocated road and cables may also be at risk of undermining again in the future if recession continues.
