Lord Howe Island Coastline Hazard Definition and Coastal Management Study

Prepared for the Lord Howe Island Board by Haskoning Australia Pty Ltd

9 September 2014

Issue 5 (Final)

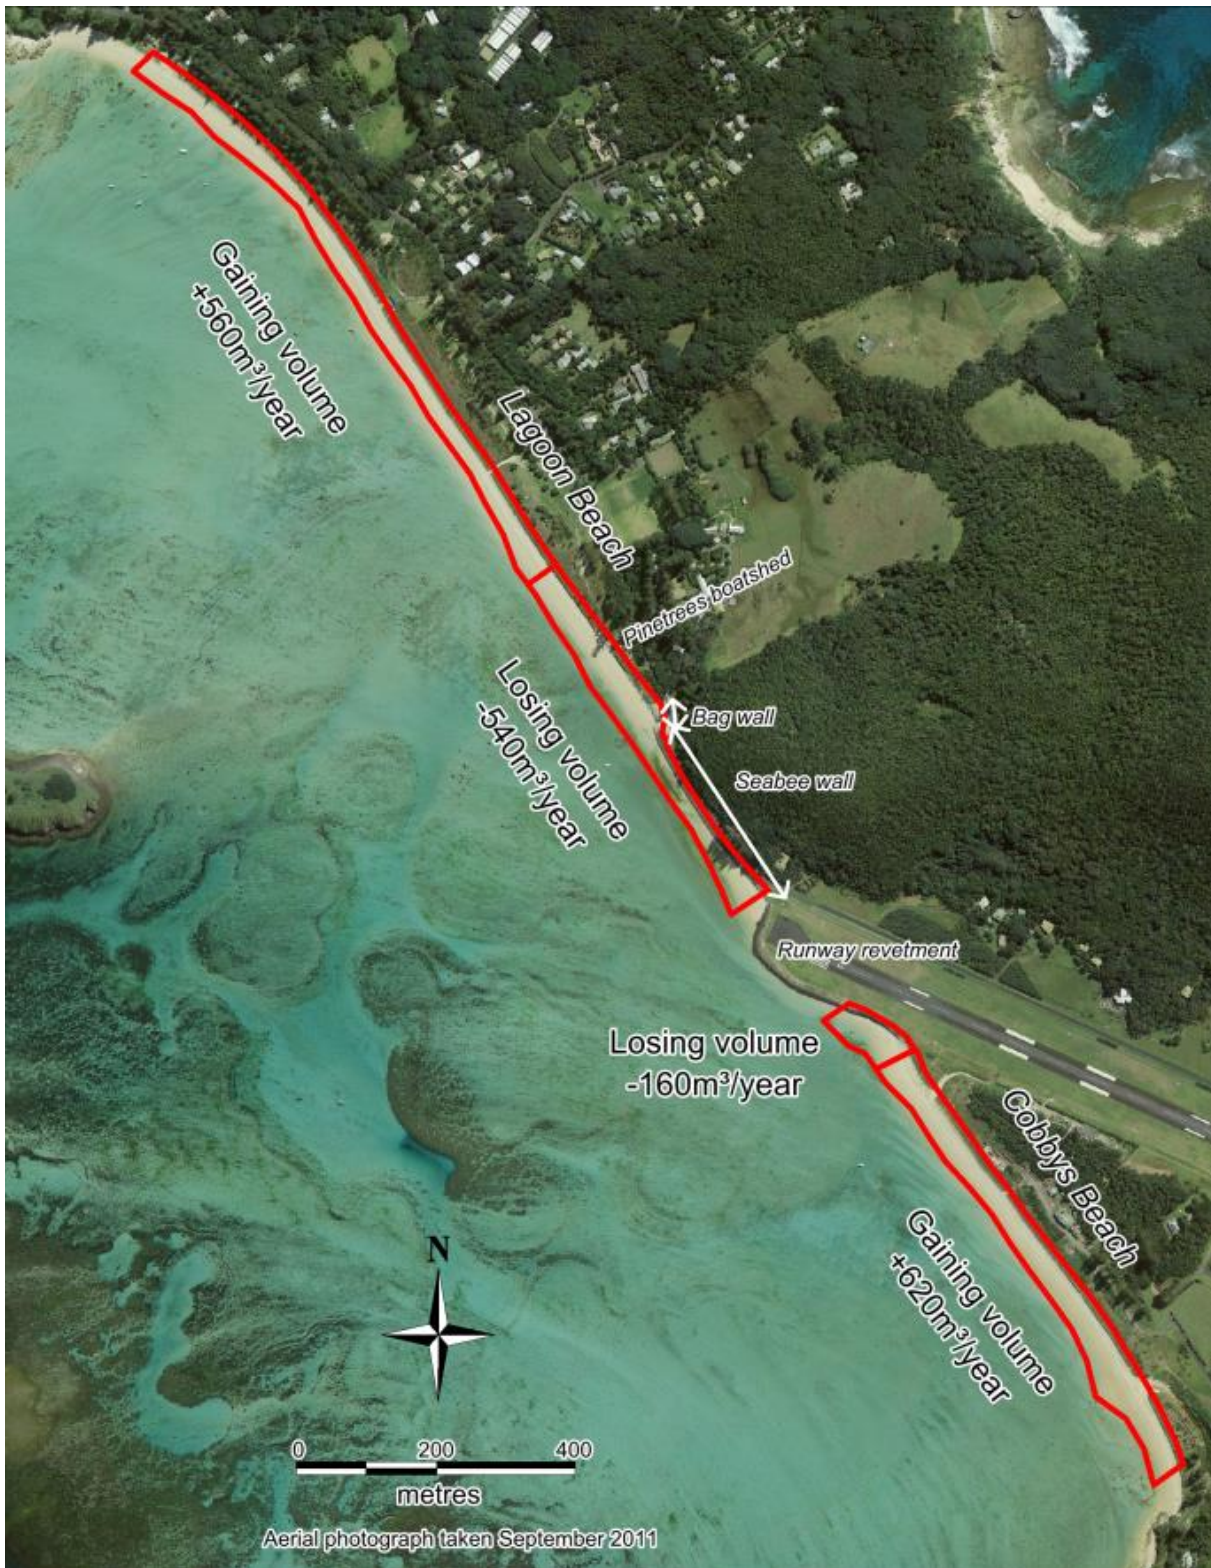
Figure ES1: Summary of long term (1965 to 2011) sand volume changes at Lagoon Beach and Cobbys Beach

Rates of change of sand volume per year in various compartments along Lagoon Beach and Cobbys Beach, based on review of 5 dates of aerial photography and photogrammetric data from 1965 to 2011 and measured above 0m AHD, are depicted in Figure ES1. It is evident that most of the length of beaches along the Lagoon at Lord Howe Island have been growing in sand volume or moving seaward (prograding). The only two areas reducing in volume or moving landward (receding) are located immediately north and south of the runway revetment, Seabee revetment, and bag wall structures.

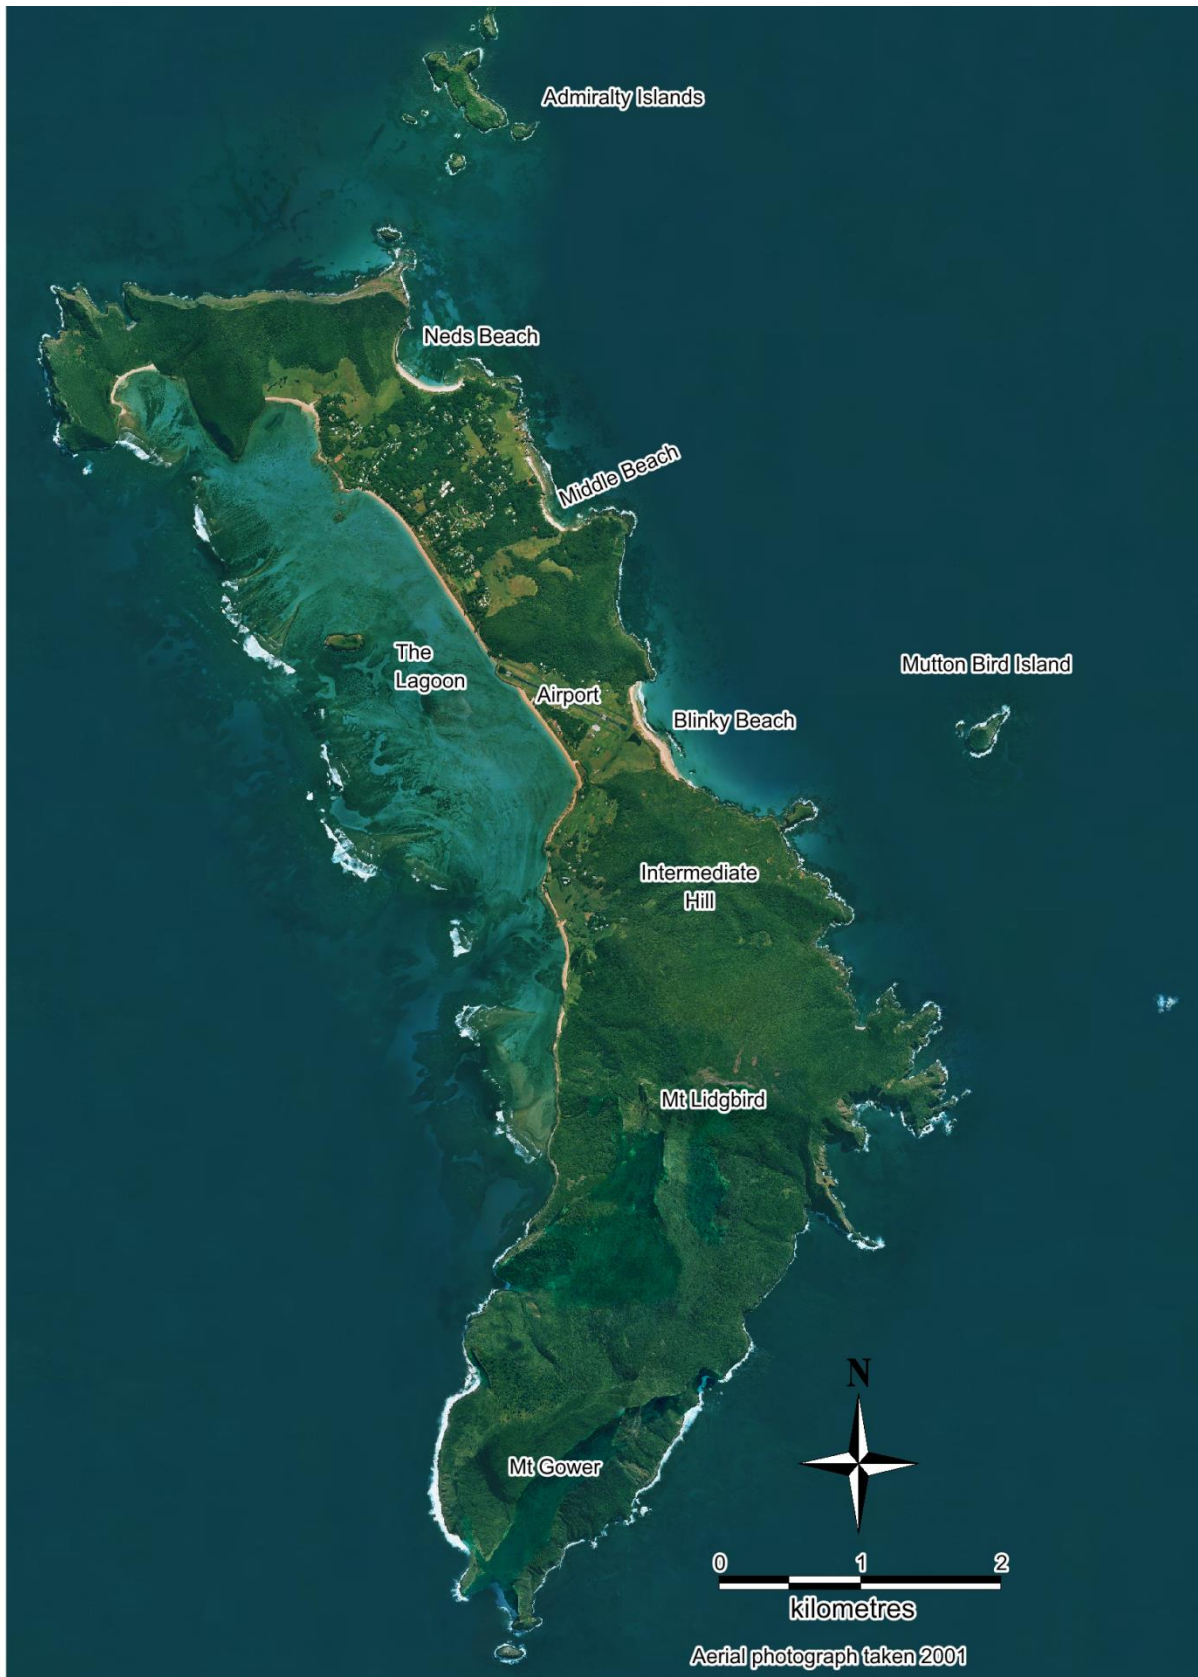
Figure 2: Aerial photograph of Lord Howe Island with key features identified

Lord Howe Island is located about 760km north-east of Sydney (at latitude 31.5°S and longitude 159.1°E) within the Pacific Ocean (Figure), and is thus exposed to waves from all directions. An aerial photograph of the Island is depicted in Figure 2. Key features include:

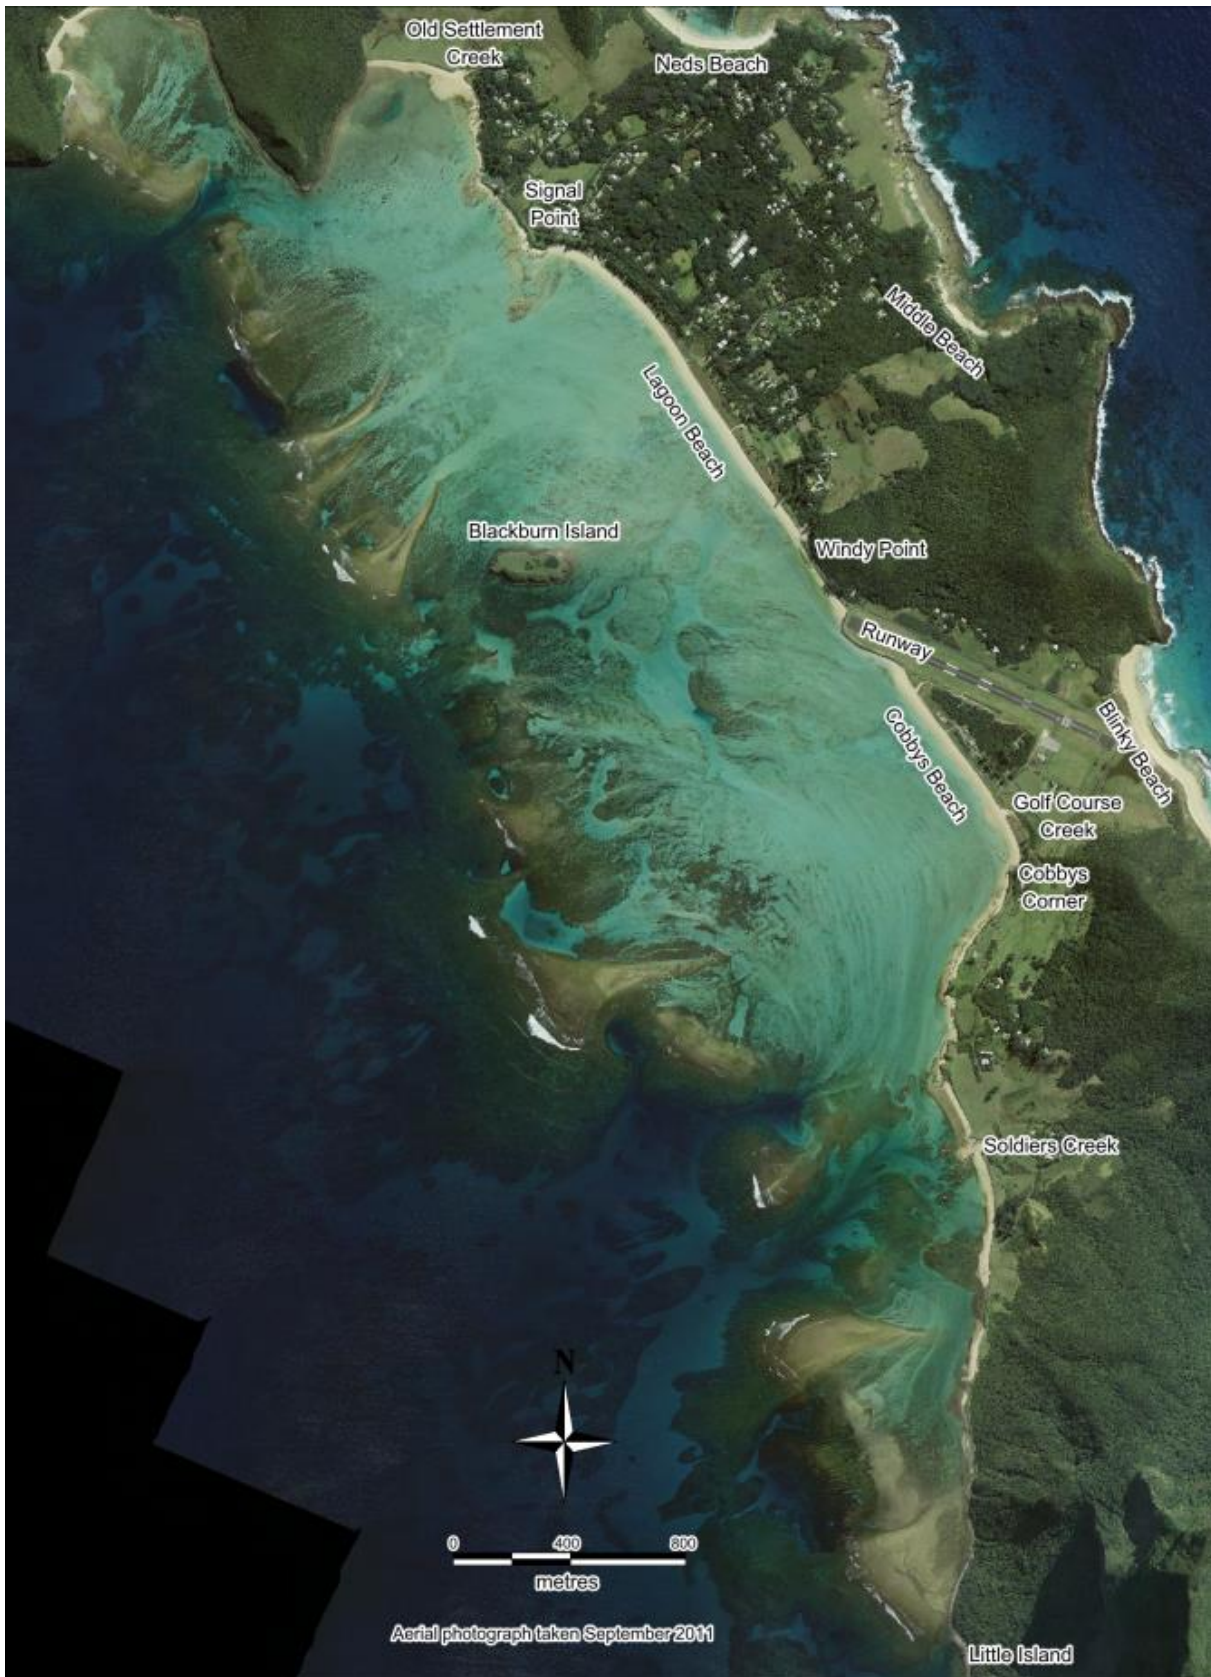
Figure 3: Aerial photograph of Lagoon area at Lord Howe Island

An aerial photograph of the entire Lagoon area is provided in Figure 3. Lagoon Beach has been defined herein to extend from Signal Point in the north to the runway (where it juts out into the Lagoon) in the south, over a length of about 1.7km. Cobbys Beach has been defined to extend from the runway in the north to Cobbys Corner in the south², over a length of about 0.8km.

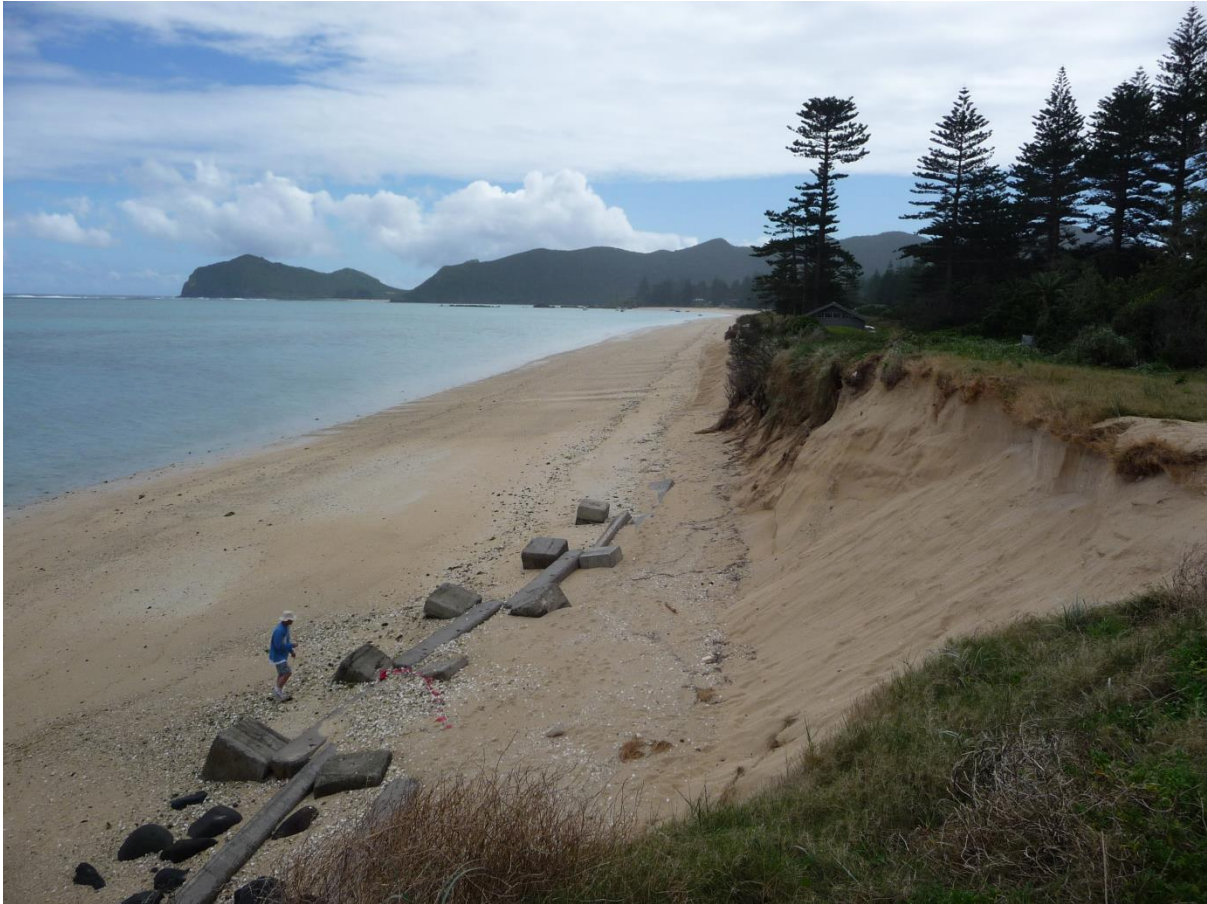
Figure 5: Concrete north of sand-filled geotextile container wall, 28 August 2012

After completion of the bag wall in May 2011, the concrete blocks originally placed in 2004 were placed immediately north of the bags at the toe of the dune. The concrete moved under wave action and was put back into position in October 2011, and then again in May 2012. A view of this area in August 2012, indicating that the concrete had again moved (or that dune erosion had extended further landward), is given in Figure 5.

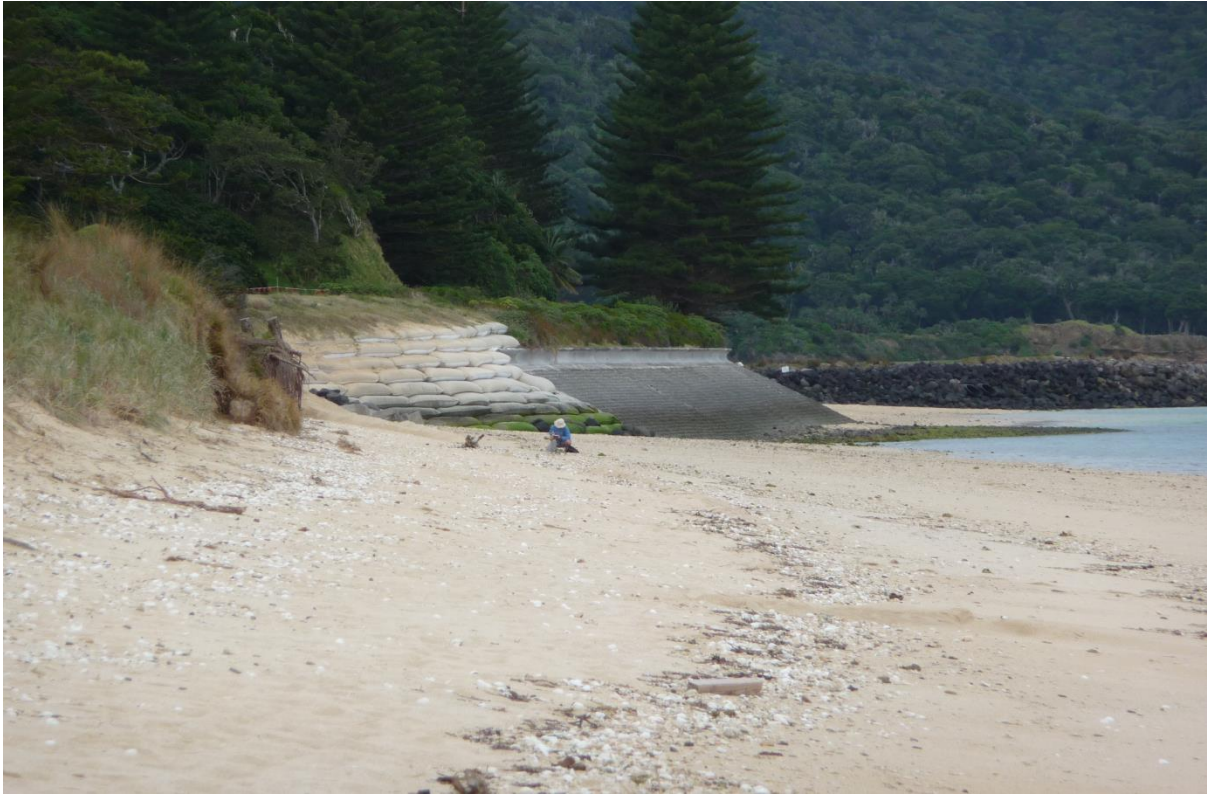
Figure 6: View of sand-filled geotextile container wall, Seabee revetment and runway revetment from the southern end of Lagoon Beach, 28 August 2012

A view of the geotextile bag wall, Seabee revetment and runway revetment from the southern end of Lagoon Beach is provided in Figure 6. A view of the bag wall and Seabee revetment from offshore is given in Figure 7. An aerial view of the location of all of these works is depicted in Figure 8.

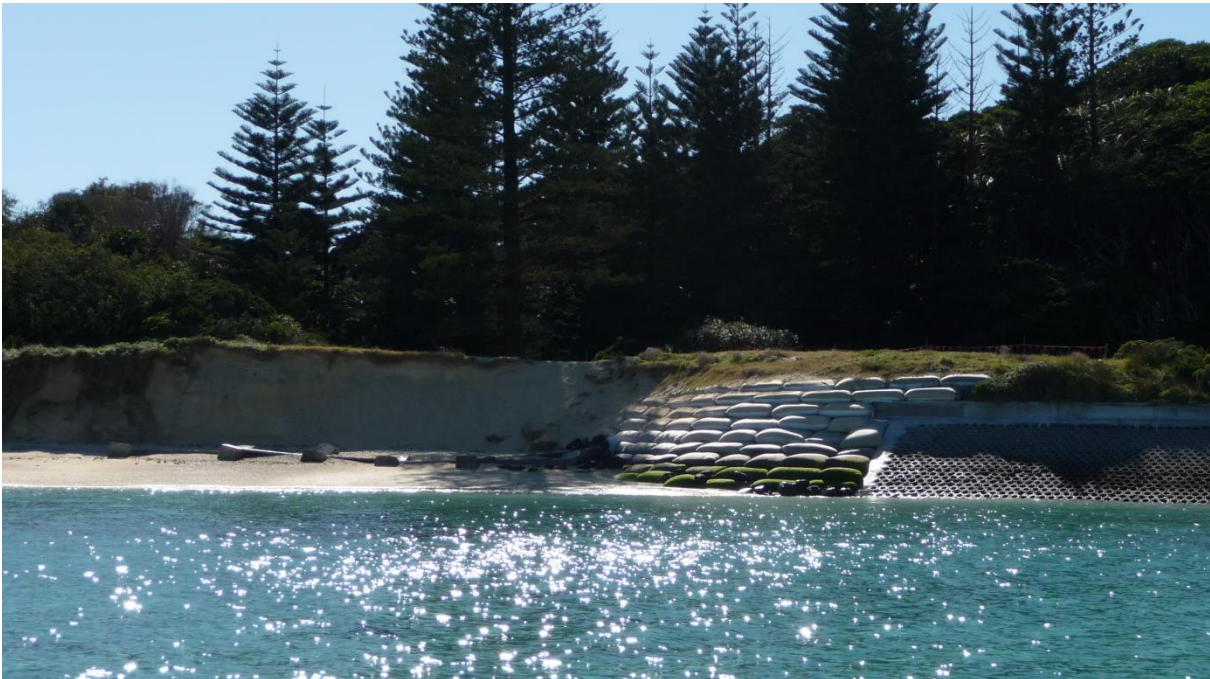
Figure 7: View (left to right) of eroding dune with concrete and rock on beach, sand-filled geotextile container wall and Seabee revetment (29 August 2012)

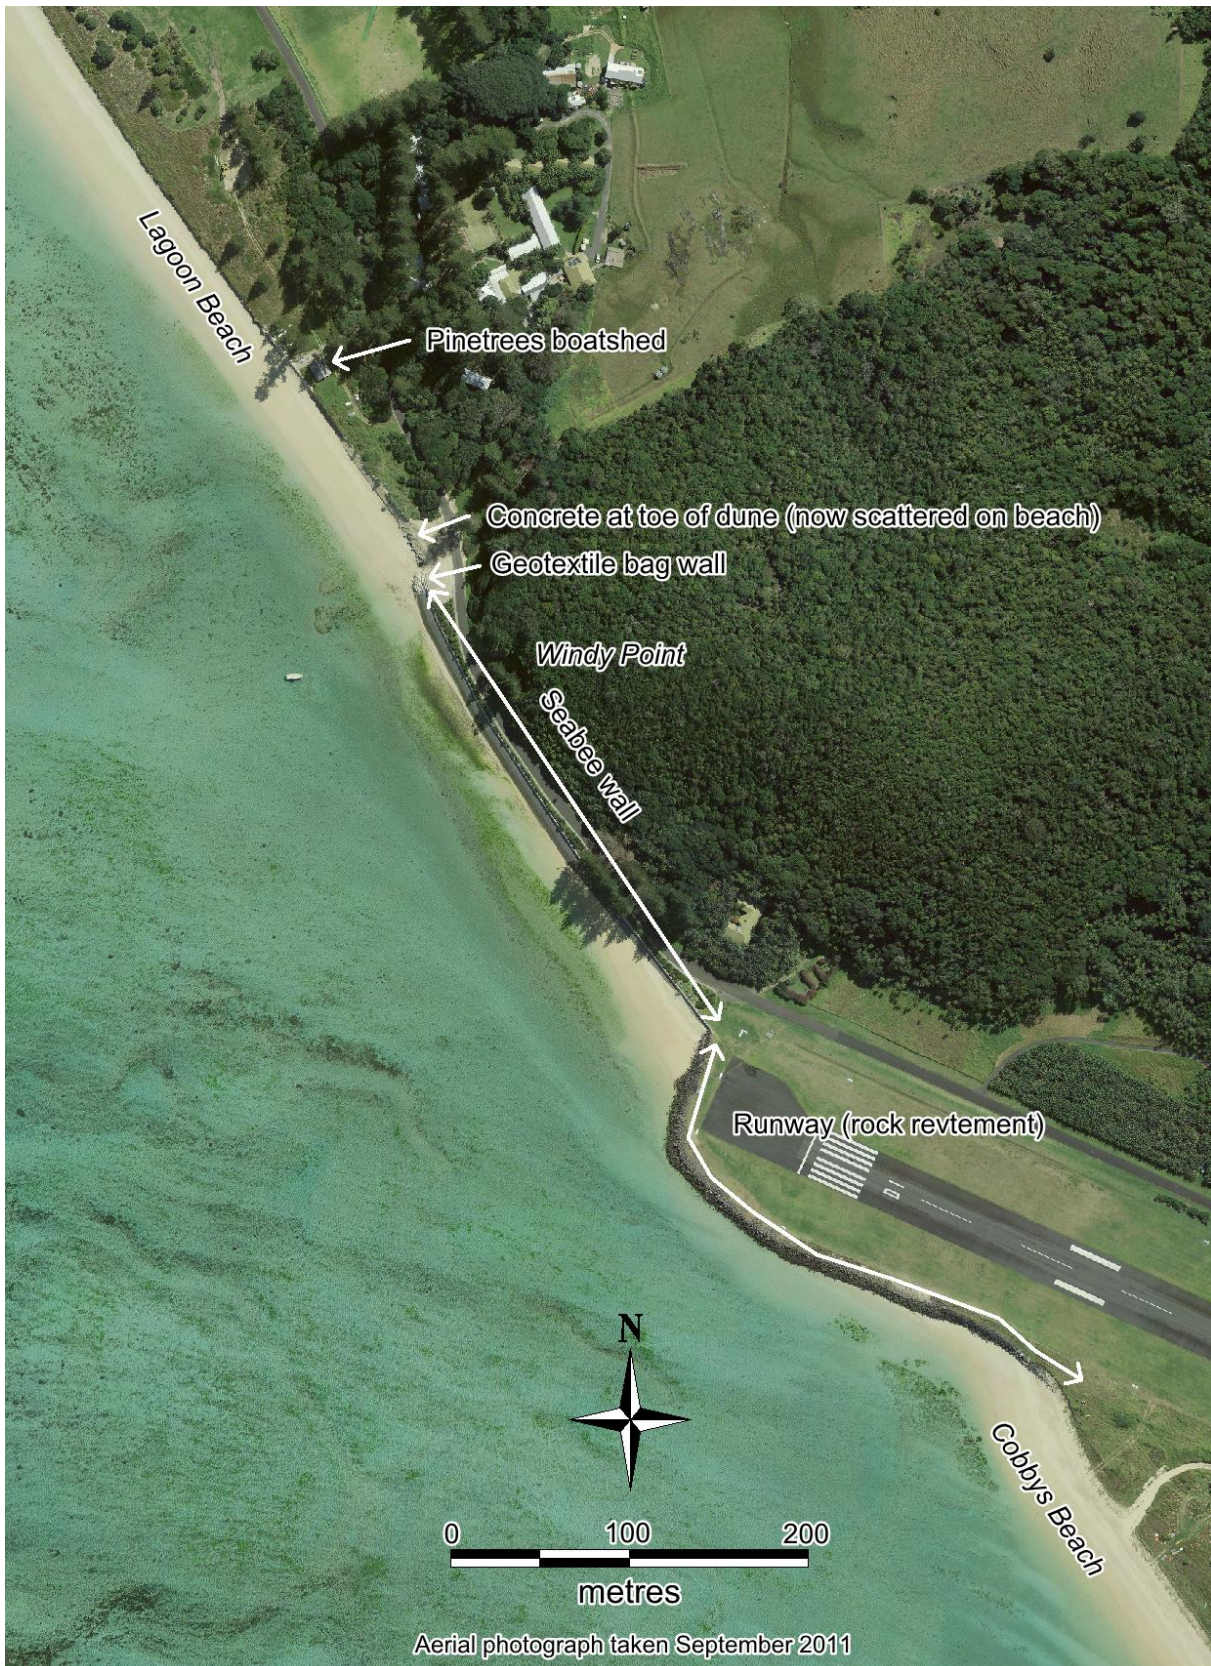
Figure 8: Location of protective works near southern end of Lagoon Beach
