Lord Howe Island
Aerodrome Technical
Inspection 2017

AERODROME TECHNICAL INSPECTION

23rd – 26th July 2017

Airport Operation Support Pty Ltd

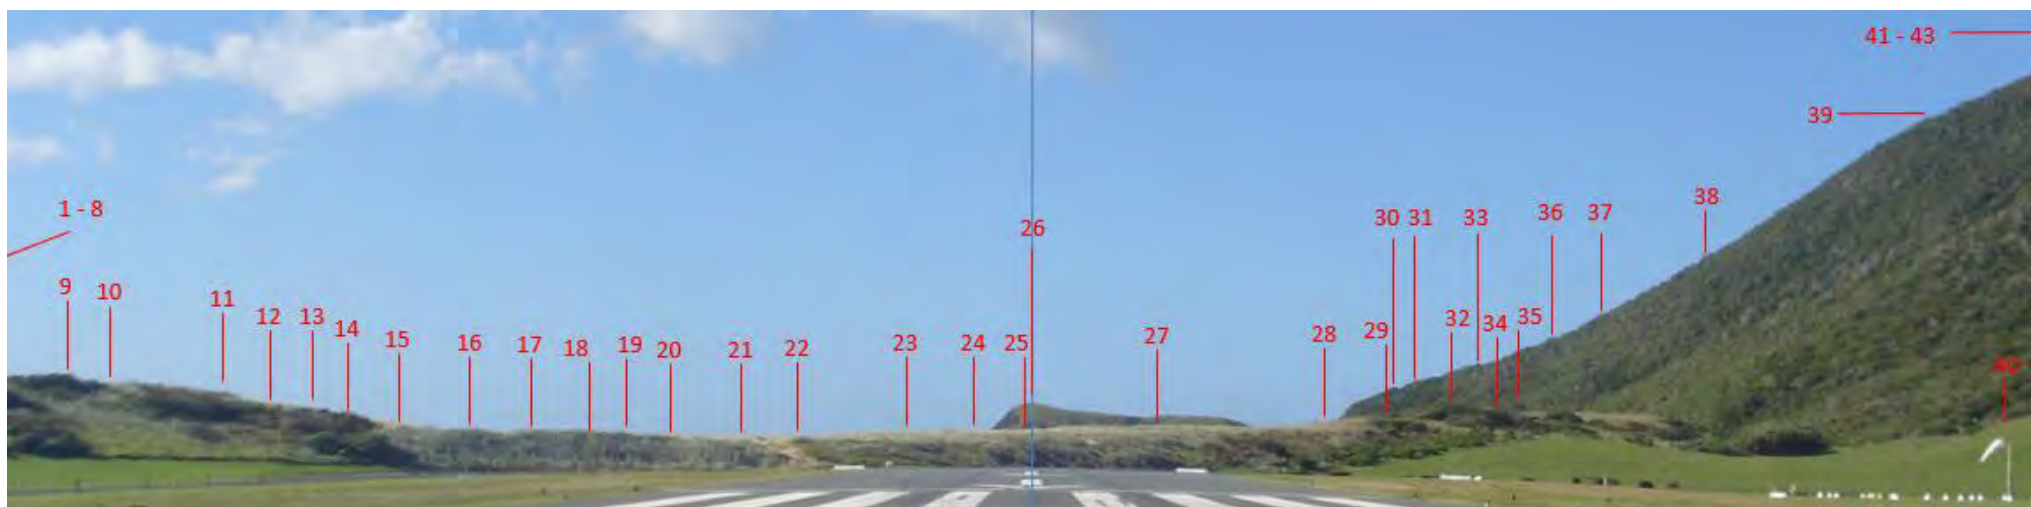
# 38	Intermediate Hill	1123.65	117.45	364.00		--	--	--	--	--					IHS	Infringes 72.65	Not Applic.	--		
# 39	Intermediate Hill	1041.45	181.20	455.70		--	--	--	--	--					IHS	Infringes 136.4	Not Applic.	--		
40	PWI	-33.85	4.33	91.10		--	--	--	--	--					TS	Under 5.11m	Not Applic.	--

# 41	Intermediate Hill	1025.35	241.24	621.30		--	--	--	--	--					IHS	Infringes 196.44	Not Applic.	--		
# 42	Intermediate Hill	661.95	200.05	517.30		--	--	--	--	--					IHS	Infringes 155.25	Not Applic.	--		
LOP 43	Norfolk pines	-324.75	41.07	200.10		--	--	--	--	--					TS	Infringes 10.18m	Not Applic.	--

Recommendation 6: To conduct a full field Emergency Exercise and complete the formal annual review of the Aerodrome Emergency Plan.				
Recommendation 7: To lop, remove or re-locate those obstacles found to be infringing the OLS as identified by yellow highlighting and the word "LOP" in the survey result tables within Section 10.2 of this report.
