LORD HOWE ISLAND BOARD

Development Application

Stage 2 involves the construction of an amenities block on the northern side of the historic Old Post Office building on Lot 44. The building will contain three toilets (including a fully accessible toilet) and a urinal, along with wash basins and associated infrastructure.

Statement of Environmental Effects

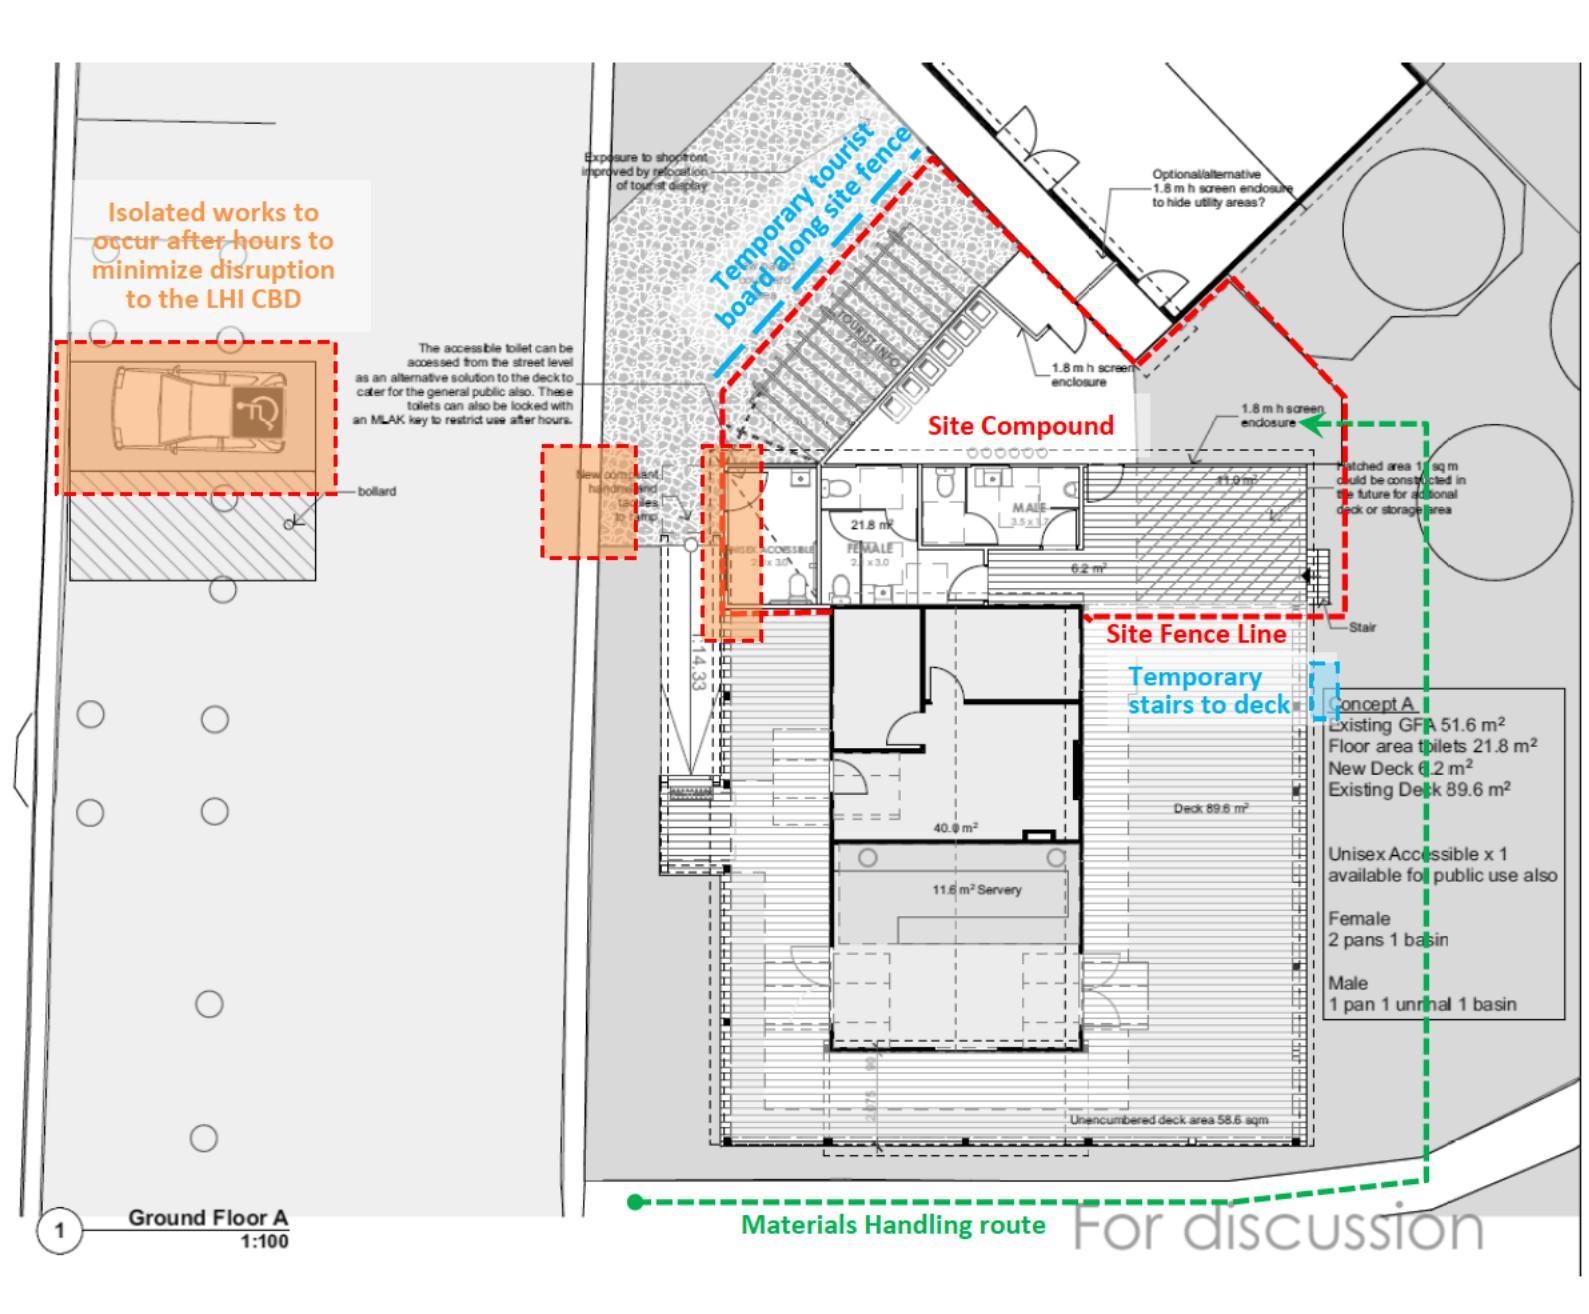
APPENDIX A – Preliminary Site Establishment Plan

Note, the preliminary site compound is indicative only and will be developed by the appointed contractor to align with the construction methodology and sequencing of works. The contractor is to consider public safety and ensure appropriate separation is provided between the public and construction activities.

A preliminary site establishment plan for Stage 2 can be found under Appendix 1.

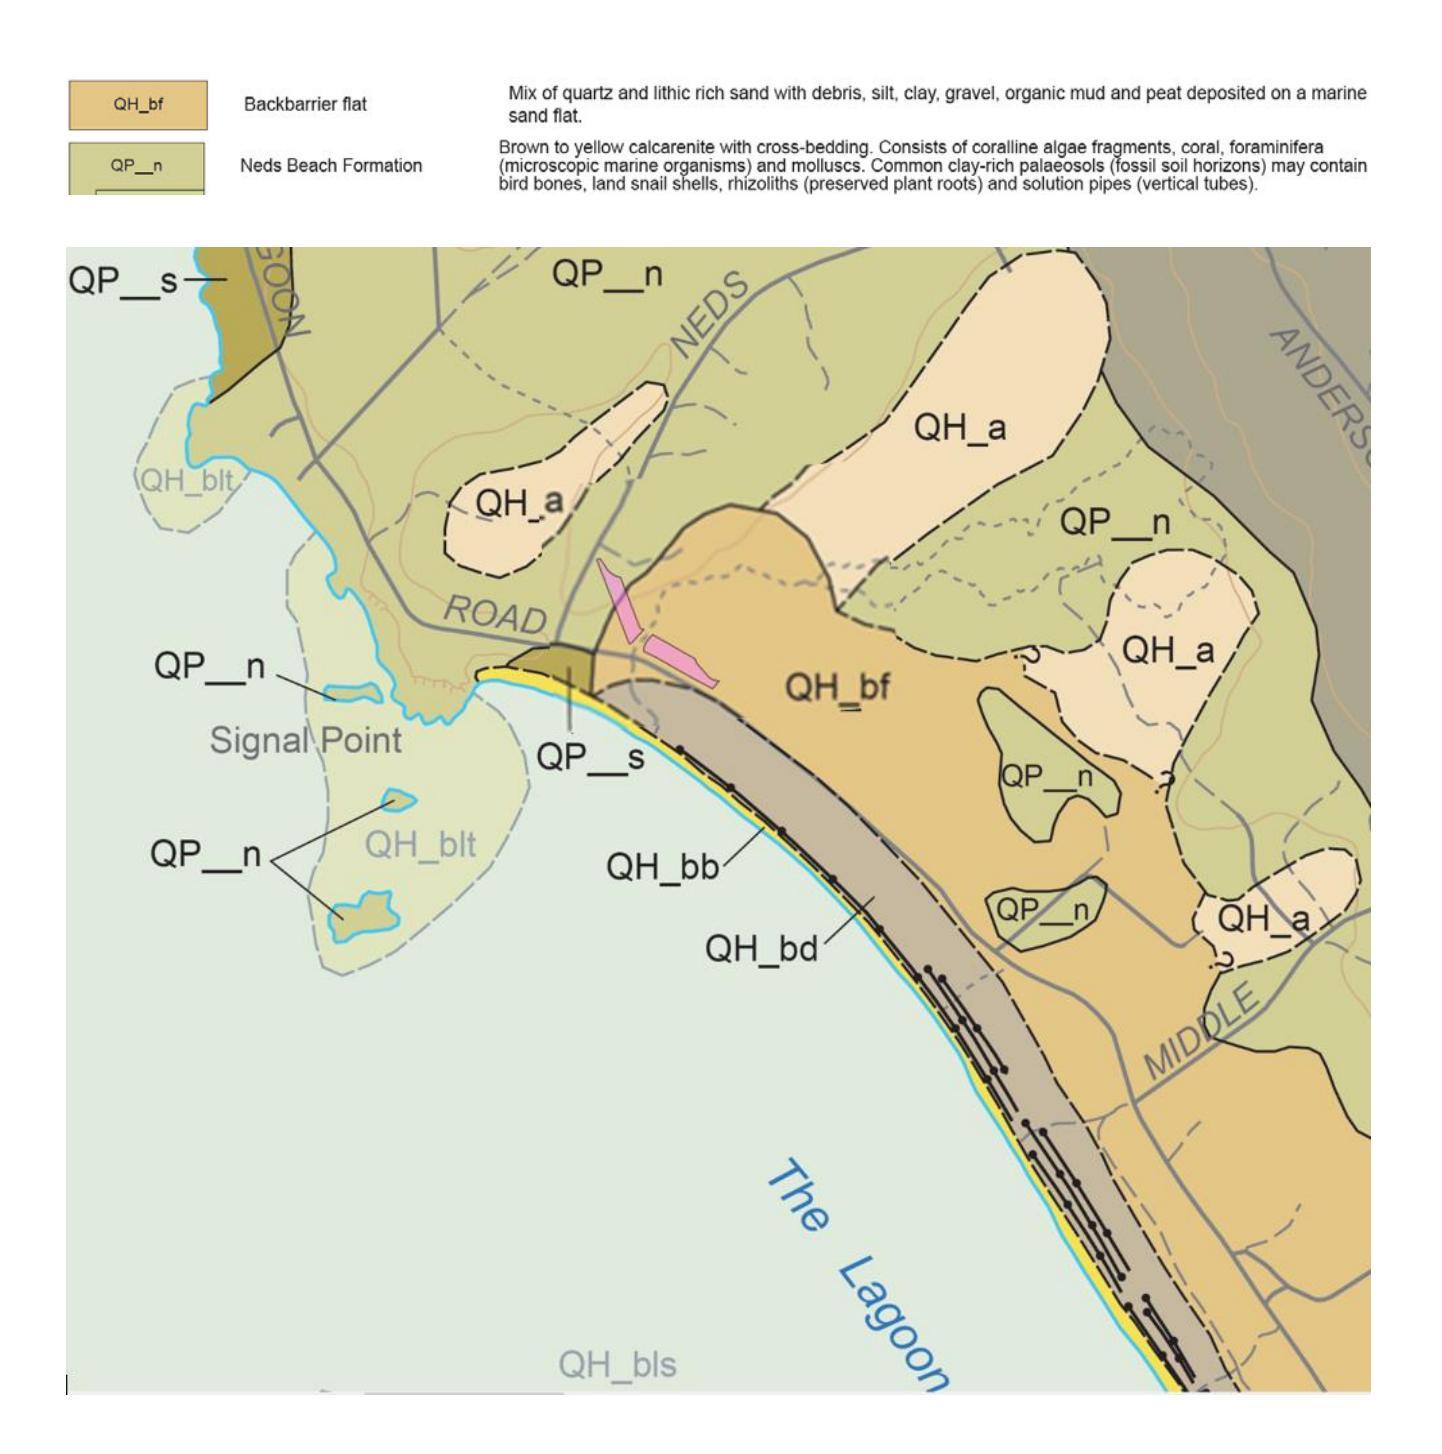
3.2 Soil Landscape Map

The following information was obtained within NSW Government: Geology of Lord Howe Island, 1:15,000, 2022. The Geological mapping indicates the Effluent management area is within the Backbarrier Flat and the Ned's Beach Formation Detailed Below.

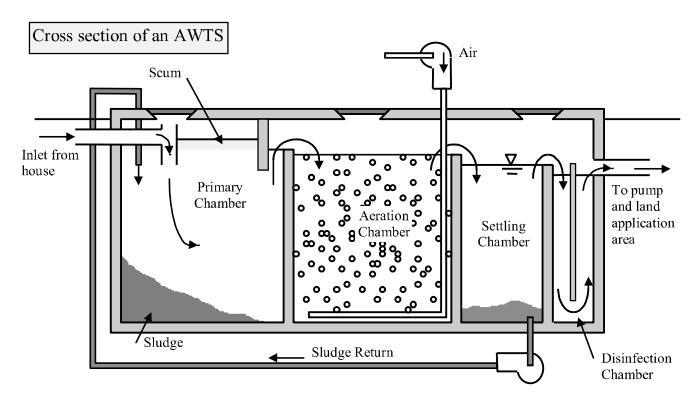
Wastewater from a household is treated in stages in several separate chambers. The first chamber is similar to a conventional septic tank. The wastewater enters the chamber where the solids settle to the bottom and are retained in the tank forming a sludge layer. Scum collects at the top, and the partially clarified wastewater flows into a second chamber. Here the wastewater is mixed with air

to assist bacteria to further treat it. A third chamber allows additional clarification through the settling of solids, which are returned for further treatment to either the septic chamber (as shown) or to the aeration chamber. The clarified effluent is disinfected in another chamber (usually by chlorination) before irrigation can take place.

Bacteria in the first chamber break down the solid matter in the sludge and scum layers. Material that cannot be fully broken down gradually builds up in the chamber and must be pumped out periodically.

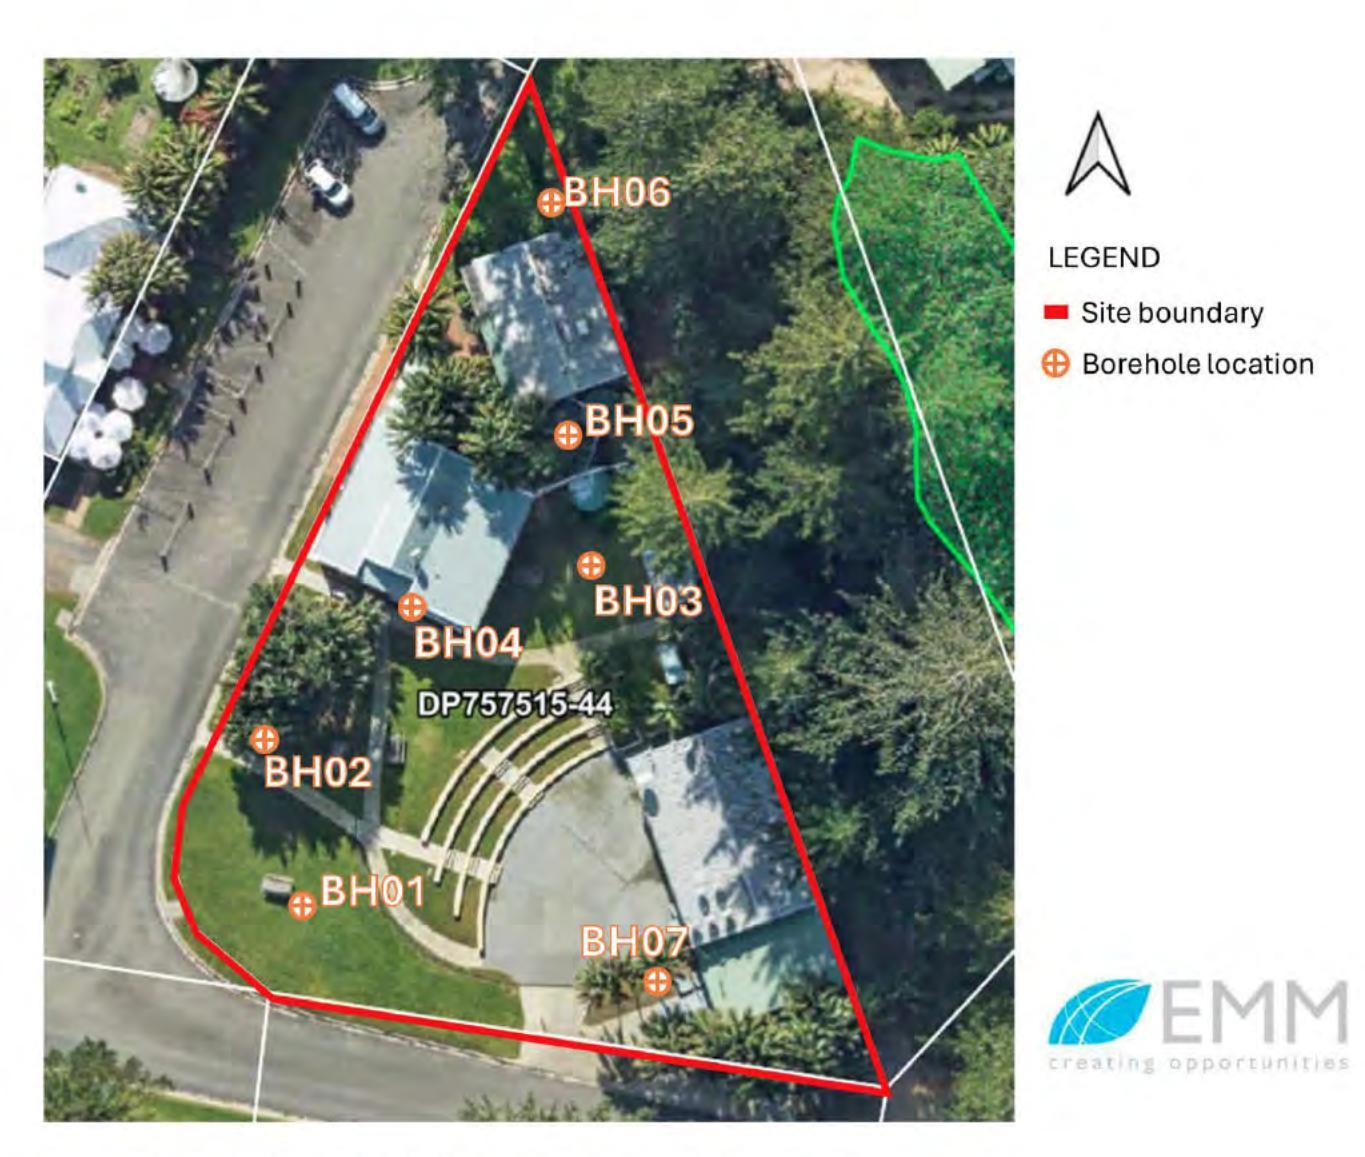
Figure 2.1 Site layout and sampling locations

Note, location BH04 was abandoned due to the presence of underground services within the area.

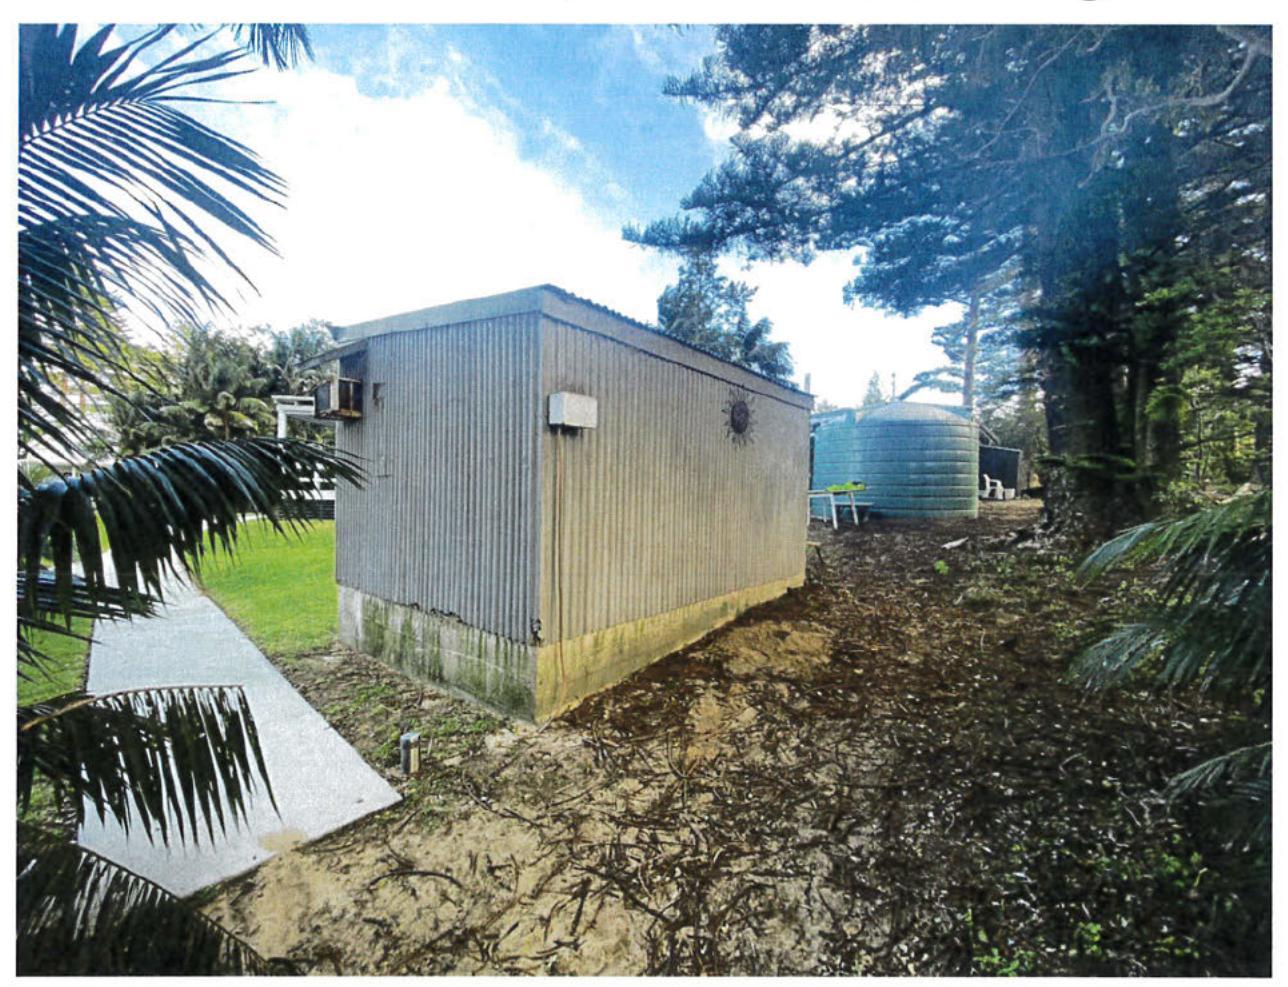
View of the site (location of borehole 1) facing a north westerly direction.

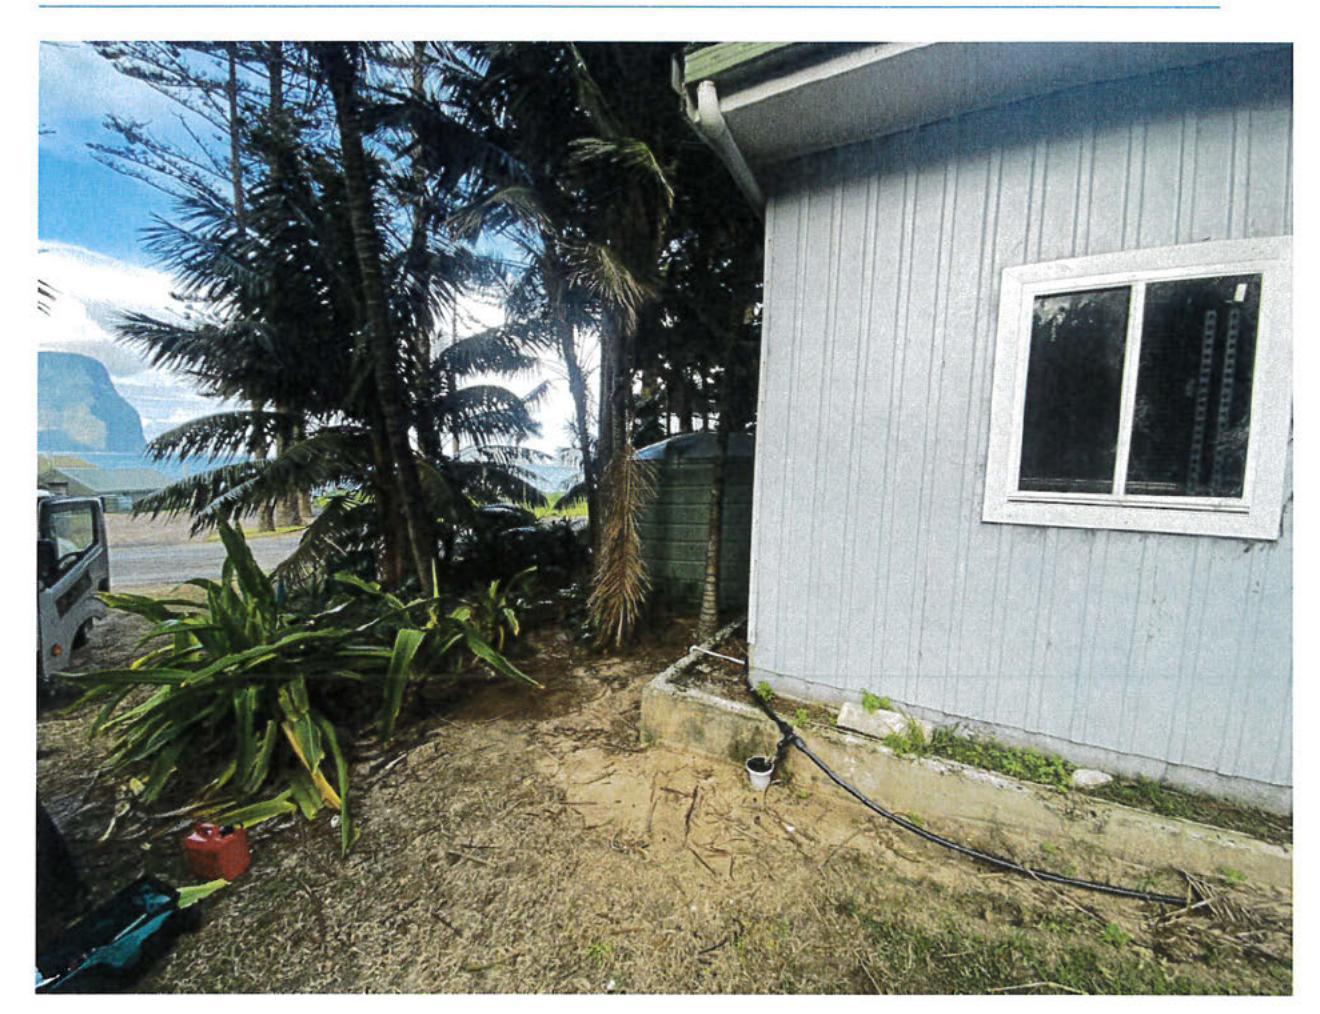
View of the site (location of borehole 2) facing a southerly direction.

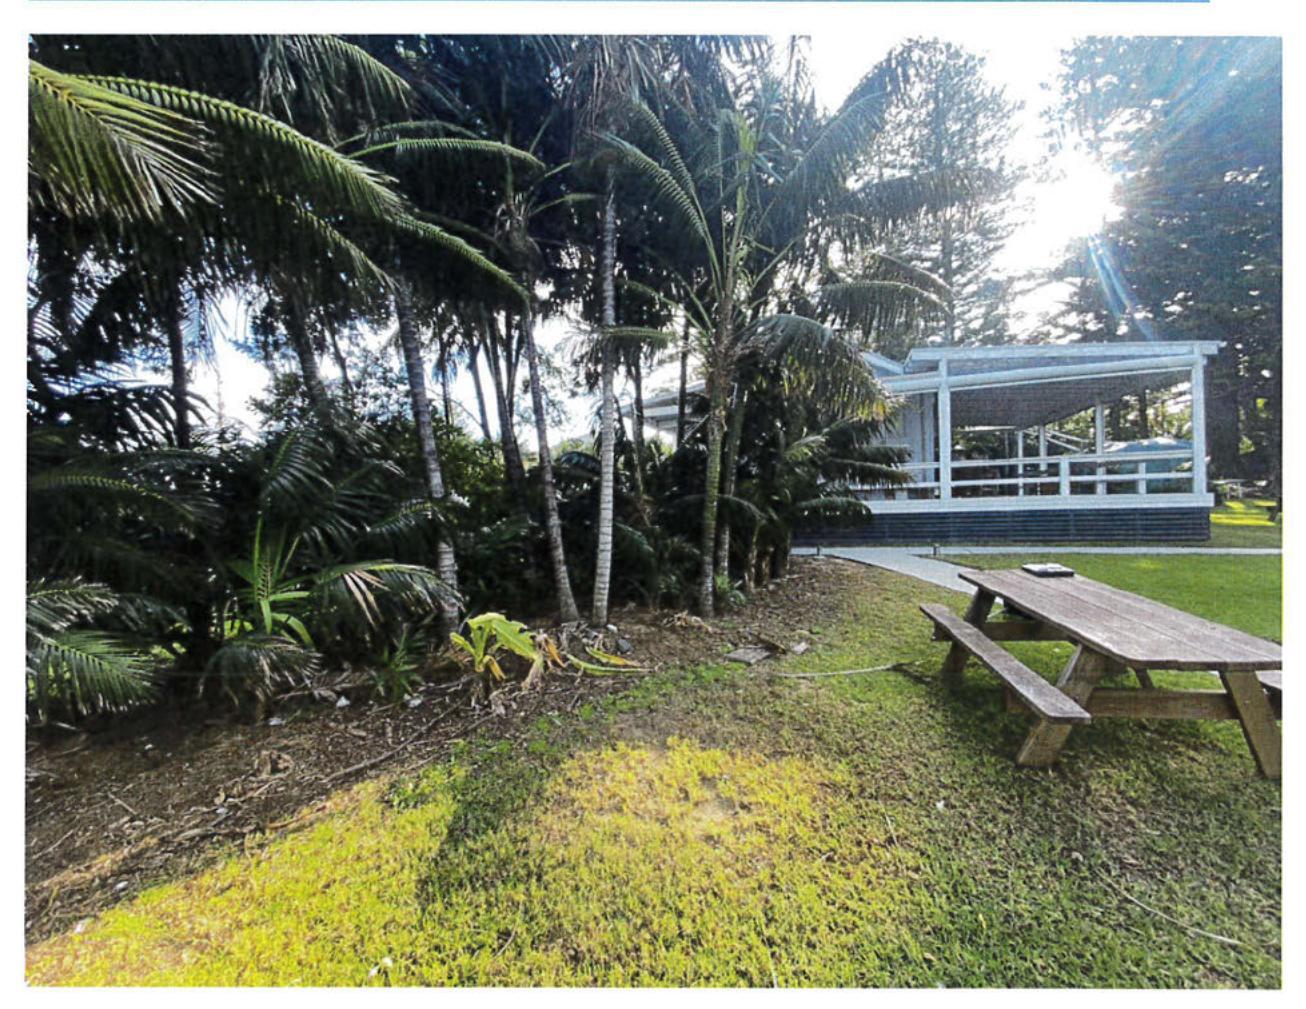
View of the site (location of borehole 3) facing a northerly direction.

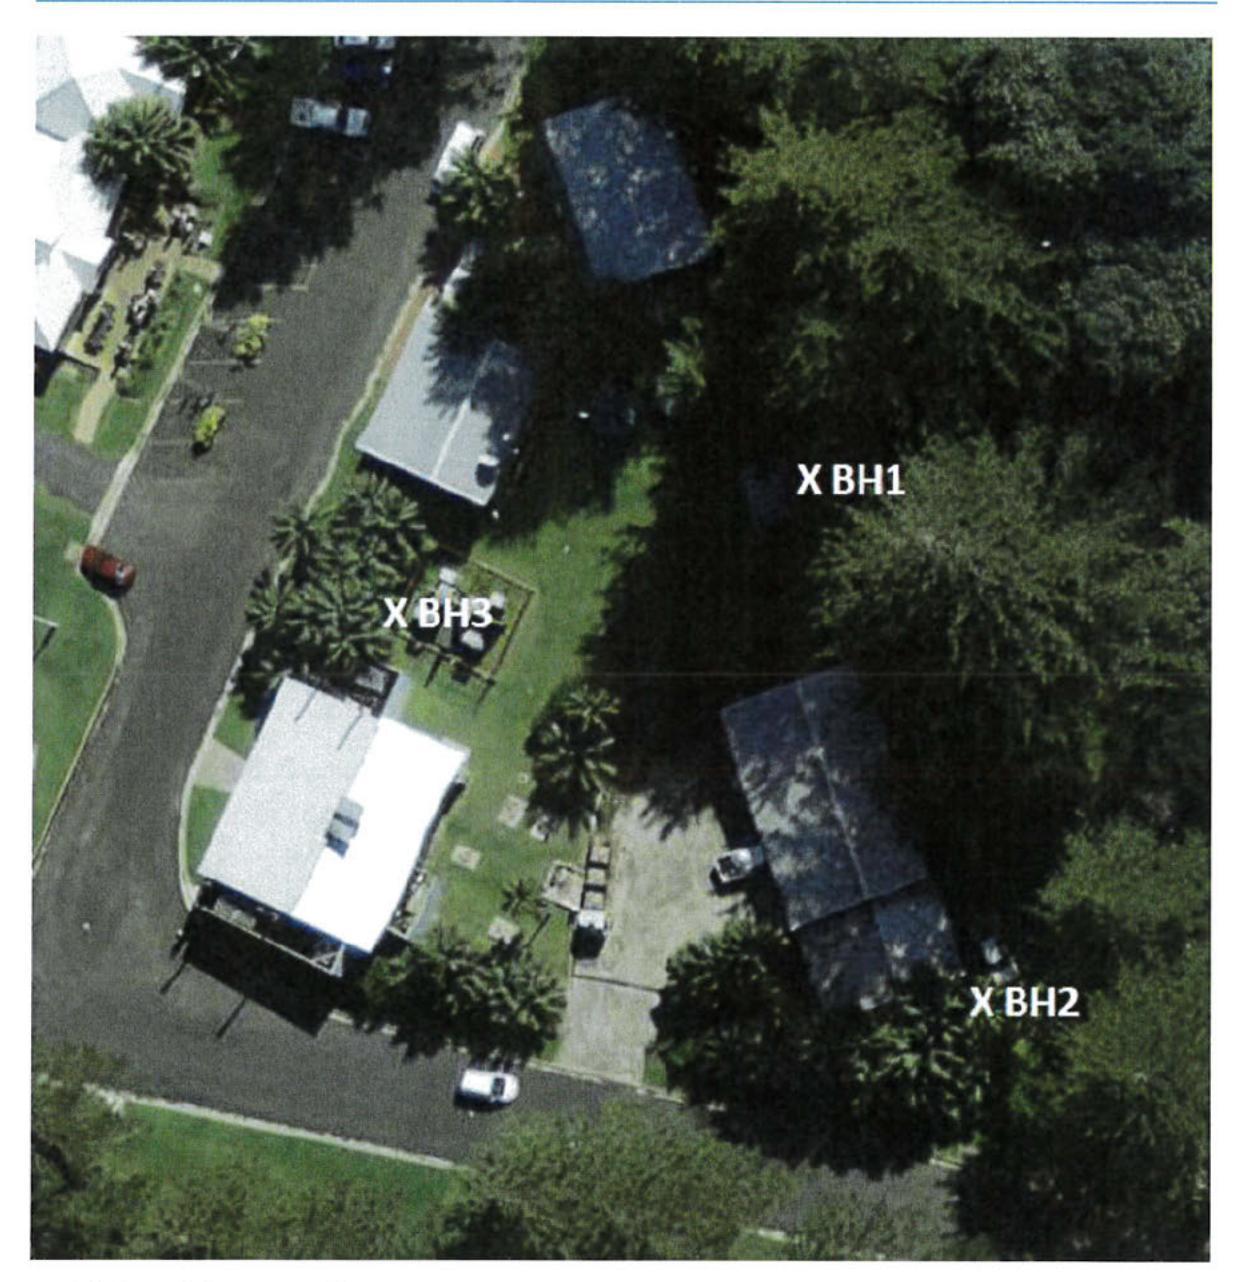
Aerial view of the site, with ASCT test positions.

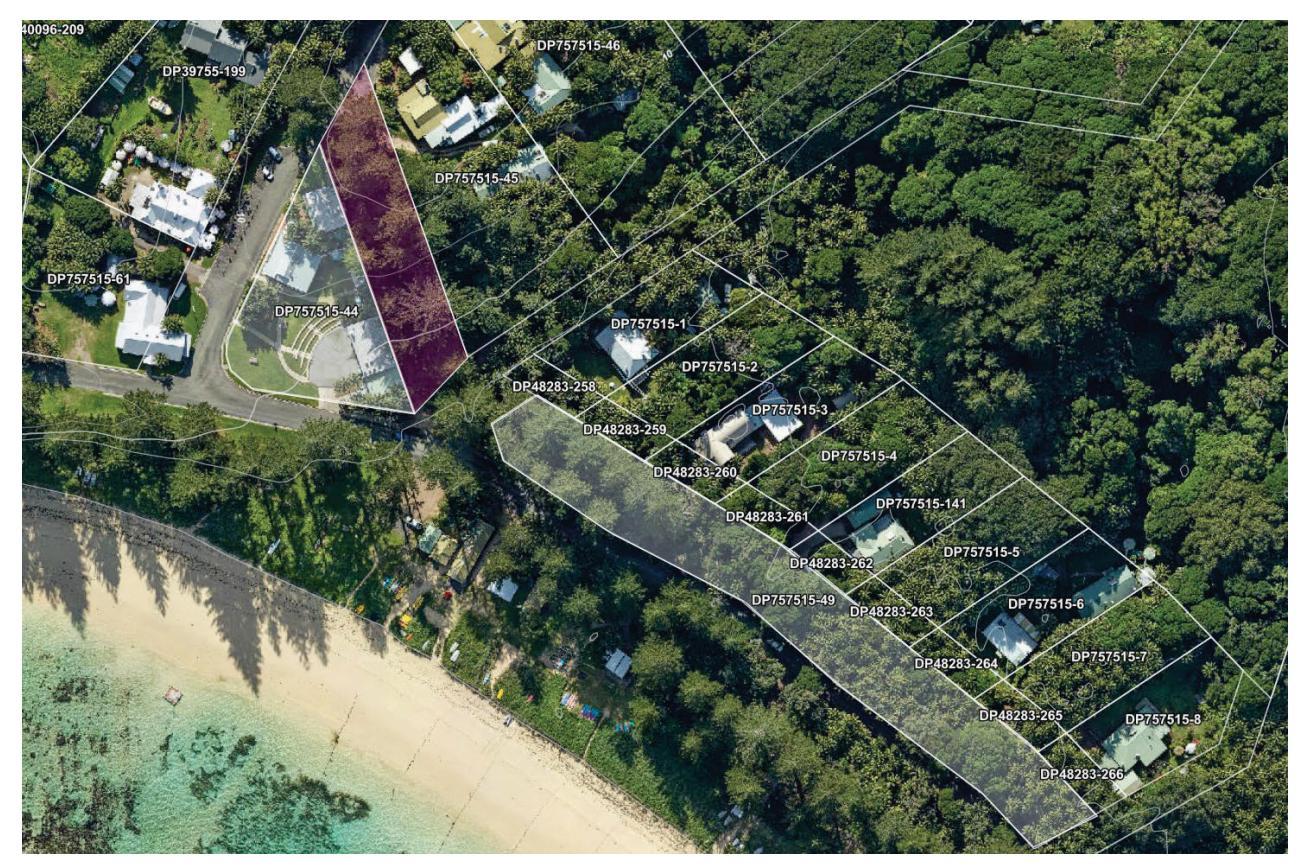
Figure 2 Subject Sites

The wastewater treatment system will be located on Lot 44, with irrigation proposed to be within the road reserve to the North East of Lot 44 (highlighted in colour on Figure 1) as well as on Lot 49 on DP757515 as noted on Figure 1 below.
